DIRECTORATE OF AIRCRAFT ACCIDENT INVESTIGATION ACCIDENT REPORT – EXECUTIVE SUMMARY

Aircraft Registration	V5 - VVJ	Date of Accident	6 July 2012	Time of Accident	15:30 UTC
Type of Aircraft	CESSNA 210L		Type of Operation	Charter	
Pilot- In - command License Type	CPL	Age	20	License Valid	valid
Pilot-In-command Flying Experience	Total Flying Hours	362.2	Hours on Type	87.9	
Last point of departure	Mushara (Etosha)				
Next point of intended landing	Swakopmund

AIRCRAFT ACCIDENT REPORT

Name of Owner/Operator : Scenic Air
Manufacture : Cessna
Model : 210L
Nationality : Namibian
Registration : V5 - VVJ
Place : Swakopmund
Date : 6TH July 2012

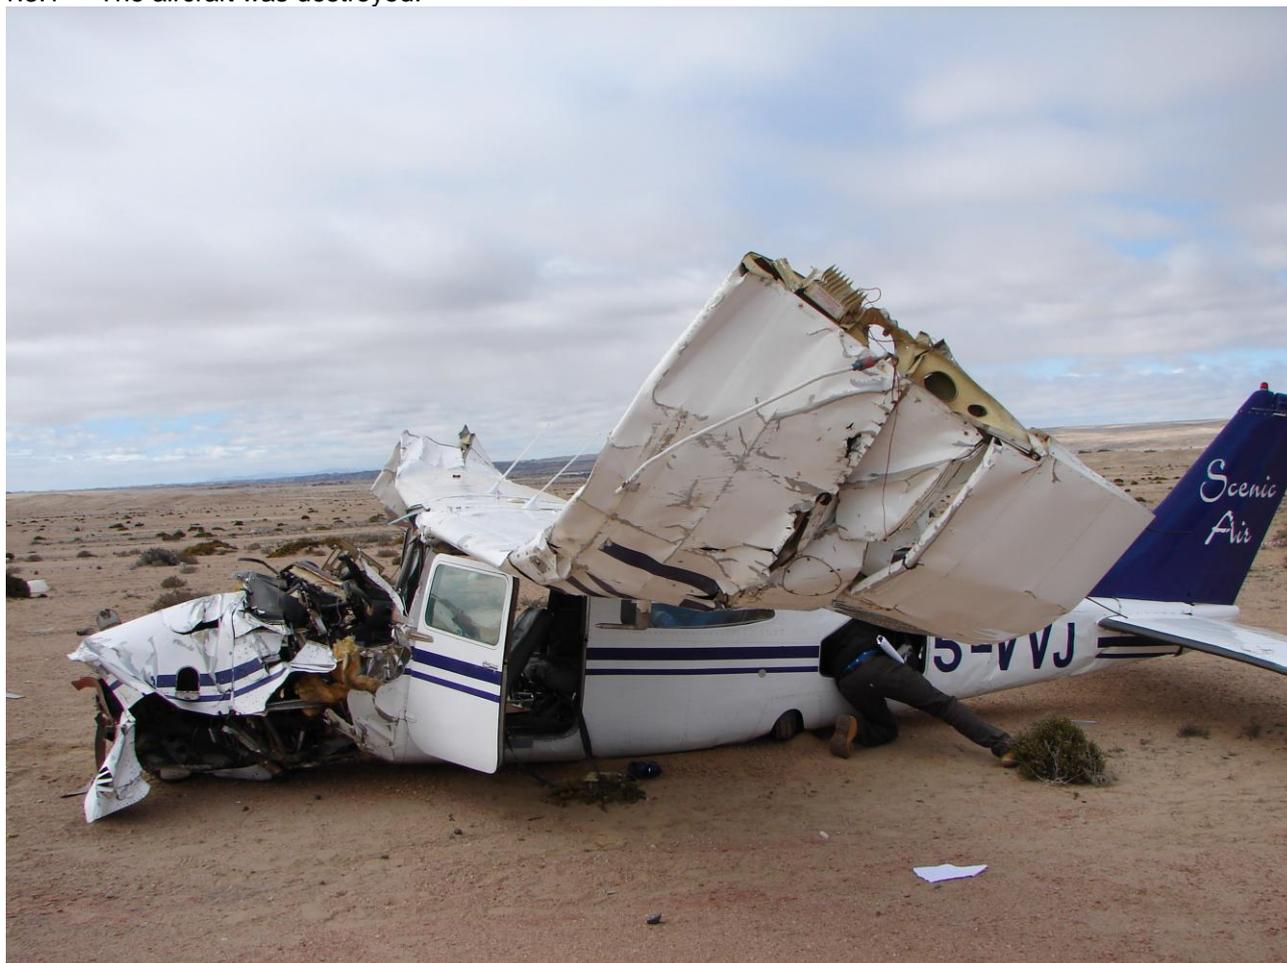
1.3.1 The aircraft was destroyed.

Figure 2: View of the wreckage after the accident

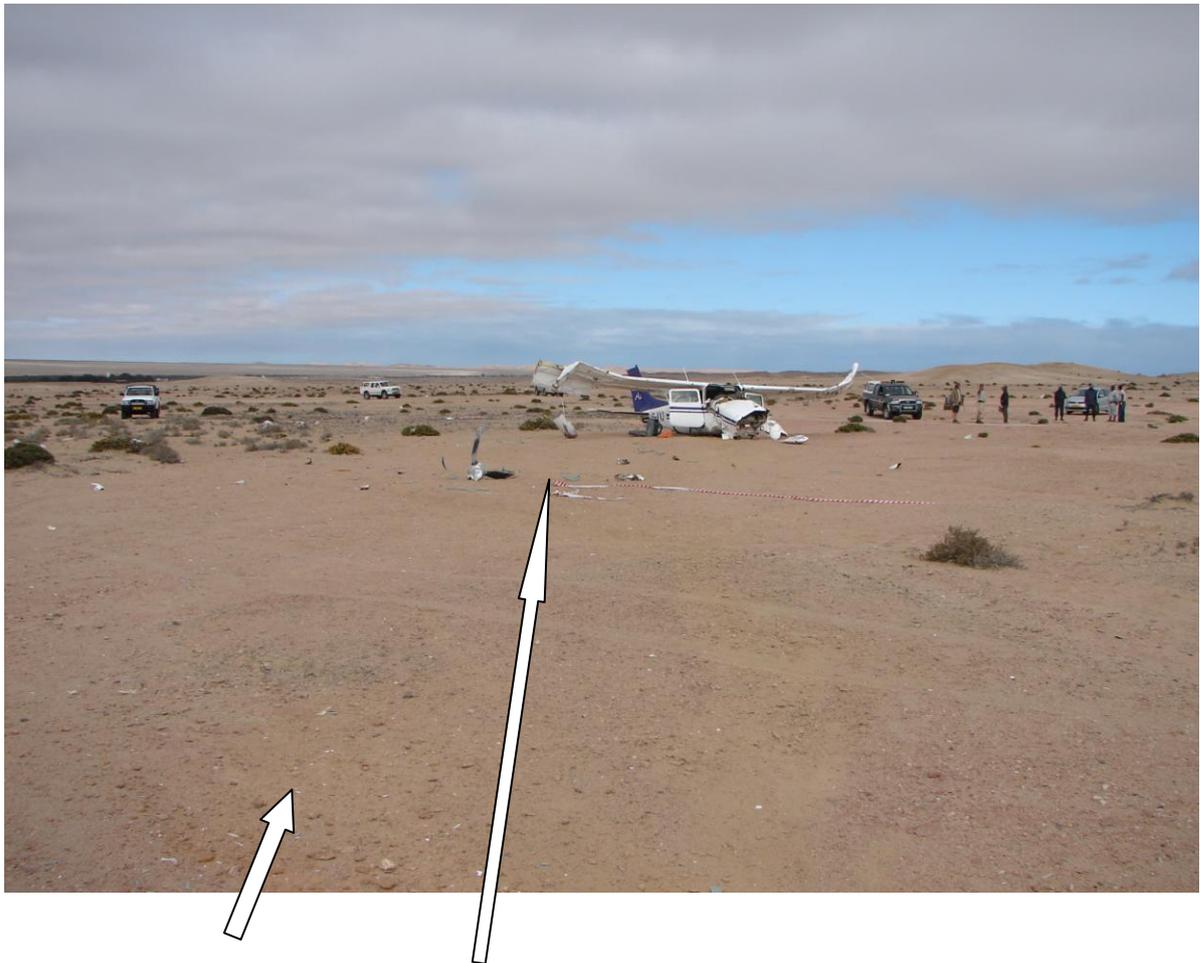
The impact occurred in a westerly direction, with a high rate-of-decent in a nose-down attitude whilst in a slight left-hand turn. The initial impact marks of the left wing tip were approximately 32m from the main wreckage.

Figure 3: initial impact on the left wing followed by propeller contact with the ground catapulting the aircraft on a 180° spin.

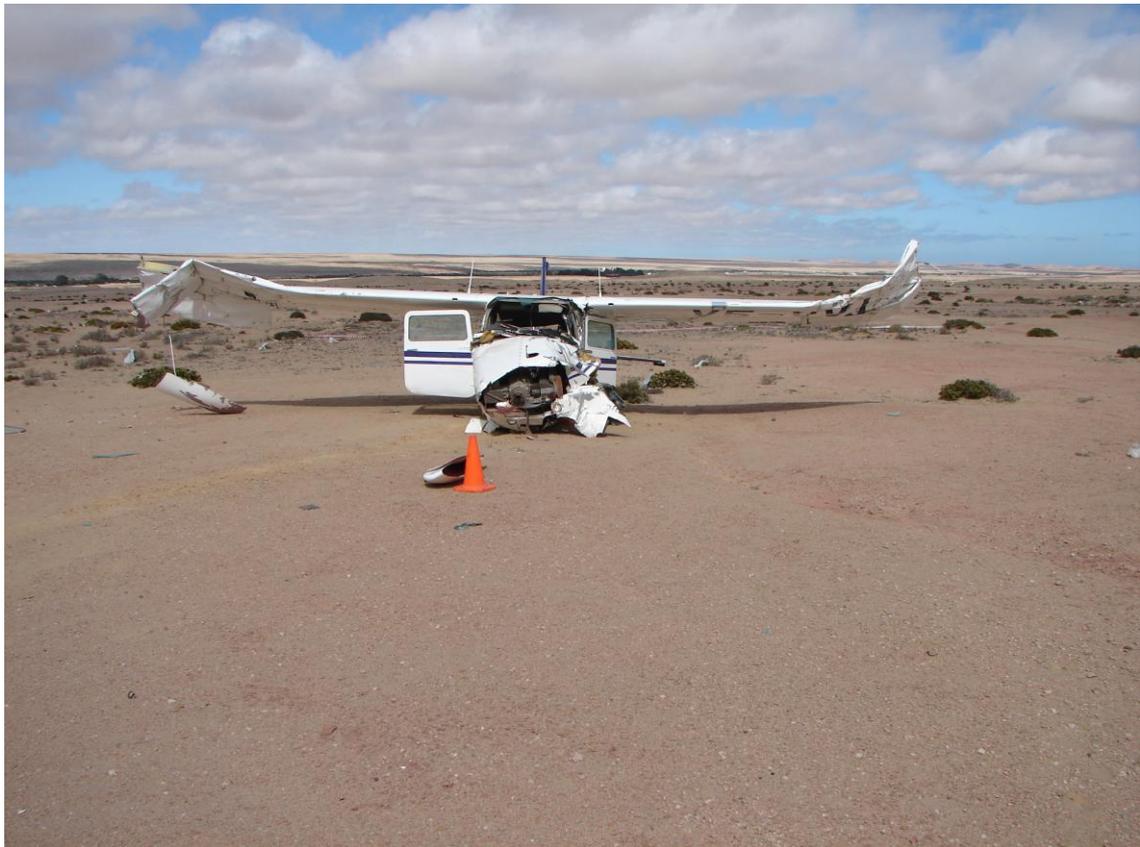
Fig 4: final resting space about 32m from initial point of impact.

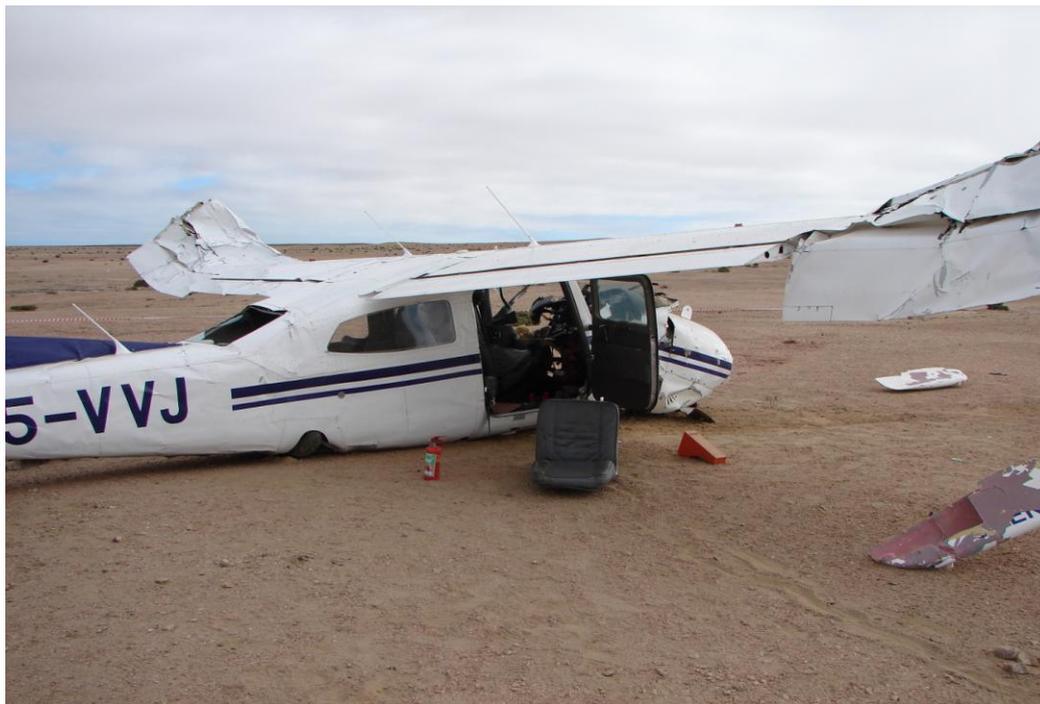
Figure 5: The right hand seat detached on impact from the rail and later removed from the aircraft when rescuing the passenger.

1.15.2 The right hand seat detached from the seat rail.

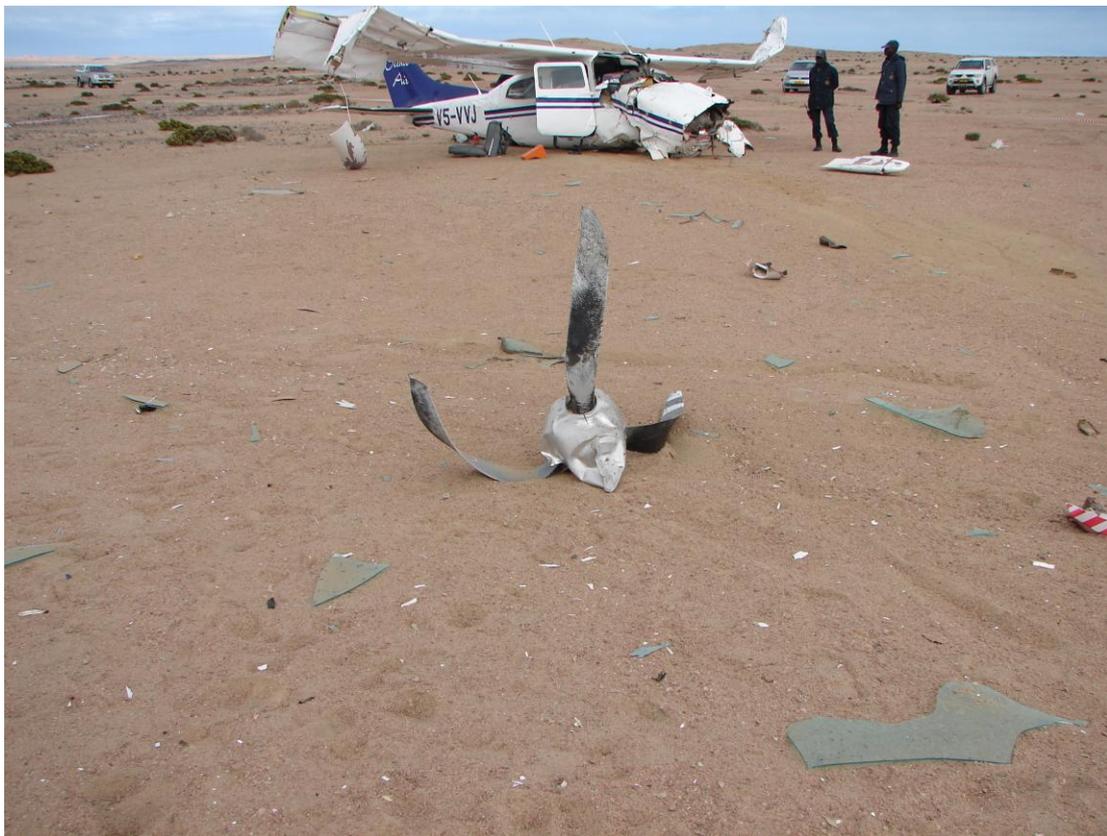
Fig 6: The Propeller hub detached on impact as the engine absorbed most of the impact.

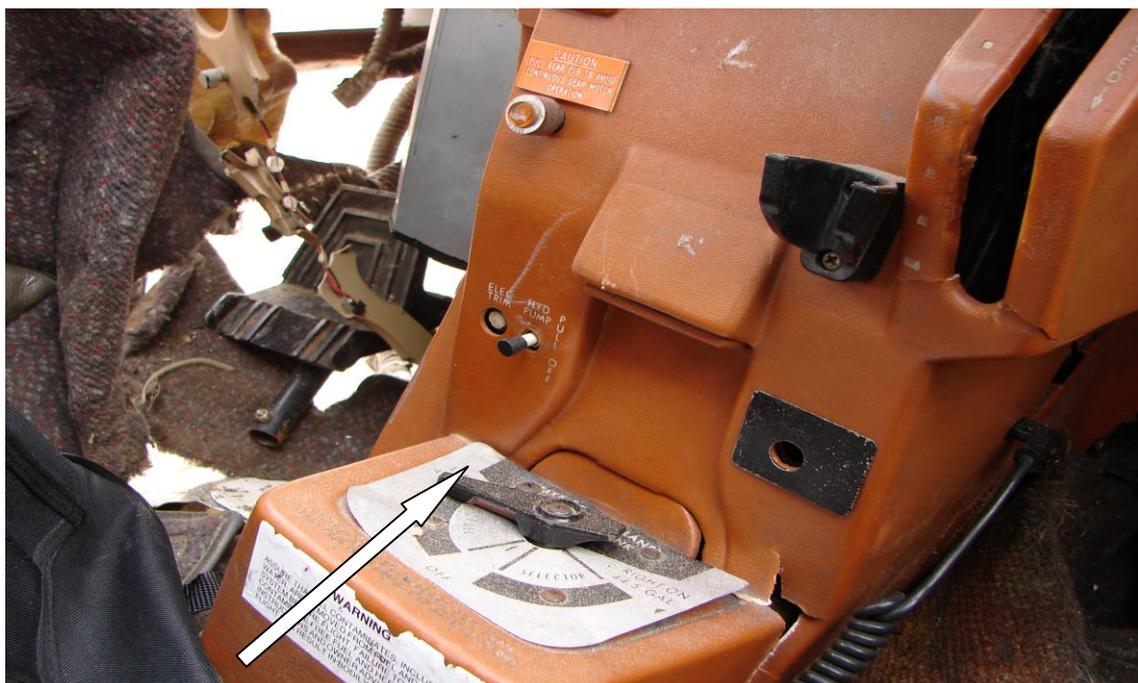
Fig. 7.
Fuel selector valve changed to the left tank after engine stopped.

1.16.3 The fuel selector was function checked and found operational. (see appendix 2)

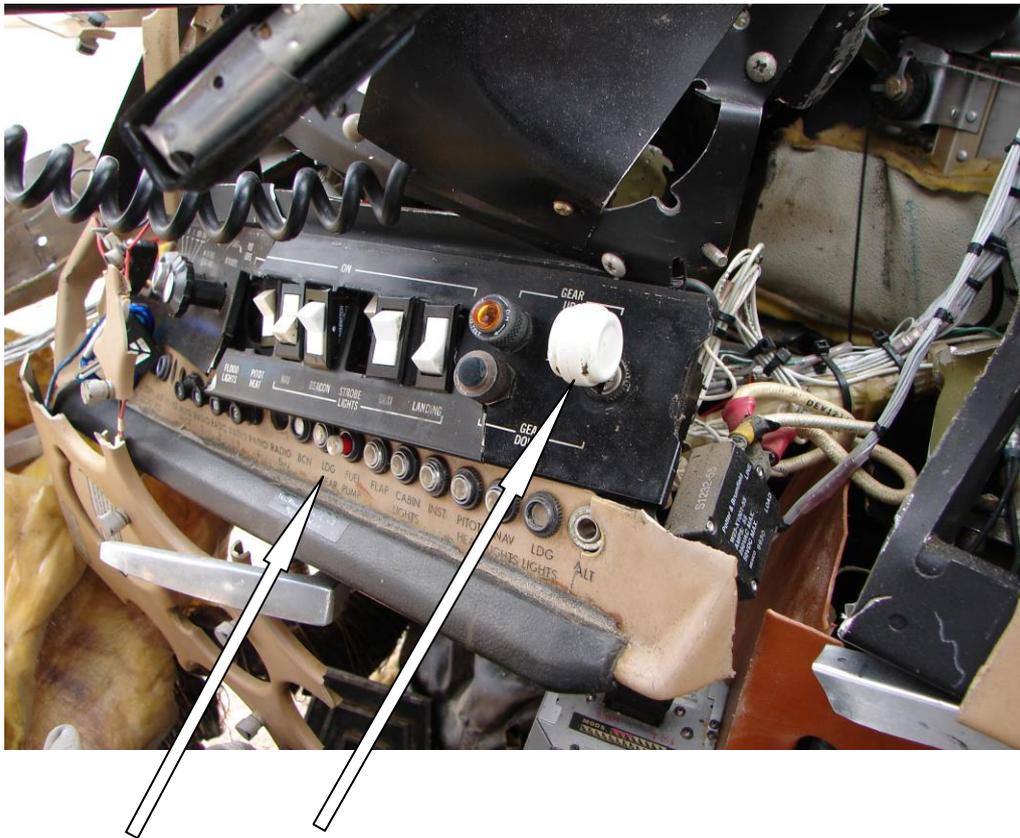
**Fig 8. Landing gear selector lever still set to up.
Fuel pump CB (circuit breaker) popped out due to pump running dry.**

- 2.3 The accident was survivable, though proper aircraft configuration for landing could have caused the under-carriage to absorb most impact forces and reduce the damage to the fuselage.

- 3.1.7 Investigations revealed that the SOPs (Standard Operating Procedures) were not followed with regards to aircraft configuration on forced landing as well as briefings to passengers on the emergency.

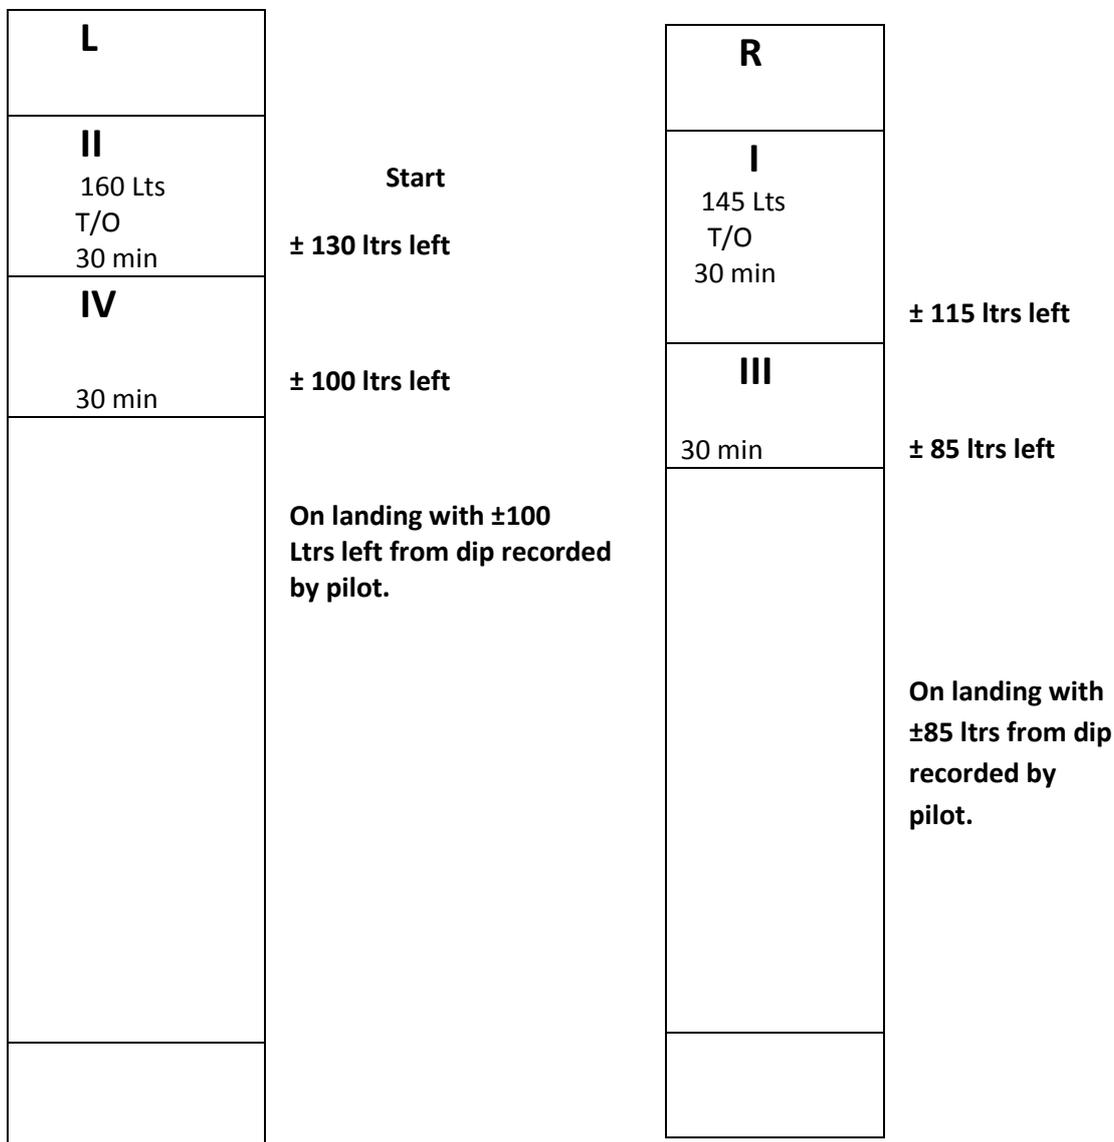
Graphical illustration of fuel management on the outbound leg. (Swakopmund-Mushara.)

- 3.1.1 Examination of the aircraft flight log, fuel log and manifest indicated that not all entries were consistent with the operator's procedures. The mass and balance sheet basic principles were not adhered to adequately as the C.O.G (centre of gravity) was close to the margin on take-off and shifted progressively as fuel burned off. Fuel log calculations as documented by the pilot did not demonstrate acceptable level of management technique. (see appendix 1).

Actual fuel used 115 Ltrs on flight log by dipping method- Pilot confirms.

Take-off Swakopmund : 305 ltrs both tanks.

Land Mushara: 185 ltrs both tanks.

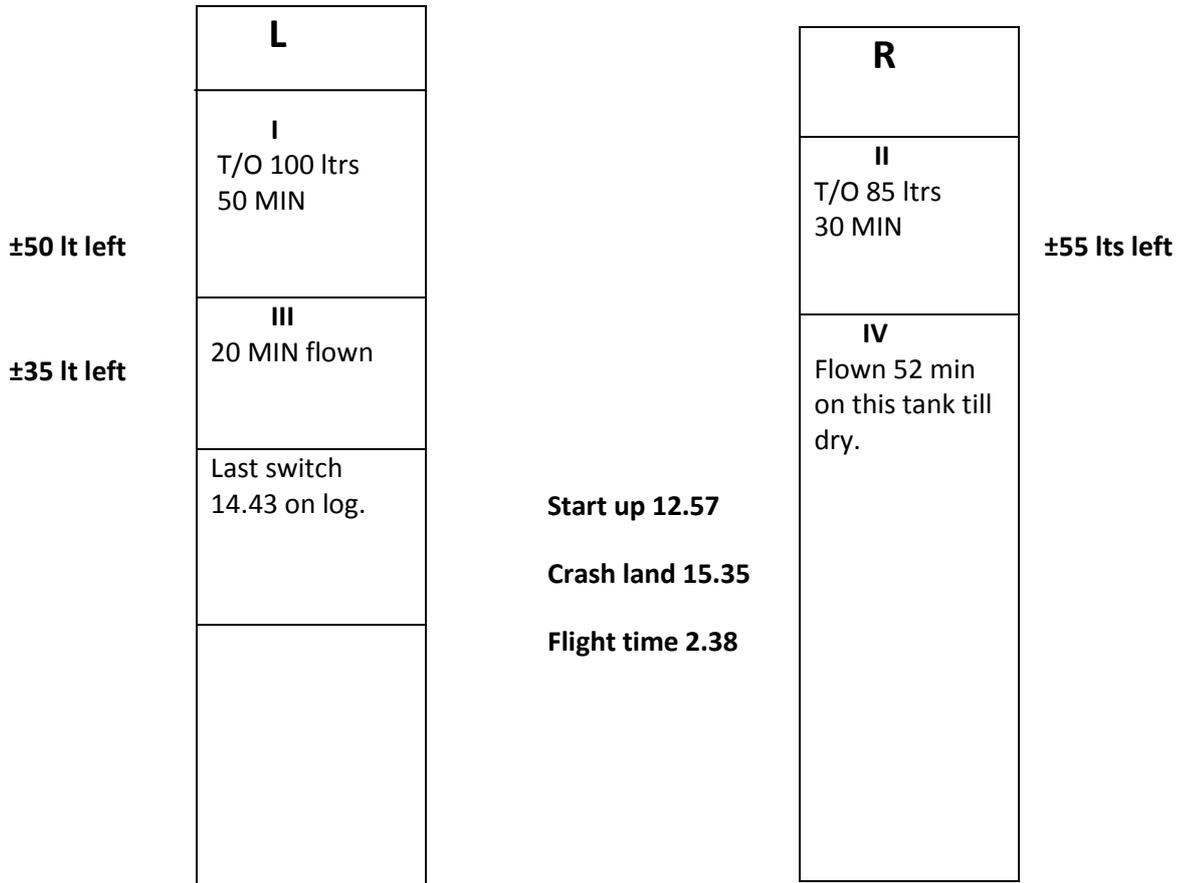
Graphical illustration of fuel management on inbound leg.

- 3.1.2 Pilot started off on flight reversing the quantities of fuel in tanks on her flight log. Wrong quantity was burn on time basis. However after dipping at Mushara the pilot realized the problem and started doing her calculations correctly. However she decided to rectify fuel imbalance on which she flew 50 min leg instead of 30 min to get balance back. In sector III she had flown only 20 min because of low fuel tank. The last fuel switch was at 14.43 UTC before the decent. Having flown, descended and diverted before turning back to Swakopmund with 55 lts in right tank, sector IV took ±52 min before the engine stopped due to fuel starvation.

- **Pilot admit about 30 l/tank in interview. ETA for SWP 14.52. Crash 43 min after ETA in reserve**
Switch to right tank after failure/Photo evidence

Take off Total Fuel 305 lt	±305 min @ 55 lt ph = 5h 05 minutes.
Flight time x 4 h 58 @ 55 lt ph	= 275 lt
Fuel available in left tank	<u>30 lt</u>
	<u>305 lt</u>
Total flight time was 4 hrs 58 @ 55 lts p/h	275 Ltrs.
