Directorate of Aircraft Accident and Incident Investigations

Aircraft Accident Investigation Final Report

AIRCRAFT TYPE: ULF-1E, Ultralight glider (D-NEQR)

DESCRIPTION OF OCCURRENCE: High-speed stall caused by a high angle of attack

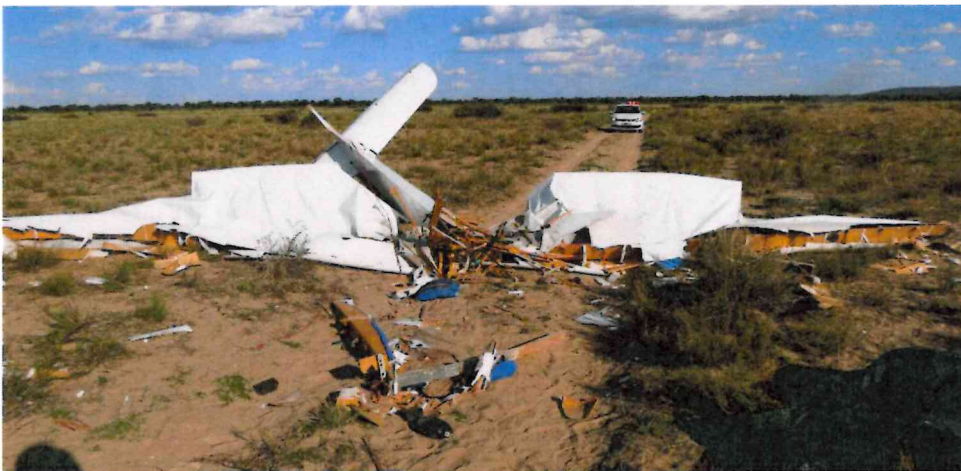
Figure 3 Accident scene

- 1.12.1 The aircraft dived into the ground at a near-vertical angle and then broke apart. A small crater on the ground with protruding wooden splitters was evident. The dope and wood airframe was scattered over a small radius.

- 1.12.2 The fuselage was broken about halfway. The front fuselage was separated from the bandage. The right rudder the pedal was broken and had a repair point.

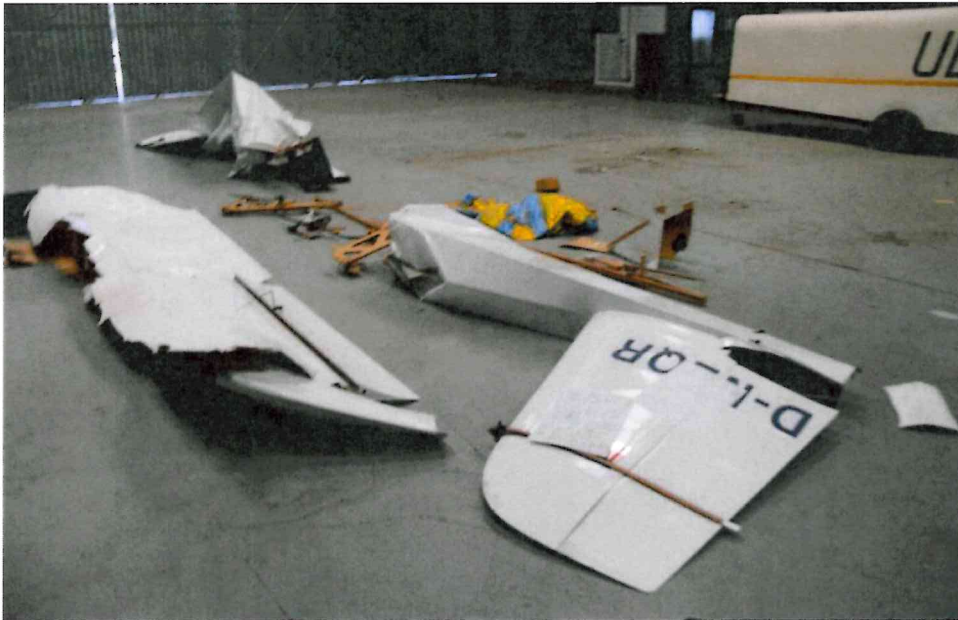
Figure 4: Wreckage at the Hangar

The fuselage was broken about halfway. The front fuselage was separated from the bandage.

The control cables and linkages were connected. The elevator control linkage was bent approximately 80 degrees. The drive rod was compressed about 30 cm in front of the main bulkhead. The control cables for the elevator drive were undamaged but showed signs of corrosion. The turnbuckles were secured. The elevator drive rod from the rear bulkhead was not compressed. External signs of corrosion were visible on the screw connections and ball head.

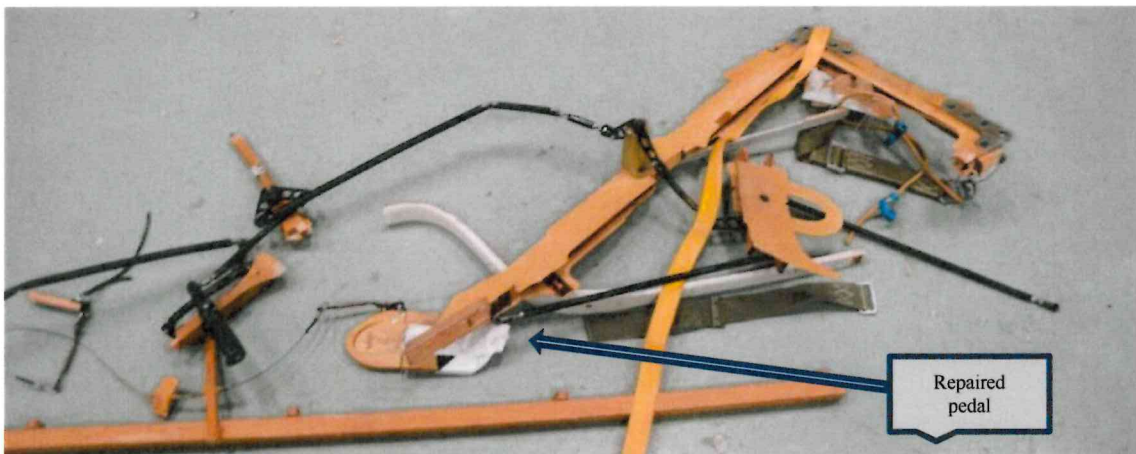
Figure 5: Steering system showing the repaired (unapproved) rudder pedal

The investigator in charge conducted several interviews and reviewed the existing records the findings indicate that repairs which were done on that morning and previous occasions on the rudder pedals as well as on other flight control surfaces, were accomplished in a manner that rendered the glider not airworthy.

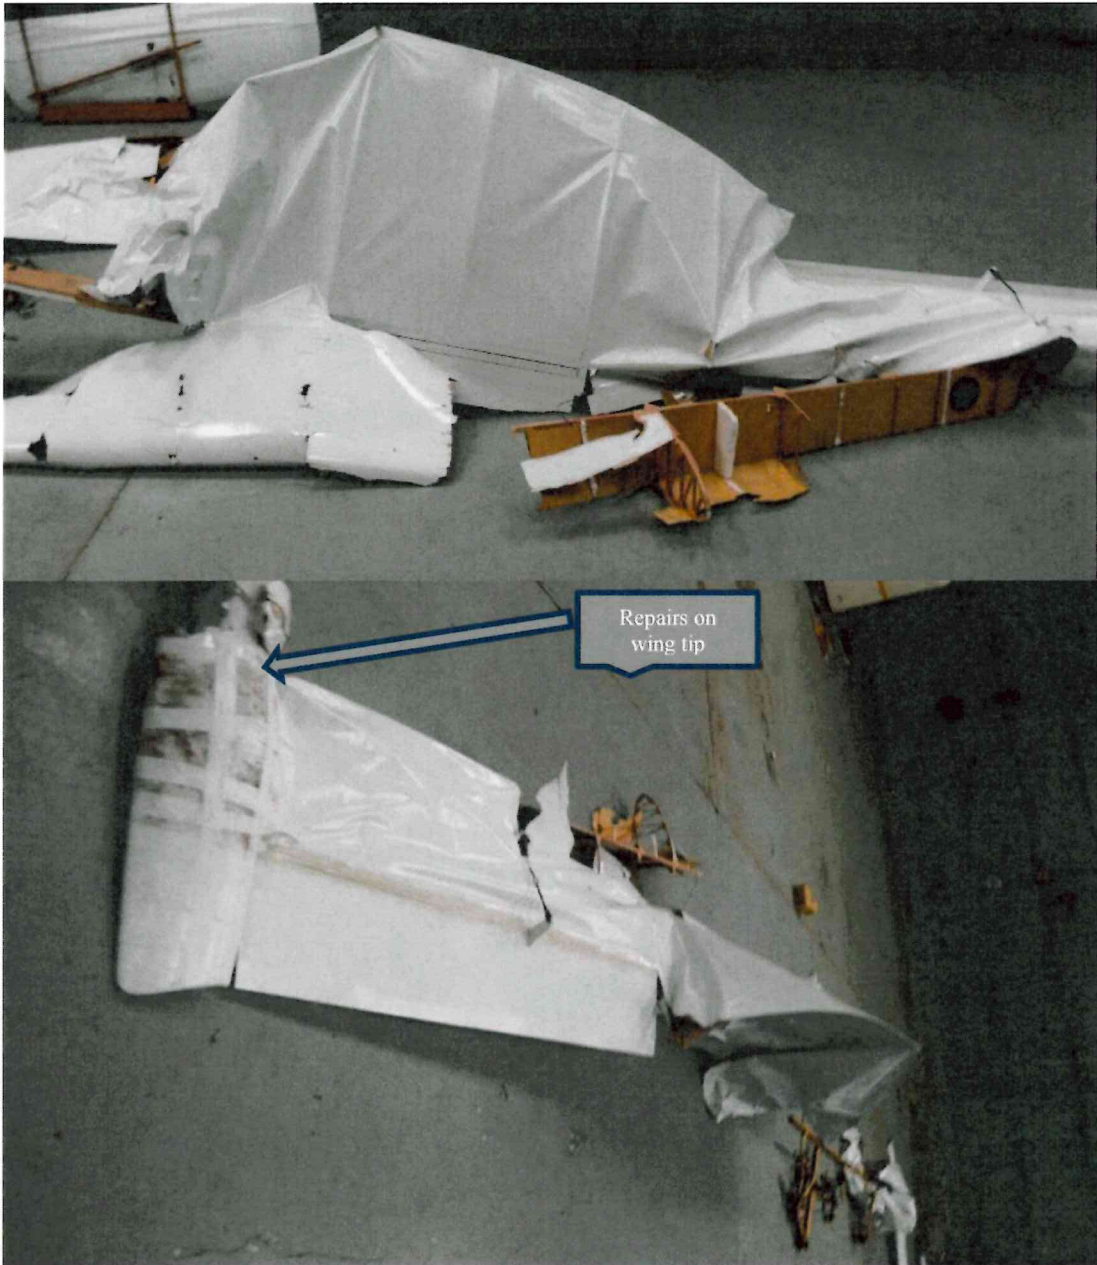
Figure 6-7 Depicting the left wing damage and the unapproved repairs on the wing tip.

The left wing was dented in the area of the wing nose. The wing was compressed several times. Ribs 1-3 were broken. The wingtip had a repair point. The aileron control cables showed signs of corrosion.

The leading edge of the wing had a repair area with ducktape on the right side at the height of the first and third rib after the middle

Investigation on the wreckage, indicate multiple repairs done on many sections of the aircraft, on the fuselage wings flight controls and flight control surface. Most if not all these repairs were all not done according to the manufacturer/builder's specifications and using approved methods of repair and with approved parts. The adhesive and repair patches were made for boat repair.

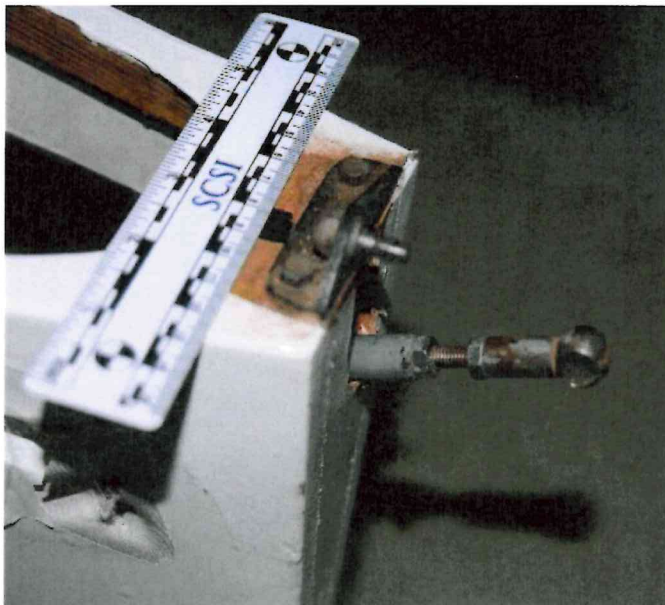
Figure 7 Socket joint showing corrosion

The ball socket and ball head of the elevator linkage showed corrosion. The ball connection requires little manual force to loosen.

Elevator's Ball Socket joint required little manual force to delink

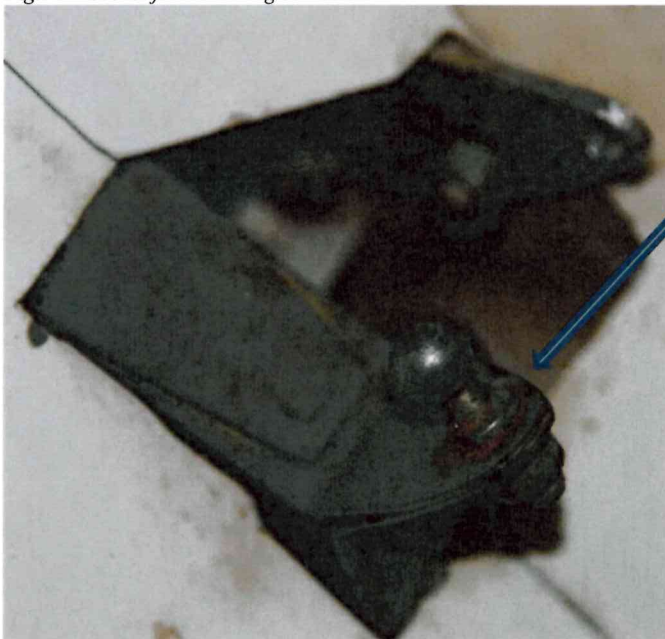
Figure 8. Ball joint showing corrosion

The wreckage investigations reveal repairs at the wing and the fuselage not responding to the building manual. Life limited parts weren't replaced: Belts, Bungee rope at the Elevator, Steering cables, and tennis balls in the Skid. There was no evidence that the rigging grease was used at the bolts and ball head and socket.

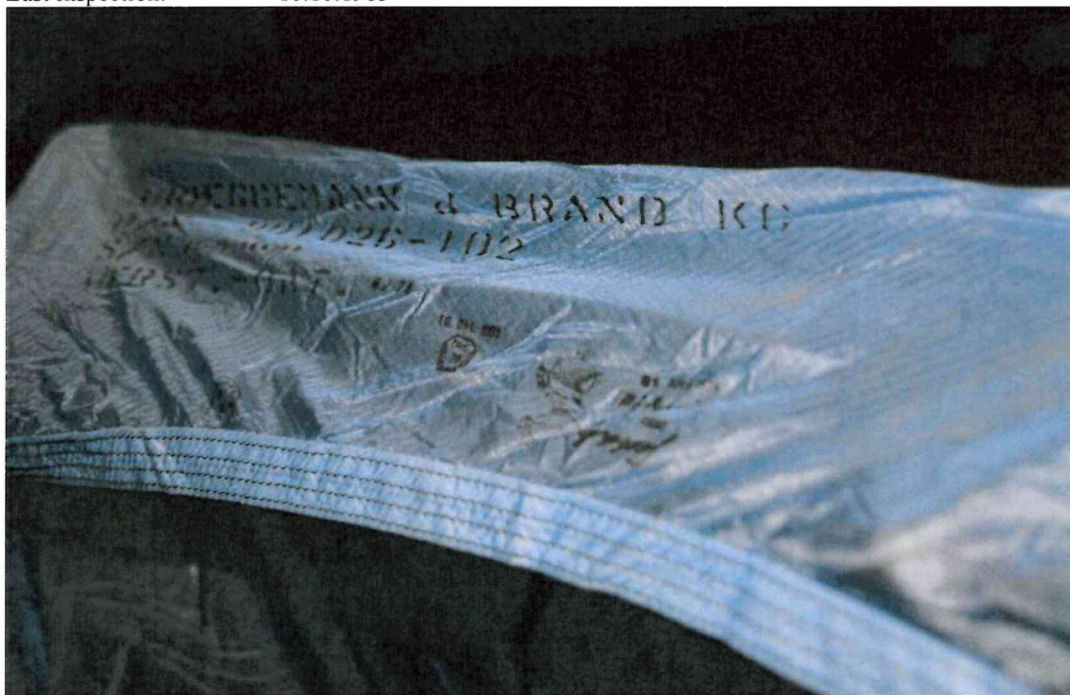
Figure 9. Rescue parachute.

A rescue parachute was installed in the glider. The system was not activated or triggered.

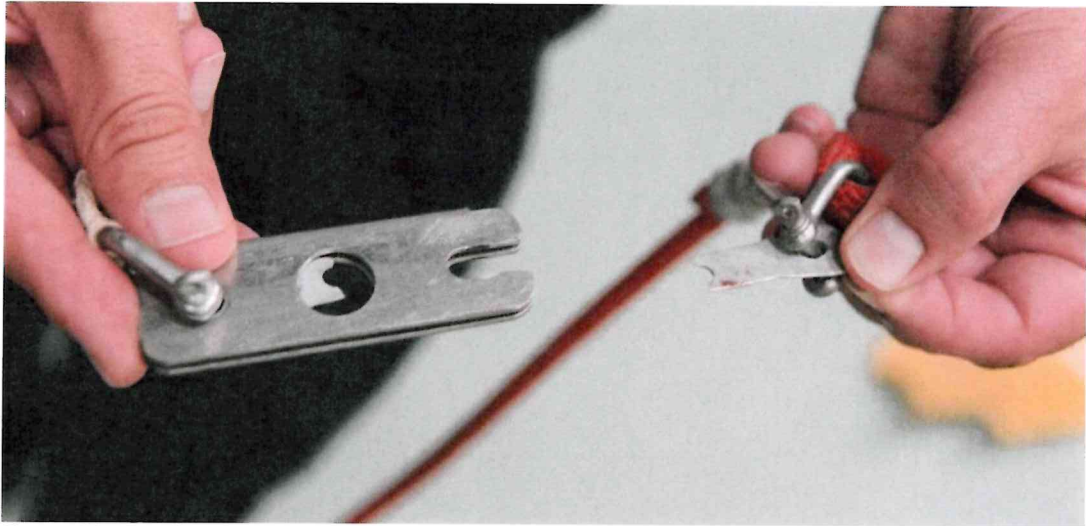
Figure 11: Breaking-point

The red lead winch rope had a ring pair at one end and a predetermined breaking point at the other end. The breaking point was found broken. The counterpart was still attached to the white winch rope.

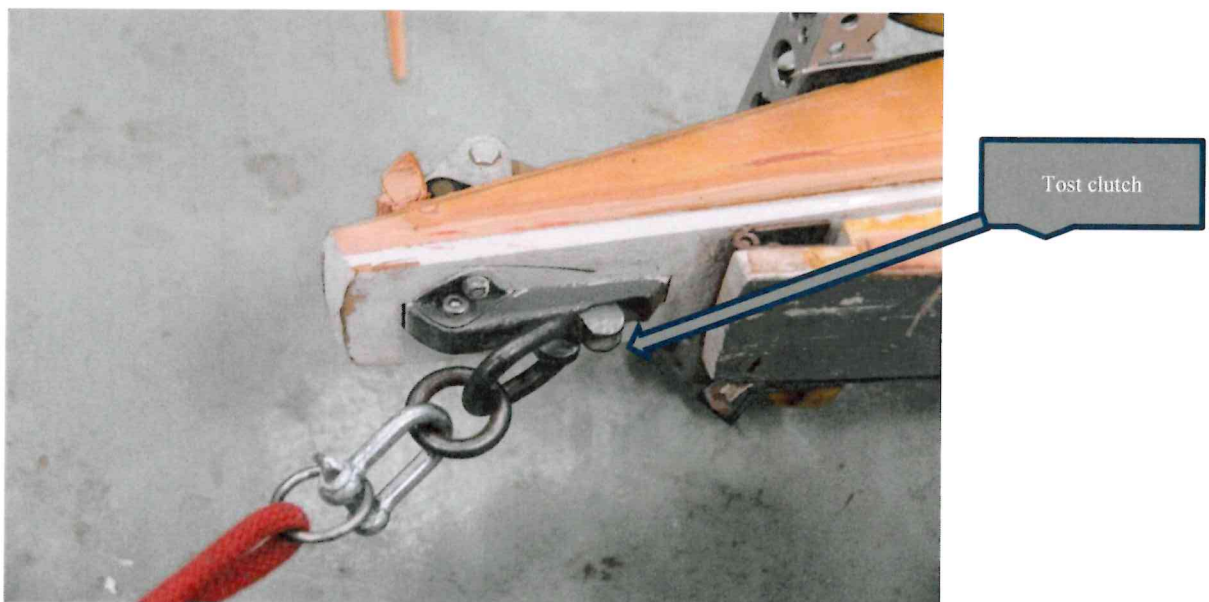
Figure 12: Ring pair connect with the lead rope and Tost clutch

During the winch launch, where the Tost clutch was positioned in front of the glider, a nose-down force was applied to the glider through the winch rope. In response, the pilot applied a nose-up input to the elevator to counteract this nose-down moment. As the speed of the glider increased, the force on the rope and the glider itself also increased. Video footage depicted the glider gradually gaining speed while climbing at a slow rate, leading to significant forces acting on the elevator.

The designer noted that the Tost winch clutch installed was not approved for use in winch launches with this particular glider. A CG clutch should have been used instead for winch launches.
