Occurrence Reference: ACCID/12112023/ 01-07

Aircraft Accident Investigation Final Report

MOTORGLIDER JS-MD3RES D-KIBD

DESCRIPTION OF OCCURRENCE Crashed on landing due to impact with wildlife

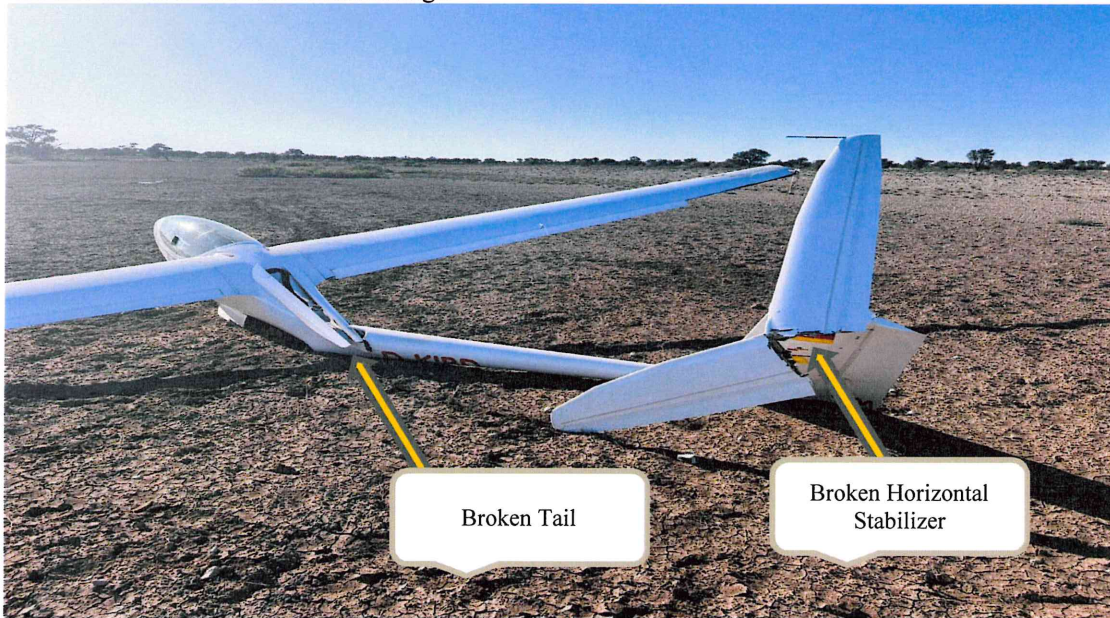
1.3.1 The aircraft sustained substantial damage.

Figure 1: The aircraft as it came to rest.

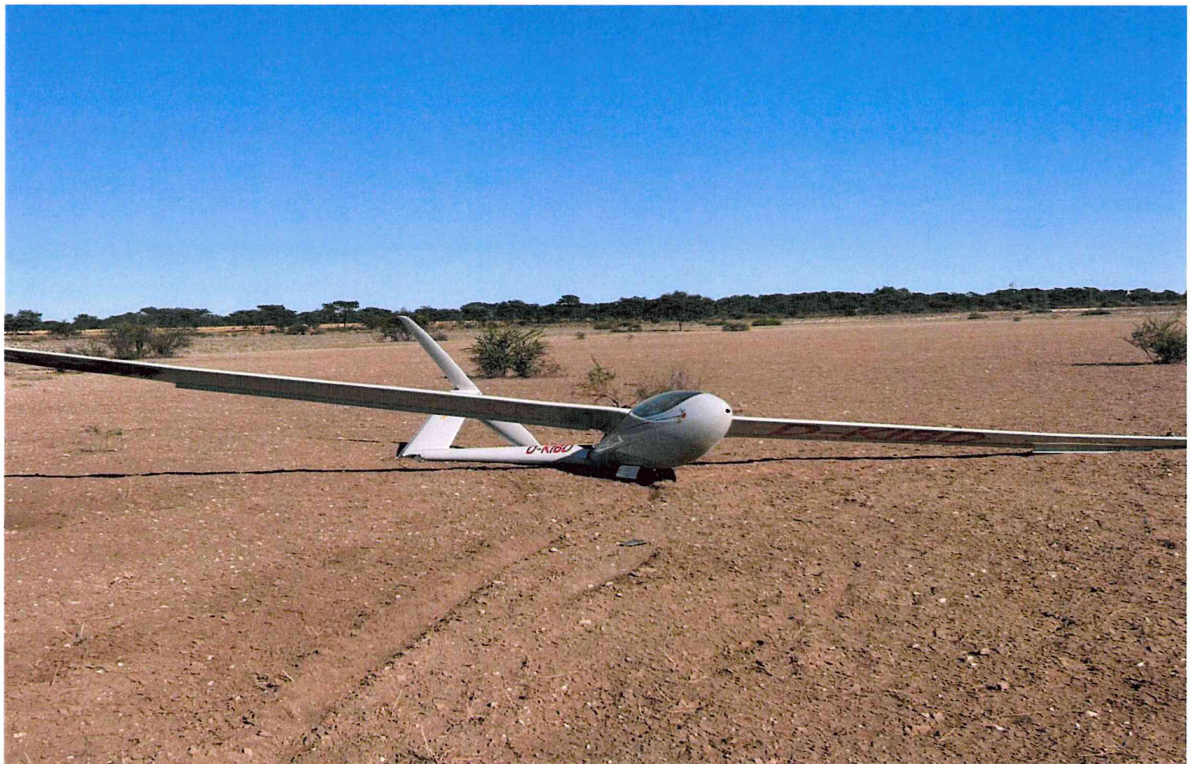
Photo 3 Photo depicting the ground scars by the aircraft and dry pan used for landing.

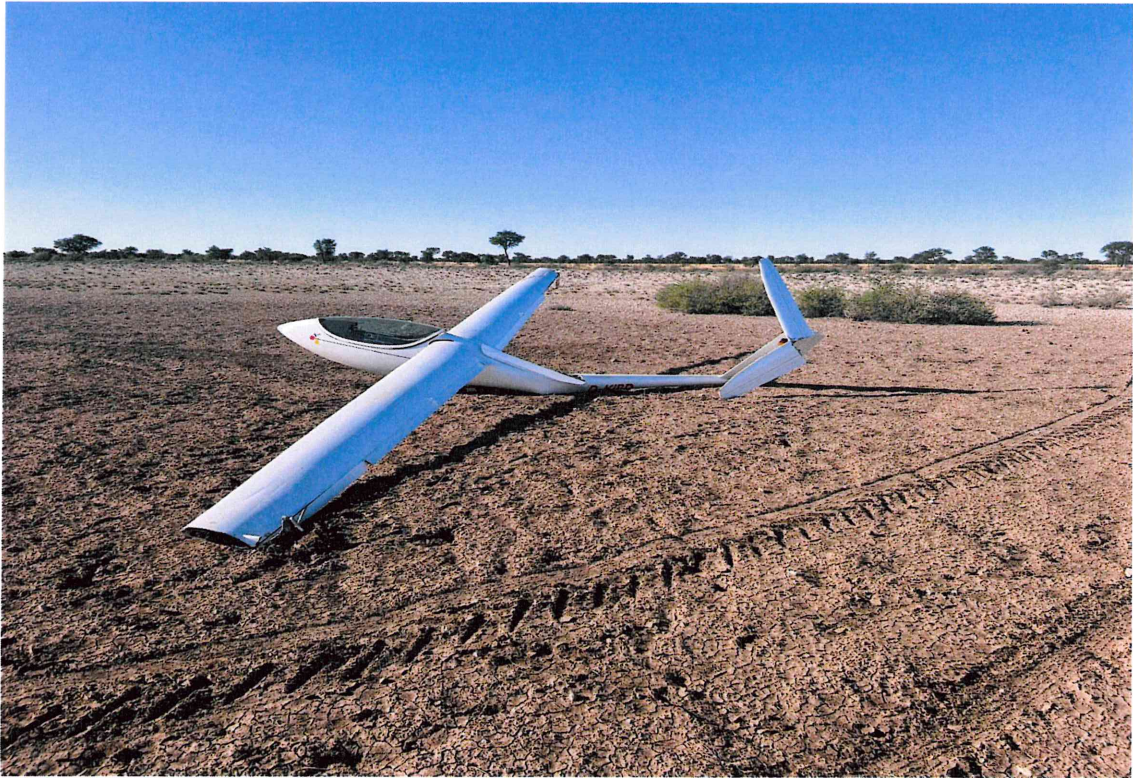
The fuselage is broken just behind the cockpit and the horizontal stabilizer is also broken due to the impact with the ground. The right wing sustained damage due to the impact with the wildlife.

Photo 4 Photo depicting the aircrafts damage and open pan.

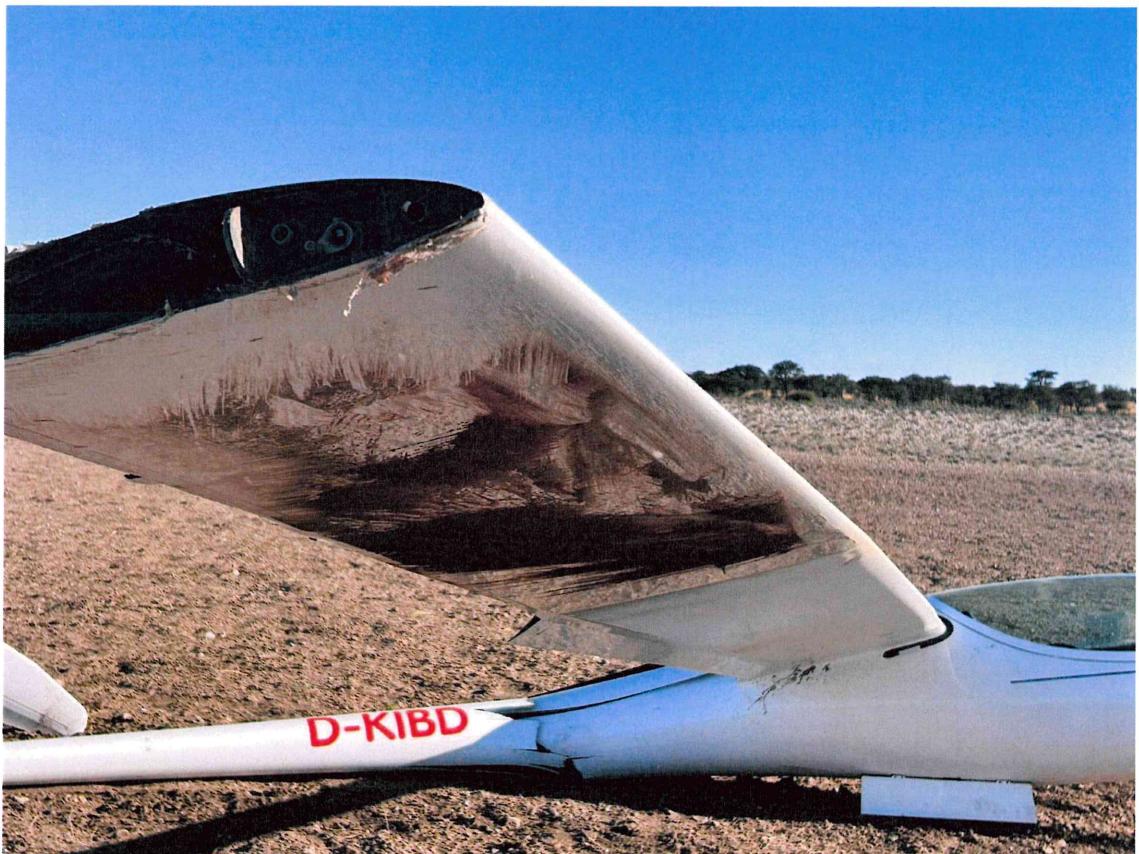
Photo 5 Photo depicting the aircrafts damage to right wing.

- 3.2.1. Impact with wildlife
