CIVIL AIRCRAFT ACCIDENT REPORT

ACCID/07242017/01-03

OPERATION : INTERNATIONAL FERRY FLIGHT
AIRCRAFT : ZS-RNO
LOCATION : KOCHENA FARM
DATE : 24 JULY 2017

Aircraft Registration	ZS-RNO		Date of Accident	24 July 2017	Time of Accident	12:20 UTC
Type of Aircraft	MBB-BO-105 HELICOPTER		Type of Operation	International Flight		
Pilot-In-Command License Type	Commercial Pilot Helicopter	Age	45	License Valid	Yes	
Pilot-In-Command Flying Experience	Total Flying Hours	4798.3 hours	Hours on Type	350.2 hours		
Last point of departure	Upington Airport (FAUP) South Africa					
Next point of intended landing	Keetmanshoop Airport (FYKT) Namibia					
Location of the accident site with reference to easily defined geographical points (GPS readings if possible)						
Kochena Farm, 27°013'10"S 018°53'23"E						
Meteorological Information	Wind: North westerly, Wind speed 15-20 knots: Visibility: >10km, Temperature: 28°C Cloud cover: Nil, Cloud base: N/A, Dew point: Not known					
Number of people on board	2 + 0	No. of people injured	0	No. of fatalities	0	
Synopsis

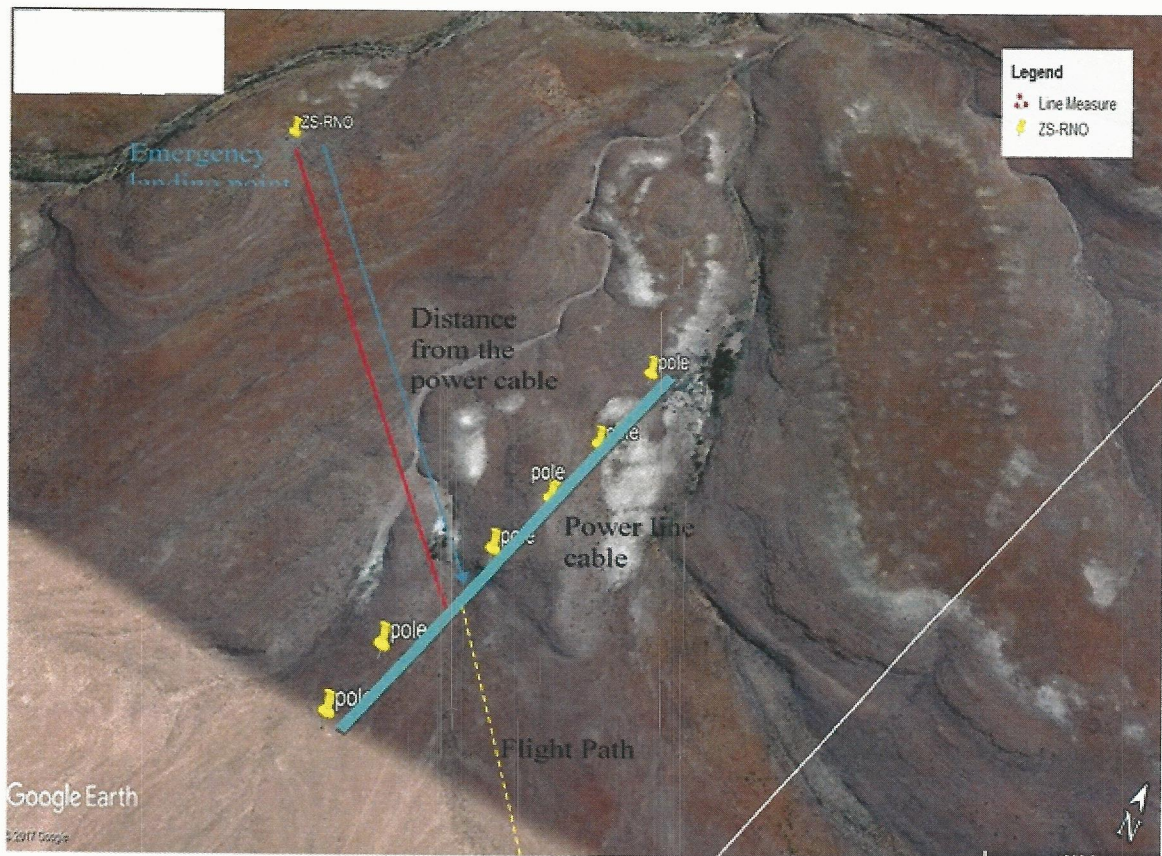
- 1.1.5 The helicopter heading before it struck the power line was $\pm 300^\circ M$ and the power line run direction North – South with geographic position S 27°00' 31" E 18° 53' 21".
- 1.1.6 The helicopter further descended to low level and shortly thereafter struck a power line. The Pilot-in-Command executed an emergency landing.

FIGURE 1. Showing the flight path in dotted yellow and power line cable in blue.

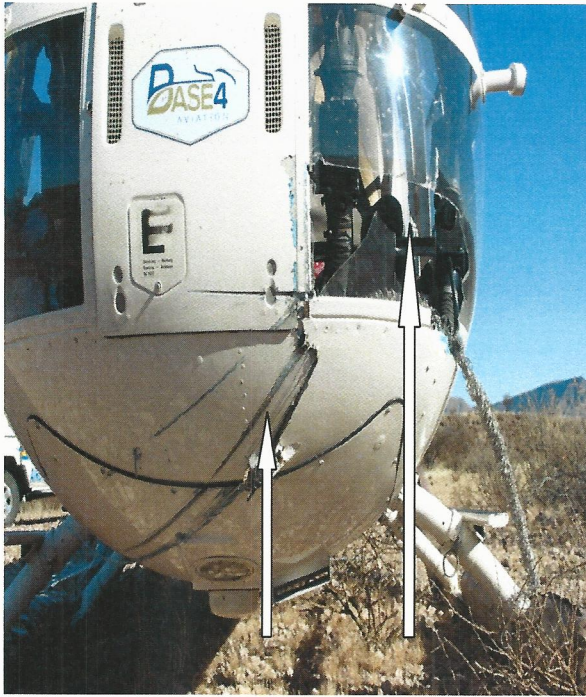
FIGURE 1: Nose section and windscreen damaged by the electrical cable.

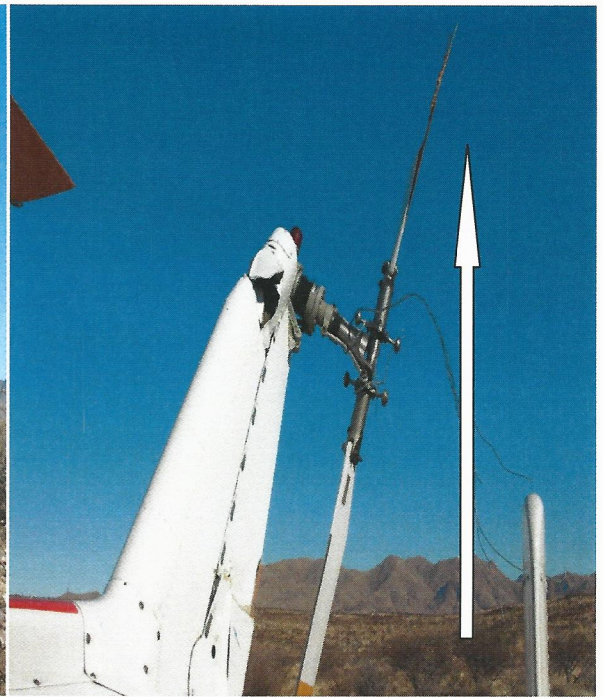
FIGURE 2: The tail rotor section and blades damaged

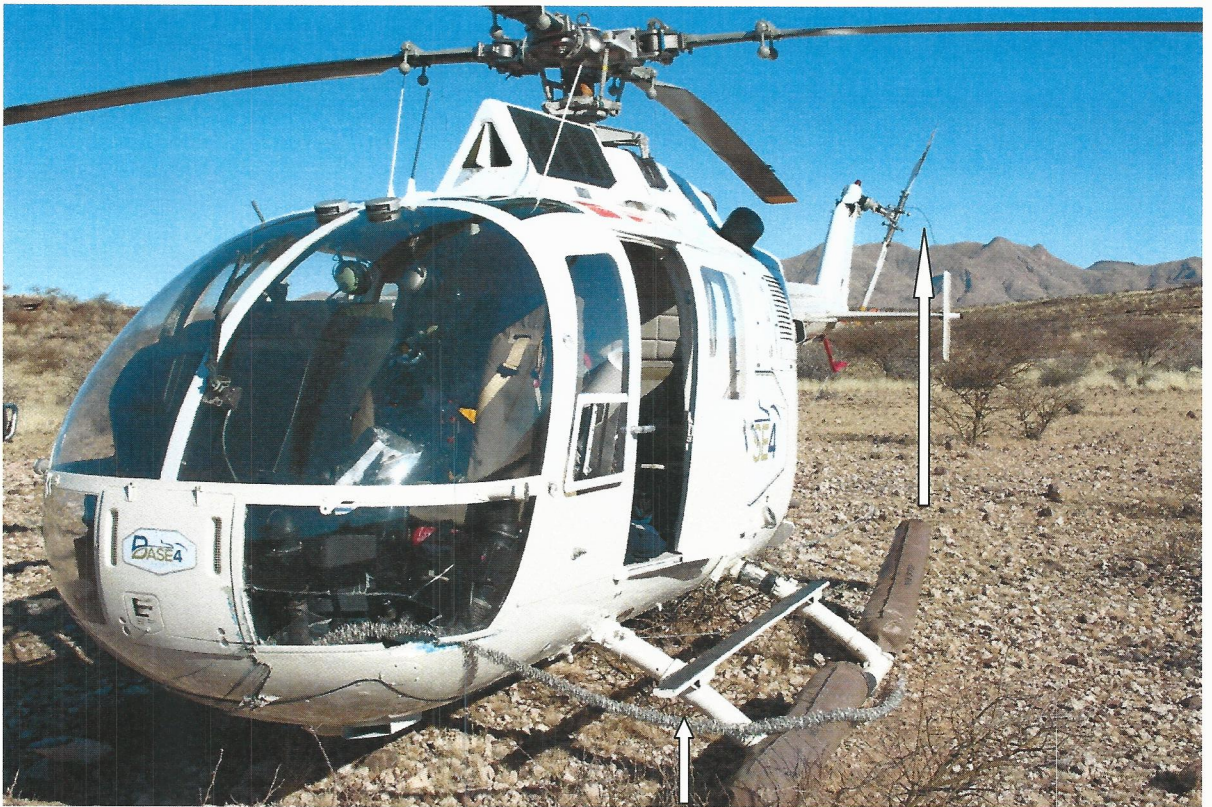
FIGURE 3: Photo showing the entangled cable.

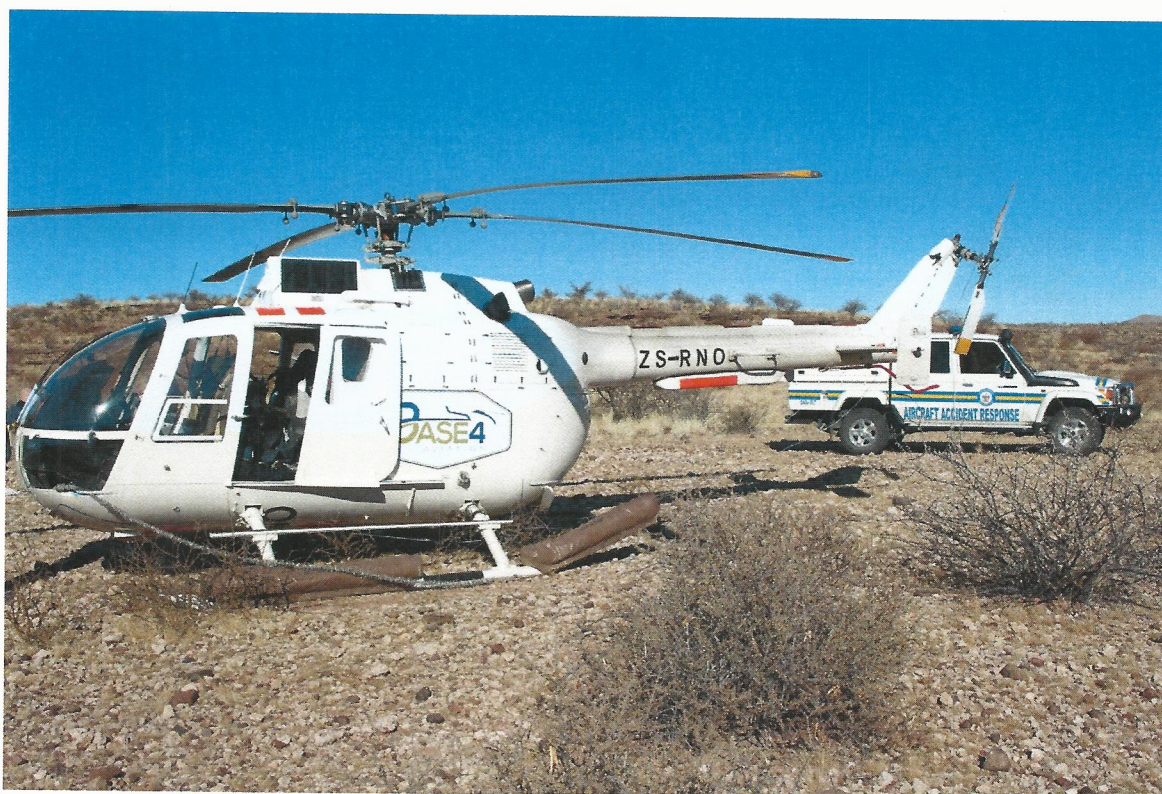
1.12.2 The single phase electrical cable that was struck by the helicopter was 10 millimetre

in diameter. The poles where the power line was erected are 10 meters tall with two (2) meter of the pole buried in the ground. The remaining poles height above ground is 8 metres, which translates to 26 feet above ground. The distance between two poles was 100 meters.

Figure 1. A photo showing where the helicopter landed and the electrical power line entangled around it.
