<p align="center"> MINISTRY OF WORKS AND TRANSPORT DIRECTORATE: AIRCRAFT ACCIDENT AND INCIDENT INVESTIGATIONS </p>				<p align="center">INCID/121319/02-18</p>	
<p align="center">INCIDENT REPORT - EXECUTIVE SUMMARY</p>							
Registration	SW-056	Date of Incident	13 December 2019		Time of Incident	19:20 UTC	
Type of Equipment	PAU EQUIPMENT		Type of Operation	Passenger assistance			
Pilot-In-Command Licence Type	N/A		Age	N/A	Licence Valid	N/A	
Pilot-In-Command Flying Experience	Total Flying Hours		N/A		Hours on Type	N/A	
Place of incident	On the Apron at Hosea Kutako International Airport						
Location of the incident site with reference to easily defined geographical points (GPS readings if possible) During the disembarking of passengers with limited mobility from flight SW 708 which arrived from Cape Town.							
Meteorological Information	Wind : 240° @ 05 knots Temperature : 25°C Visibility : CAVOK Cloud cover : Not given Cloud base : Not given Dew point: Not known

PASSENGER ASSISTANCE UNIT (PAU) INCIDENT REPORT

Name of Owner/Operator : Air Namibia
Manufacturer and Type : Nissan UD 60.
Type and Model : 2013
Registration Marks : SW-056 Passenger Assistance Unit (PAU)
Place : Hose

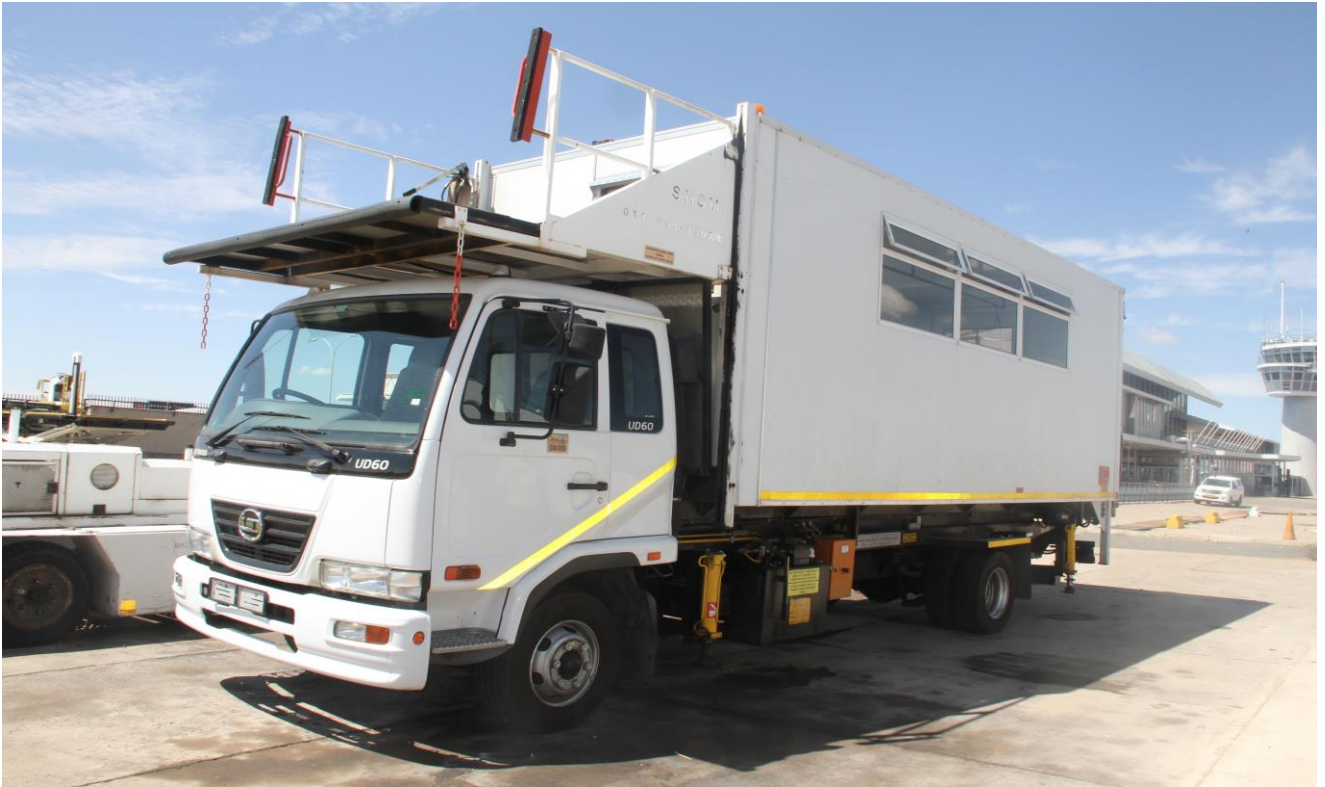
Appendix 1: SW 056 Air Namibia Passenger Assistance Unit Truck after incident

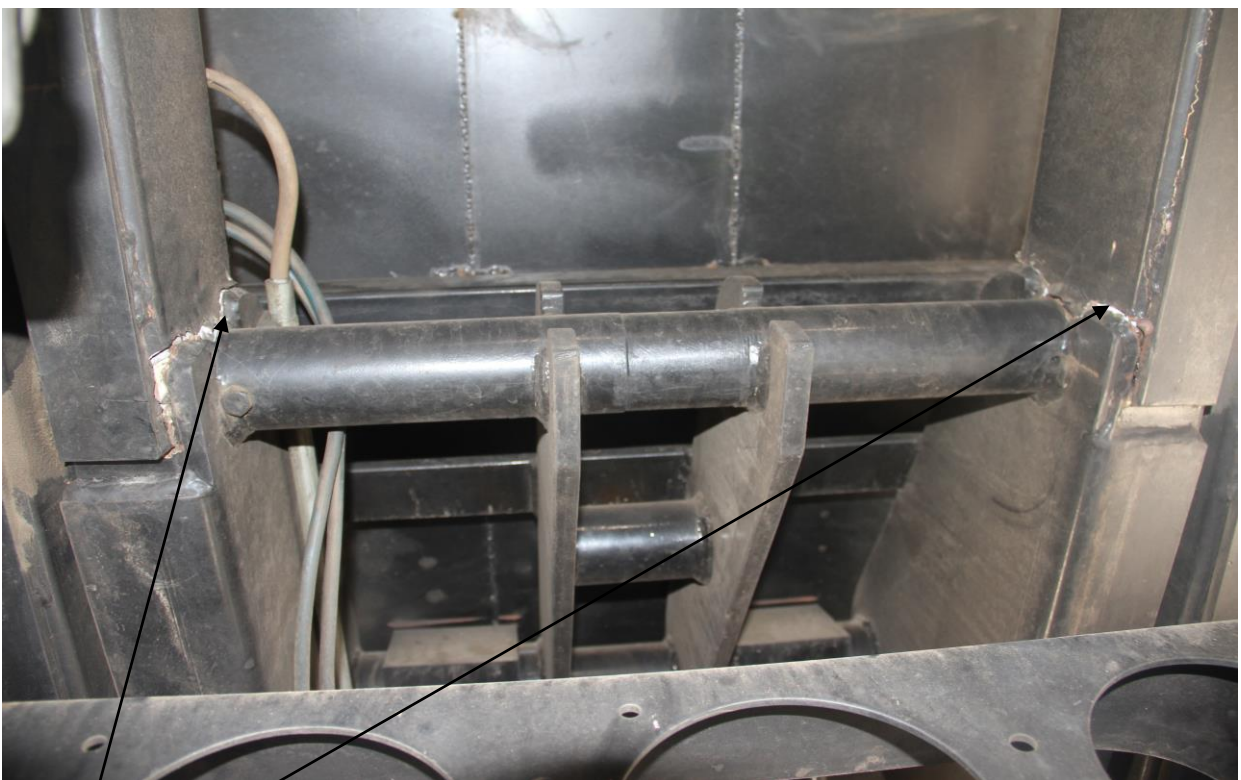
- 3.1.9 Both inner scissor beams were found cracked from the bottom side up just aft of the torque shaft attachment.
- 3.1.10 None of the working parts of the lifting mechanism indicated to have been serviced and there were no any grease or lubrication nipples.

Appendix 2: Visible cracks on both sides of the Torque Shaft underneath the truck to where the Lifting Scissors are attached (welded).

Cracks on both sides of the torque shaft.

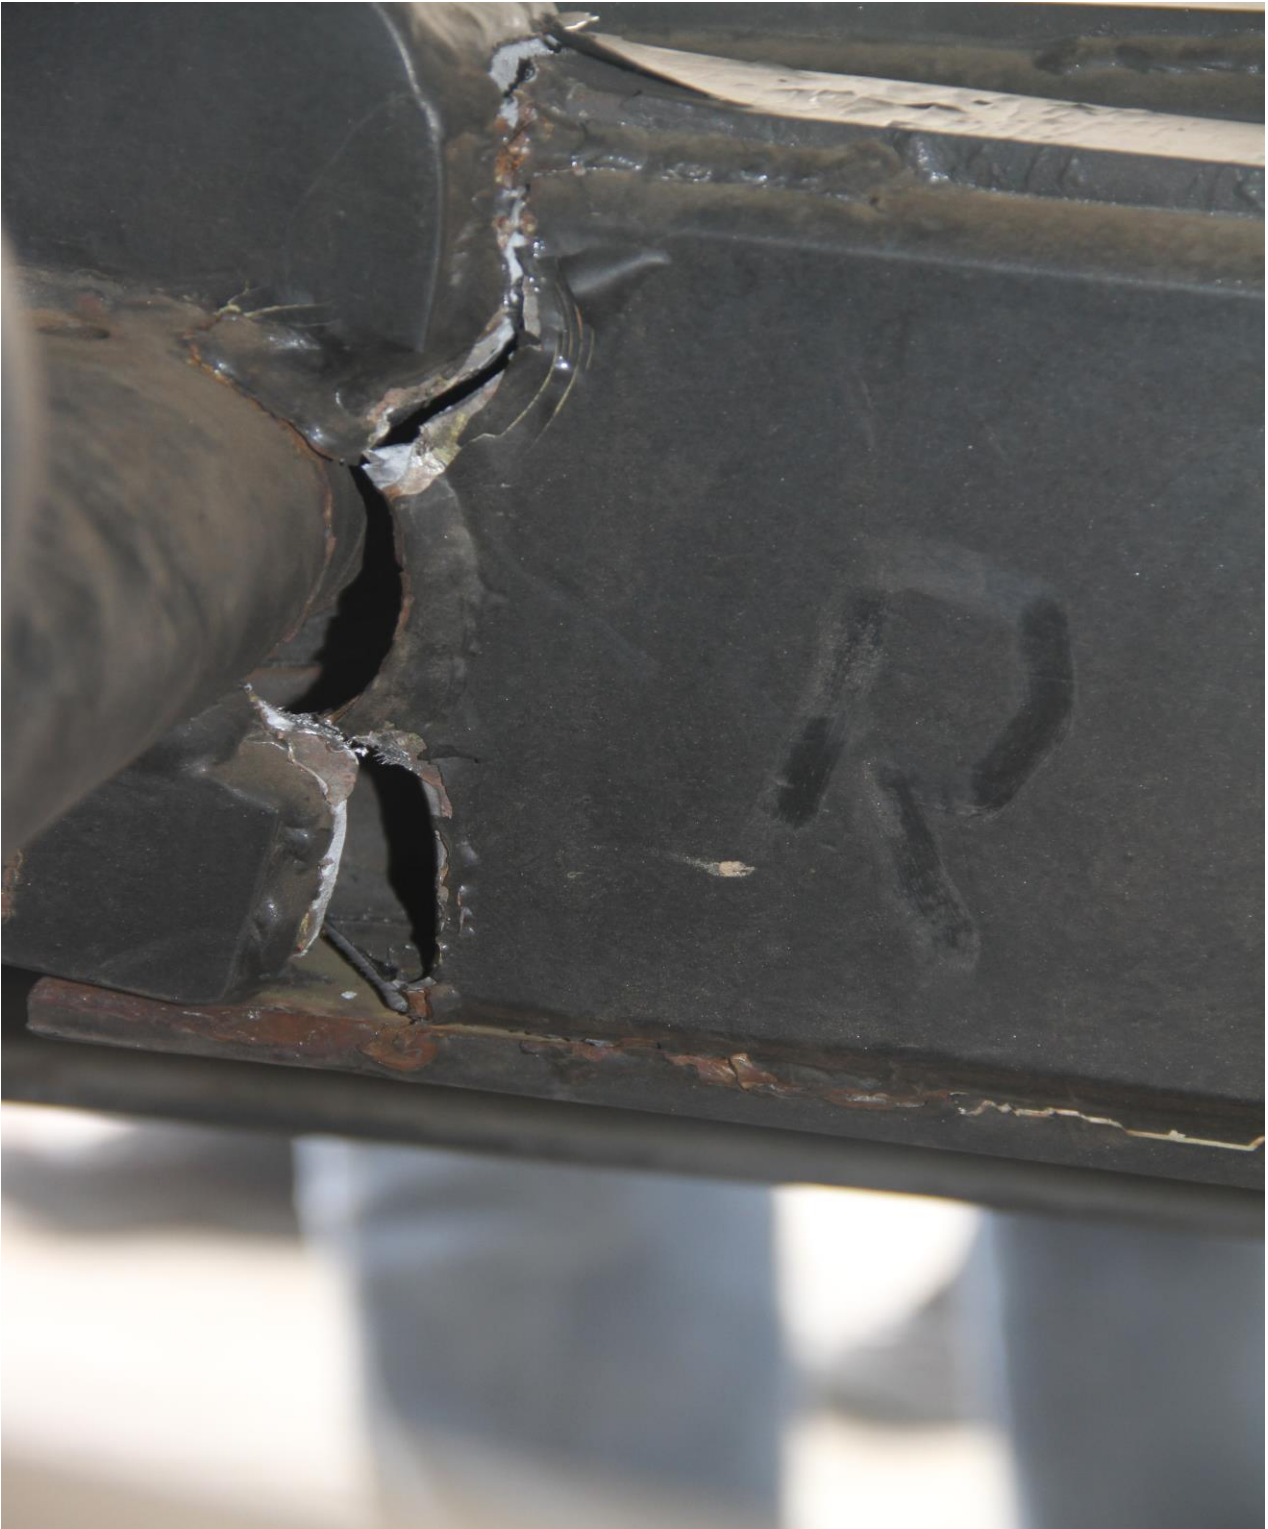
- 3.1.8 The investigation found out that the structure on the torque shaft of the PAU equipment where it was factory joined (welded), allegedly failed and broke due to strain.

Appendix 3: A closer view of the crack on the right hand (R/H) side to where the lifting scissor is attached to the torque shaft.

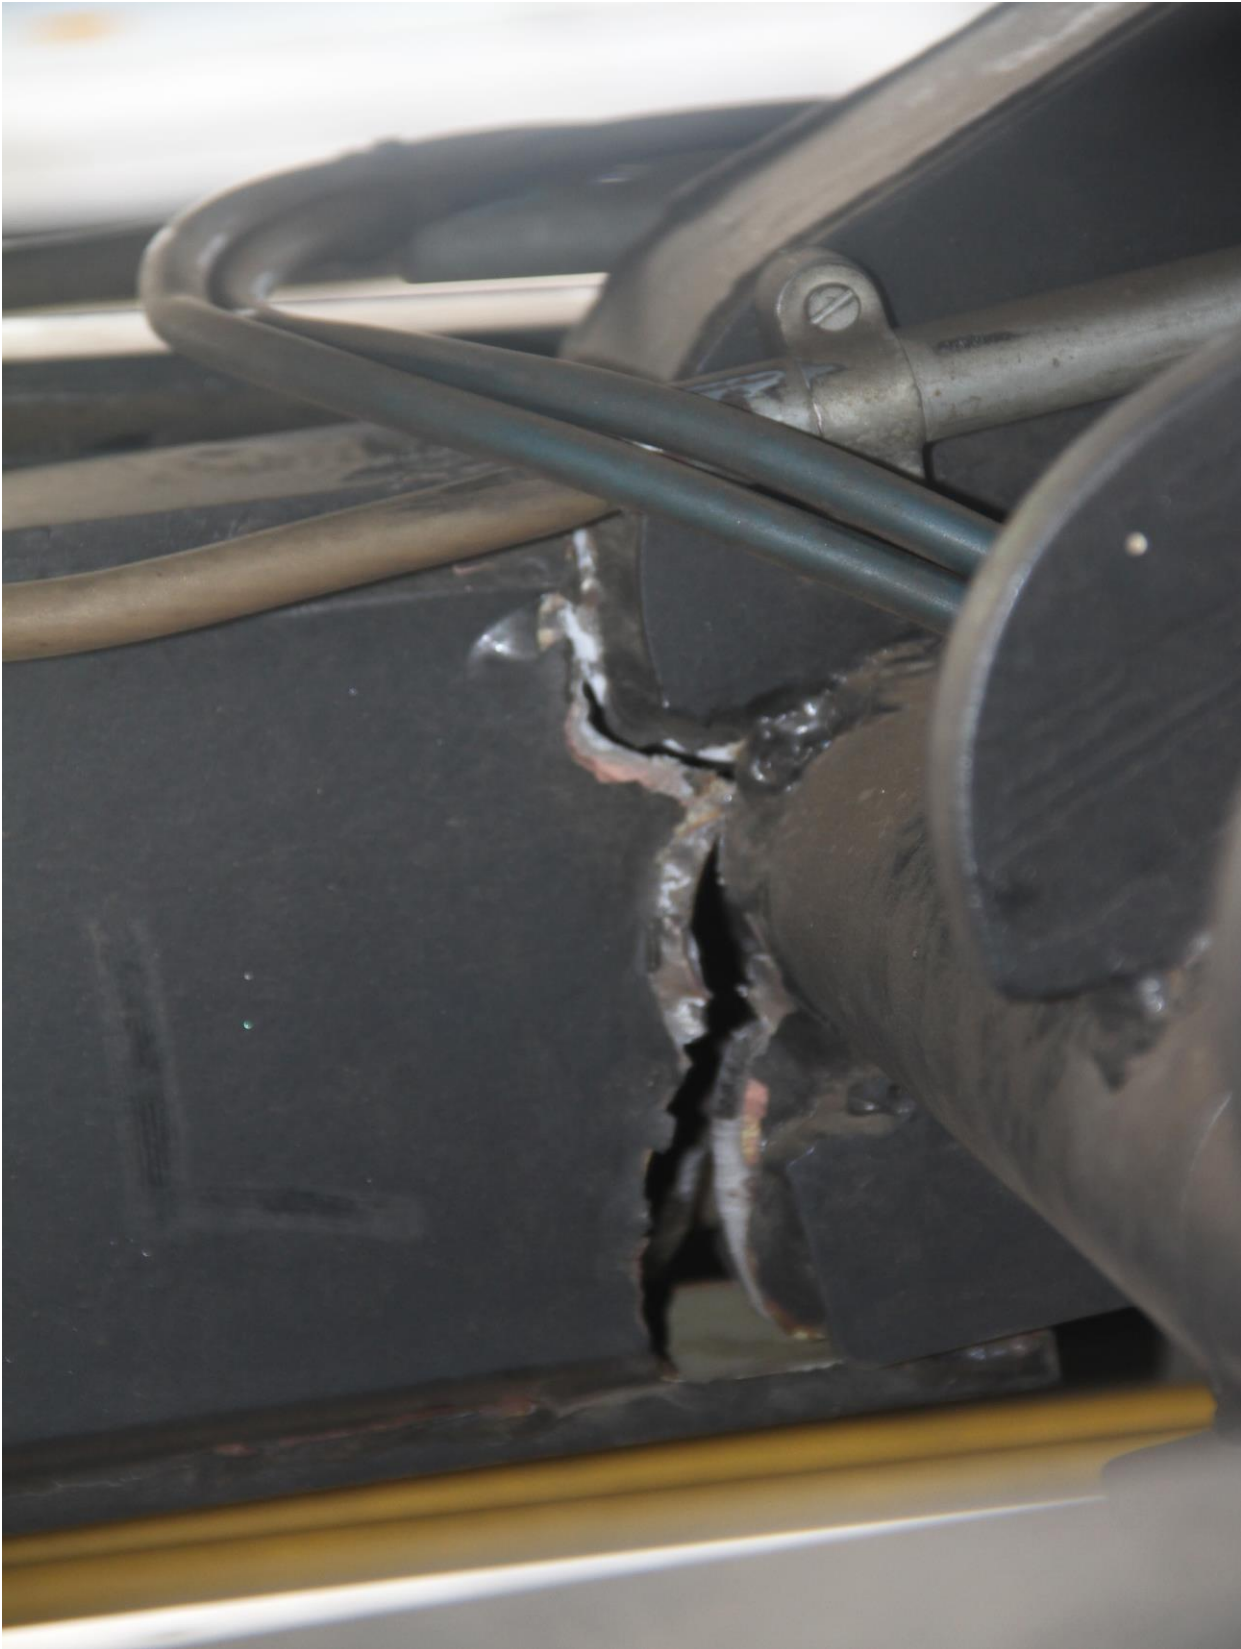
Appendix 4: A closer view of the crack on the left hand (L/H) side to where the lifting scissor is attached to the torque shaft.

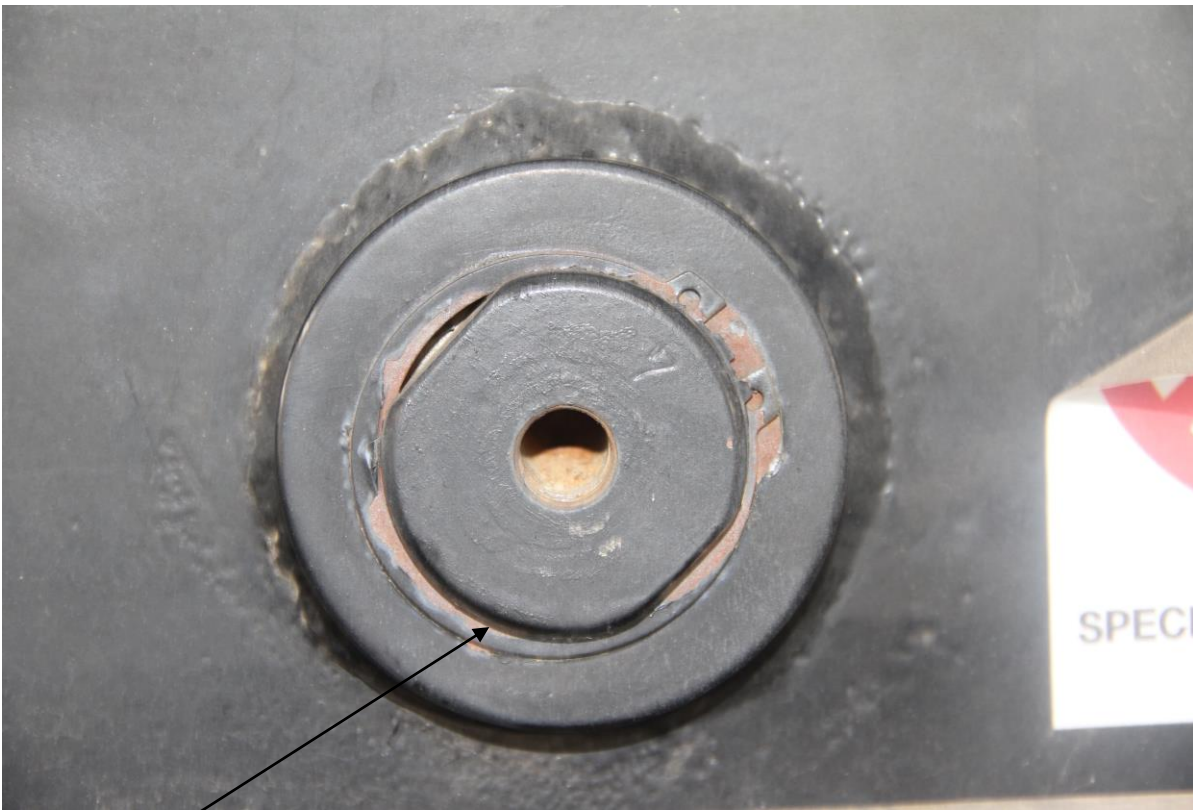
- 2.10 Due to the non lubrication of the working parts of the lifting components, the right hand side (R/H) bushing on the outer scissor beams of the torque shaft of the hydraulic actuator was severely worn with visible corrosion and no indication of lubrication to indicate that the parts were serviced.

Appendix 5: A view of the intact bushing on the left side of the torque shaft and the missing bushing on the right hand side of the torque shaft.

A bushing on the left side of the torque shaft that held the shaft in its position. The dryness and corrosion gives a sign that the equipment has not been lubricated for a long time.

DAAI recommended that Air Namibia should review the maintenance programme of their ground equipments.

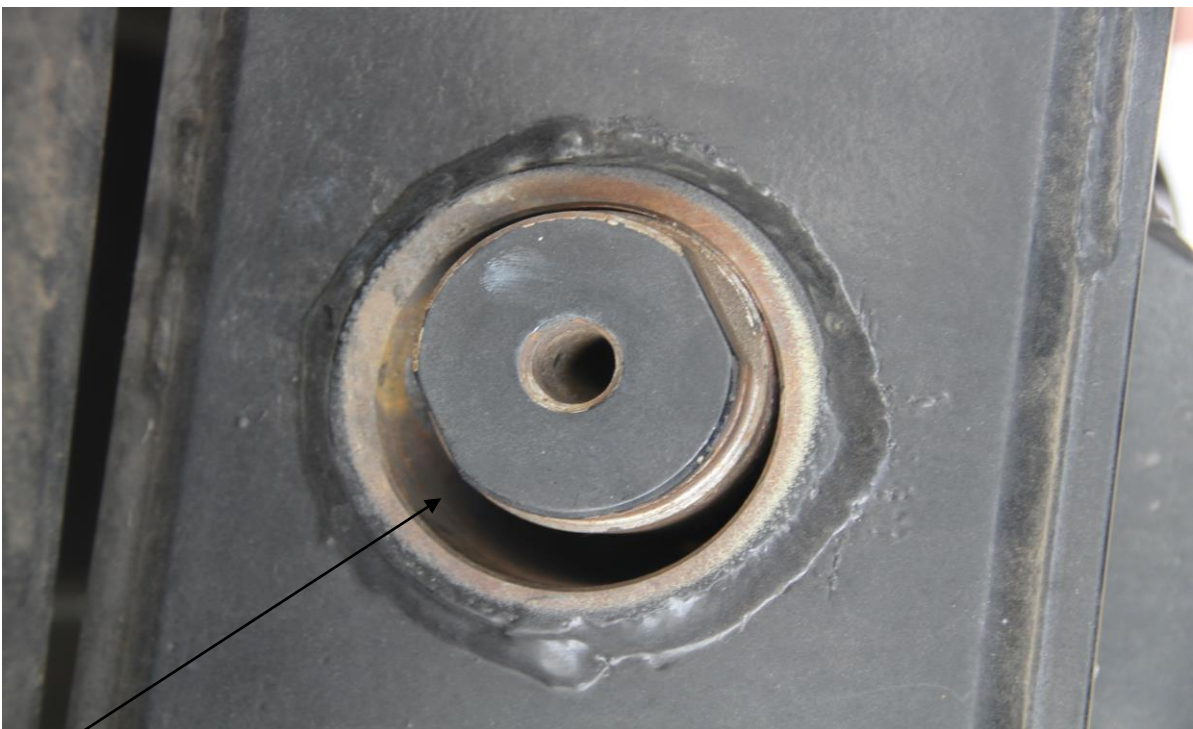
- 3.1.11 The right hand side (R/H) bushing on the outer scissor beams of the torque shaft of the hydraulic actuator was severely worn with visible corrosion and no indication of lubrication to indicate that it was serviced.

- 3.2.1 Failure of the right hand (R/H) bushing on the torque shaft caused the PAU equipment to collapse.

An opening space displaying a missing bushing on the right side of the torque shaft.

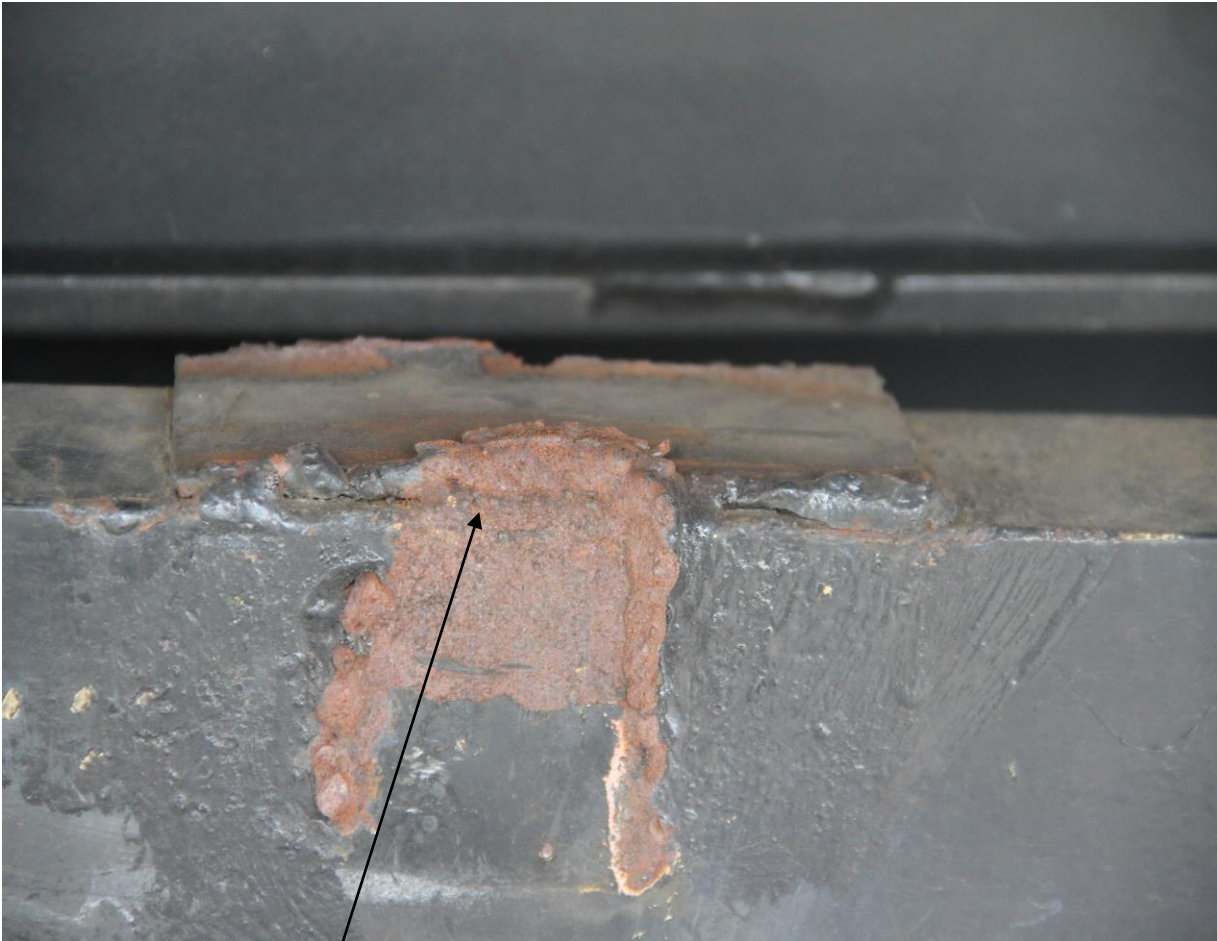
- 3.1.12 The right chassis beam appears bent at out rigger attachment point and both left and right central stow position support assemblies were found missing.

Appendix 6: Both left and right central stow position support assemblies that use to hold the cabin in place when fully down were found missing.

A place to where one of the missing central stow position support assembly use to be attached.
