**CIVIL AIRCRAFT FINAL ACCIDENT REPORT**

**ACCID/112721/02-05**

**AIRCRAFT : V5-ELZ  
REGISTRATION**

Belly landing at Eros Airport RWY 19  
Private Flight  
Beech A36, 1972 Aircraft,  
V5-ELZ Eros Airport, Windhoek  
27<sup>th</sup> November, 2021

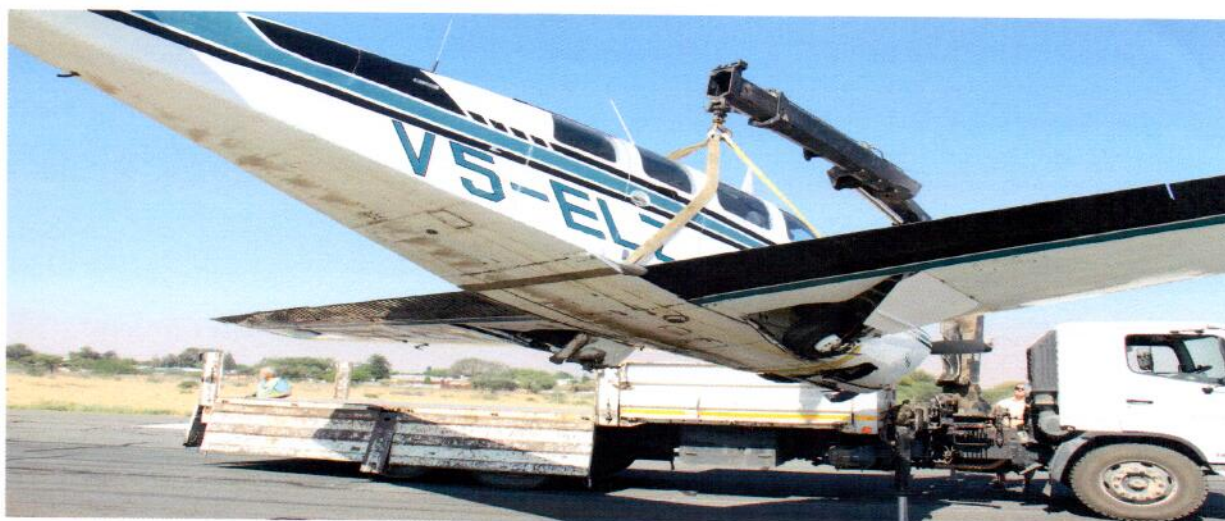
1.3.1 The aircraft was slightly damage

Figure 2: Aircraft slightly damage, mostly on its belly

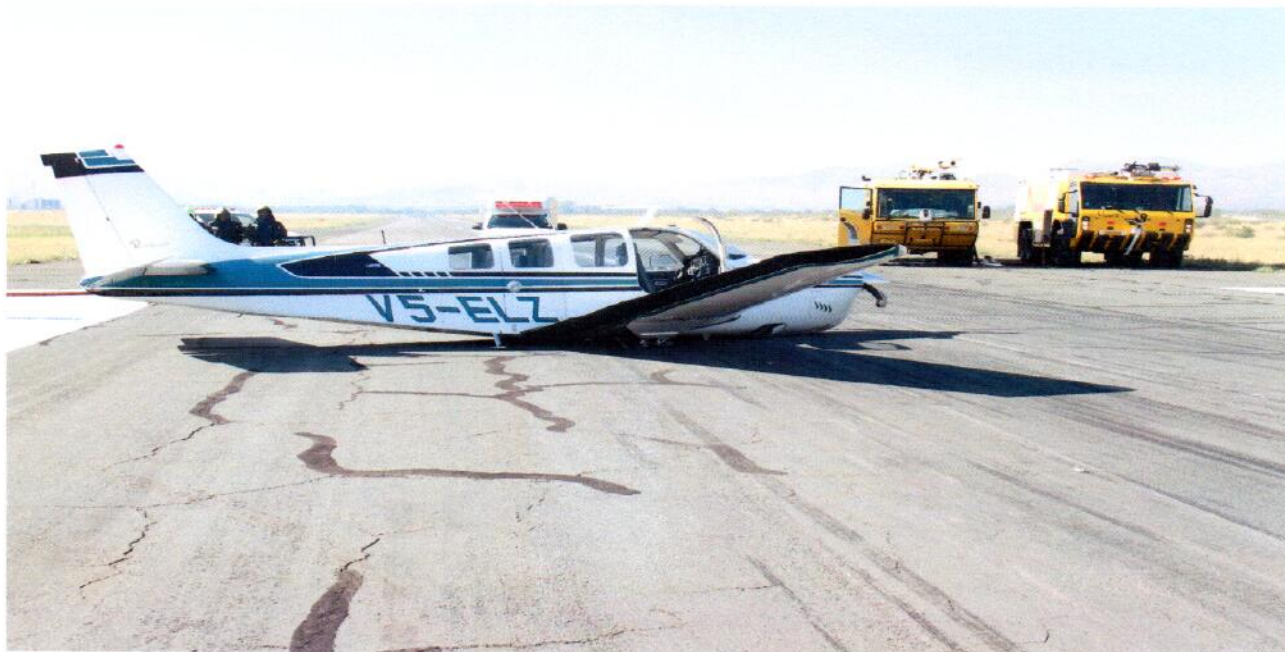
The aircraft was fully intact until it came to a complete stop on the runway. The aircraft first touchdown on the runway was 40 meters from the threshold and it skid on the runway until it came to a stop 146 meters from the first touchdown point.

**Figure 4:** Depicting where the aircraft came to a completely stop on the runway.

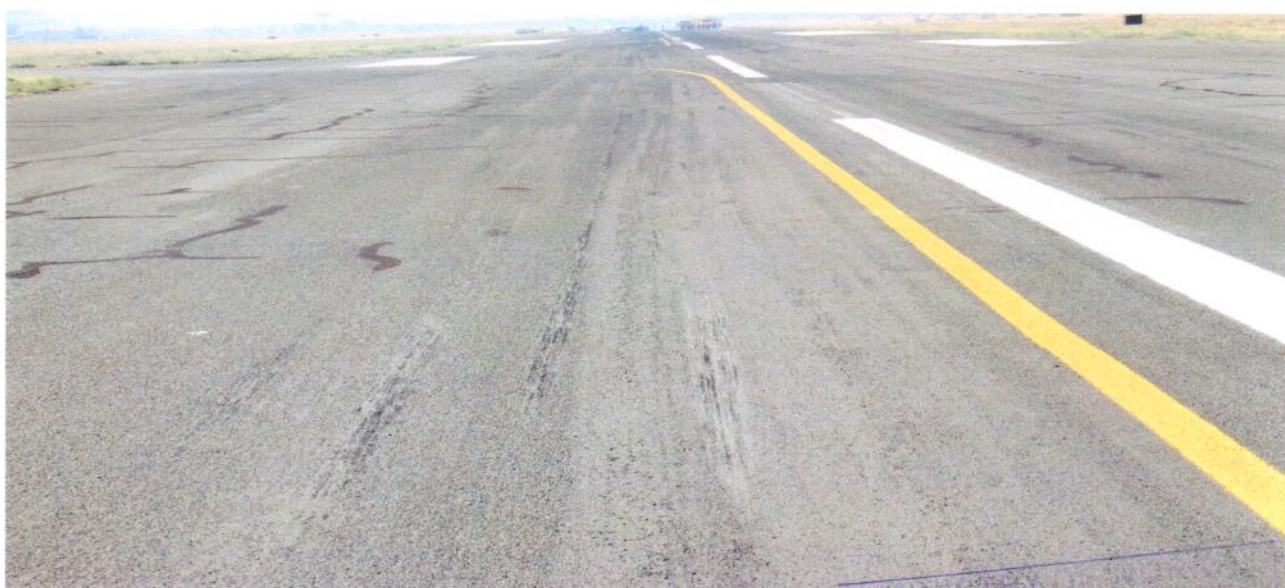
- 1.1.5 The aircraft did an emergency landing (wheels up) on runway 19. The aircraft first impact mark on the runway was around 40 meters from the Threshold and it came to a final stop on the runway about 146 meters from the first impact point.

**Figure 4:** Depicting the first aircraft impact point on runway 19.

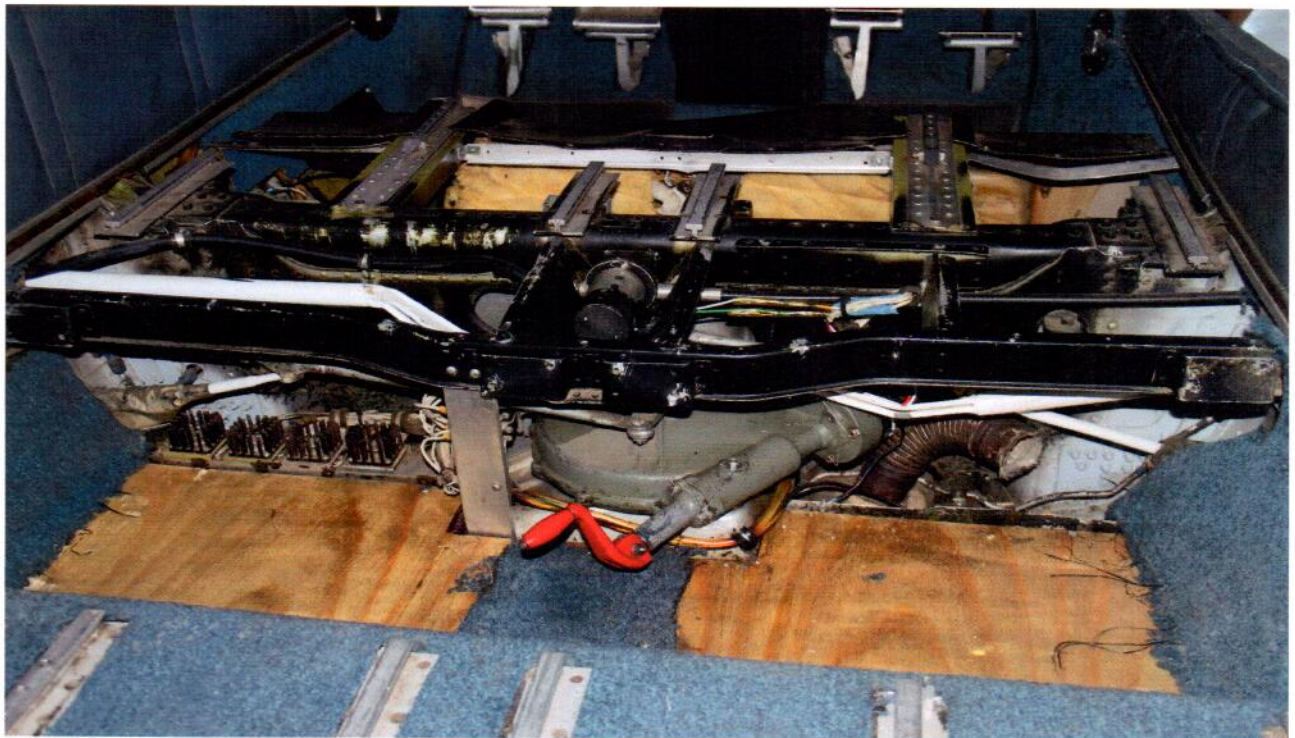
- 1.16.1. A local AMO was used to carry out the operational checks under the guidance of the DAAI investigator in-charge. The aircraft was placed on jacks and the landing gear was extended manually. The manual (emergency) extension system was engaged and the system was operated towards the full down position. The landing gear transmission mechanism was damaged during the landing and the landing gear could not be locked in the full down position due to damaged mechanism.

The landing gear was secured manually in the full down and locked position so that the aircraft could be moved safely. Although there was damaged caused by the wheels up landing the Manual (emergency) extension system operated as designed.

**Figure 5:** Depicting the landing gear Manual (emergency) extension system.

- 2.3 It is the view of the investigator that the teardrops on both runway 01 and 19 during the process of cranking the landing gear to extend and the inadequate operating knowledge of the manual (emergency) landing gear extension system added more load to the pilot which made it difficult for the pilot to execute the landing gear extension manually successfully.

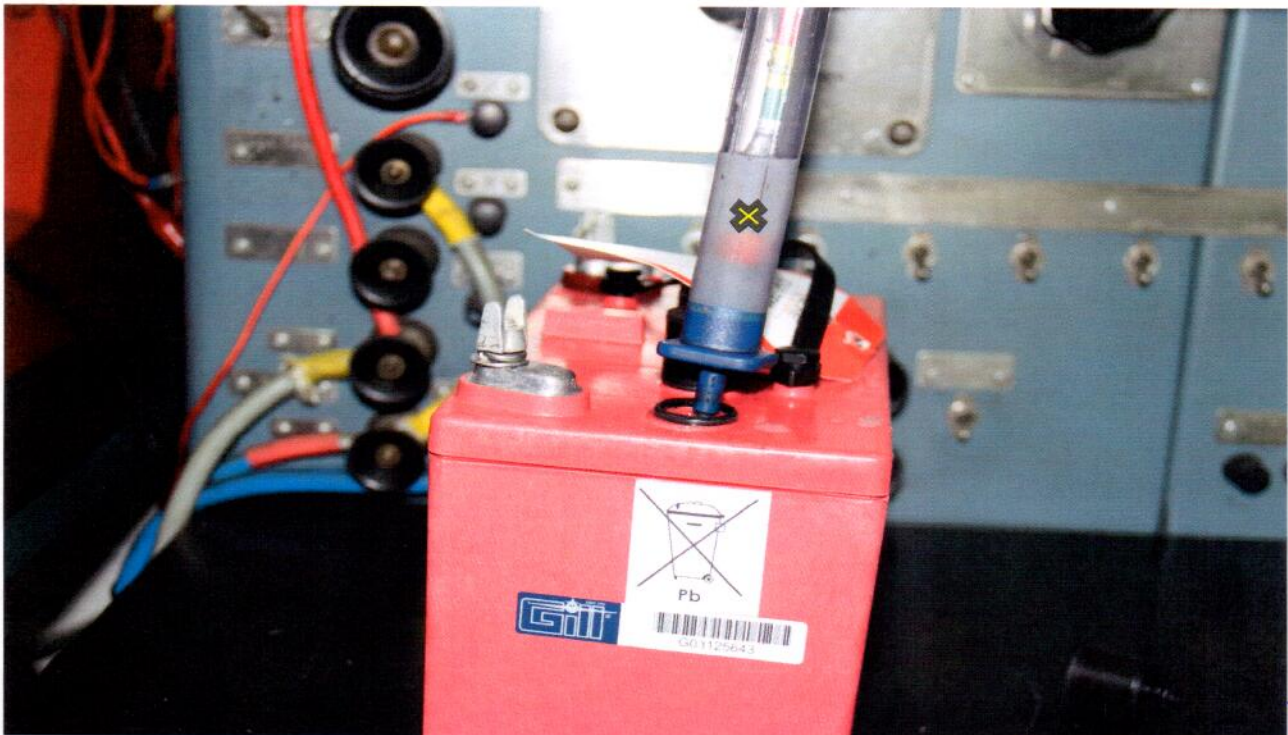
- 1.16.4 The battery was tested according to the Gill Tedelyne Dry charge lead –acid aircraft battery service Manual Q01-1120. During the test it was observed that the fluid in the battery cell was not a clear fluid as normal instead the fluid was dark grey. When the battery was put on the hydrometer the machine was unable to register a reading which is an indication that the Specific Gravity level is higher than the recommended level which should be between 1.275 to 1.295 according to the manual 5.2.4(n). When the sample from the battery was sent for further analysis at the laboratory it was found that the Specific Gravity was 1.46 above the 1.275 to 1.295 that is recommended.

A sample from the container that the AMO used to service the new battery before it was installed in the aircraft was also sent to the laboratory for testing and it was found to have a specific gravity of 1.61 way more than the recommended battery SG.

**Figure 6:** Depicting the dark grey contaminated battery fluid mark with an X on the tube.

2. 1. The higher specific Gravity level of 1.6 that was added to the battery during the battery maintenance (conditioning) caused sulphating of the plates which resulted in battery damage and failure.

**Note:** After the findings of the conditions of the battery shop were communicated to the AMO, the AMO put corrective measures in place to prevent a reoccurrence. New procedures on battery services were developed in accordance with GILL maintenance procedures.
