CIVIL AIRCRAFT ACCIDENT REPORT

ACCID/10082021/01-02

AIRCRAFT : V5- MPL

DATE : 08 OCTOBER 2021

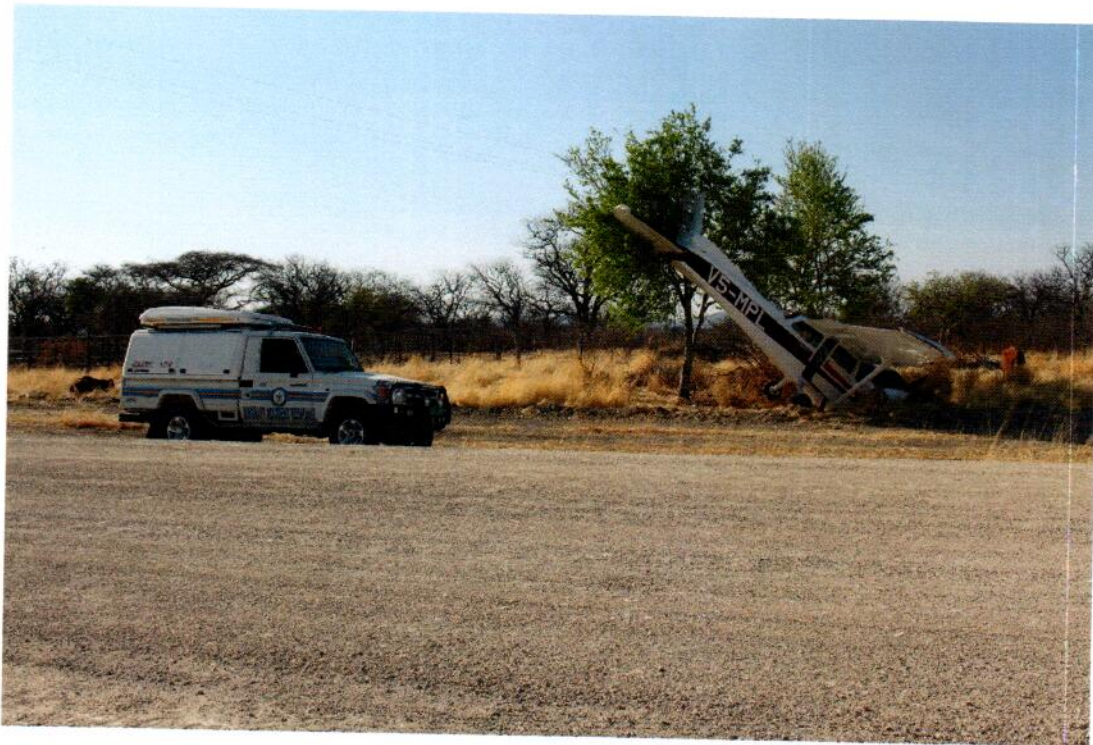
1.3.1 The aircraft was destroyed on impact.

Image 1 Aircraft crashed next to the district road.

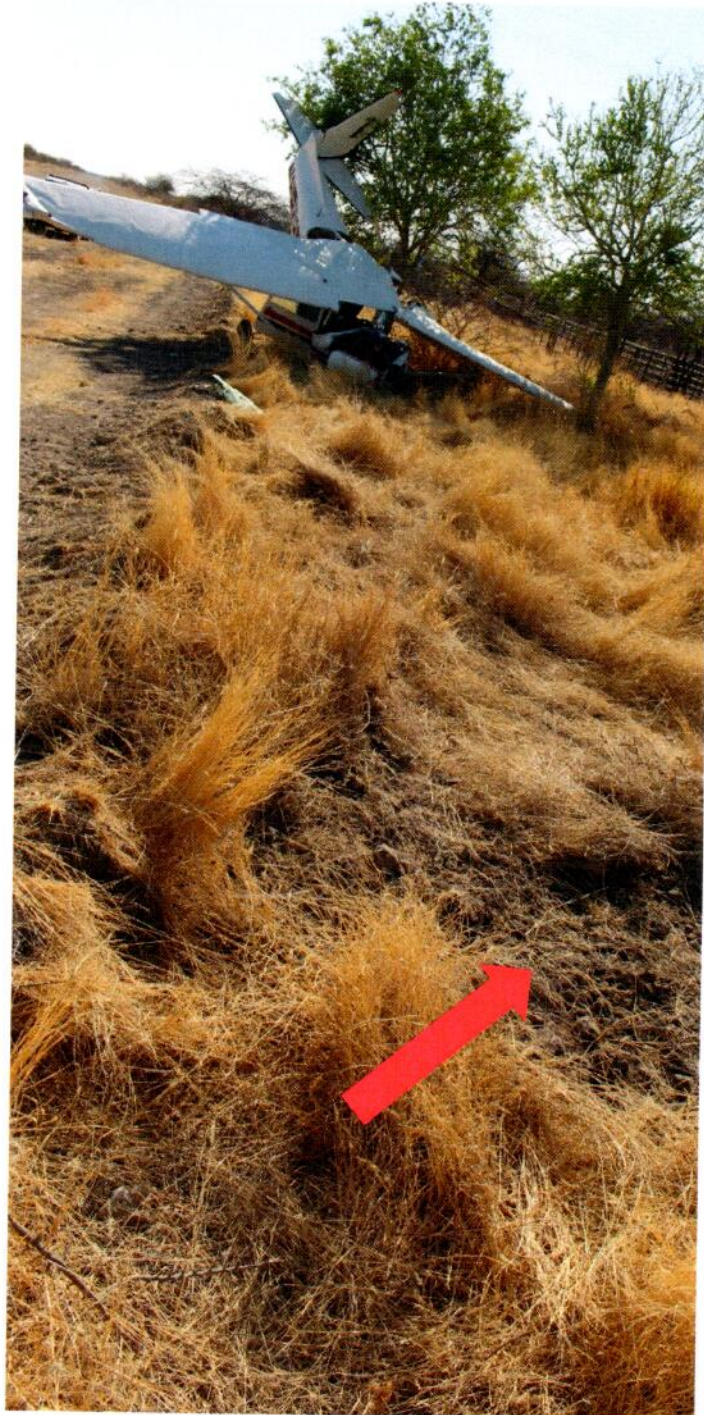
Image 3: Point of impact at a very steep angle nose down and a reversed jump backwards into tree.

- 2.3 The pilot shortly after getting airborne, tried to avoid a power line crossing the road, but lost control of the aircraft and it hit the ground at a 70 degree angle next to the road side.

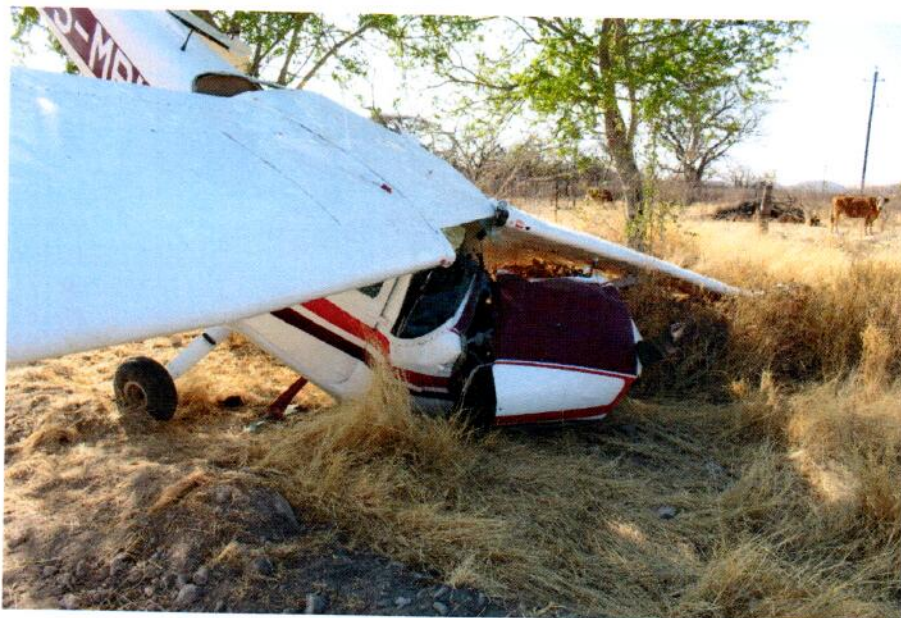
Image 4: Crushed nose section of the aircraft.

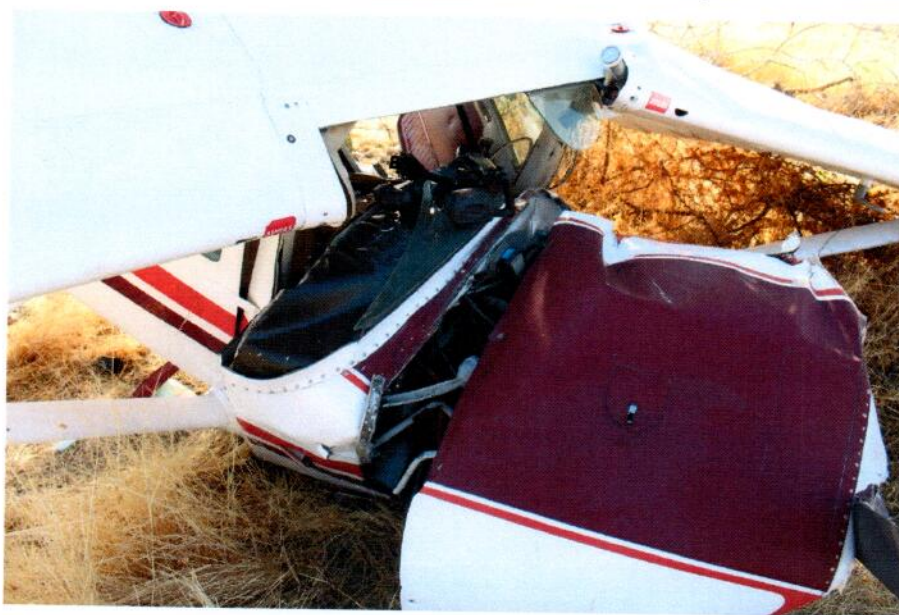
1.15.1 The accident was deemed not to be survivable due to the downward impact forces on the aircraft.

Image 5: Downward forces crushed the nose section backwards into the cockpit area, severely injuring the pilot
