**DIRECTORATE OF AIRCRAFT ACCIDENT AND  
INCIDENT INVESTIGATION**

**CIVIL AIRCRAFT ACCIDENT REPORT**

**ACCID/11152021/01-04**

<b>OPERATION</b>	<b>: TRAINING</b>
<b>AIRCRAFT</b>	<b>: V5-USC</b>
<b>LOCATION</b>	<b>: ENGINE FAILURE 10 KM NORTH OF EROS AIRPORT</b>
<b>DATE</b>	<b>: 15 NOVEMBER 2021</b>

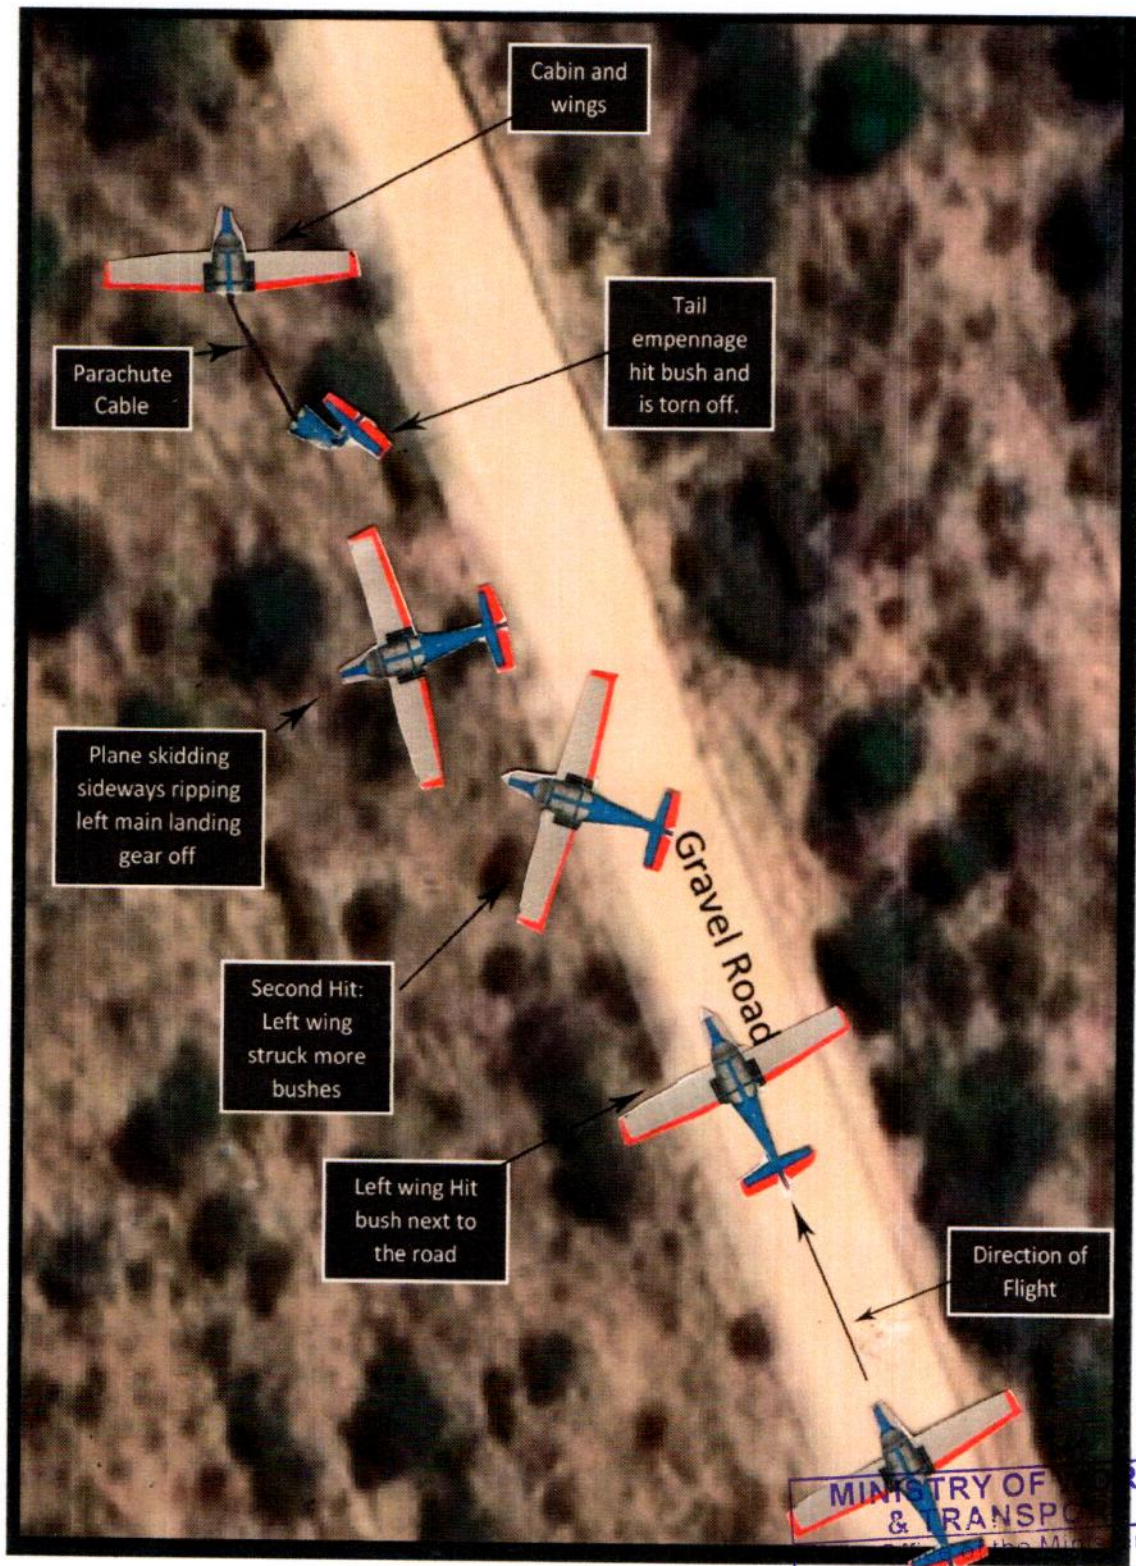
Image 1- : Illustration

- 1.1.3 The emergency landing was unsuccessful due to vegetation next to the road and on landing the left wing struck the bushes and this caused the aircraft to veer to the left where it hit more vegetation and was destroyed by the impact.

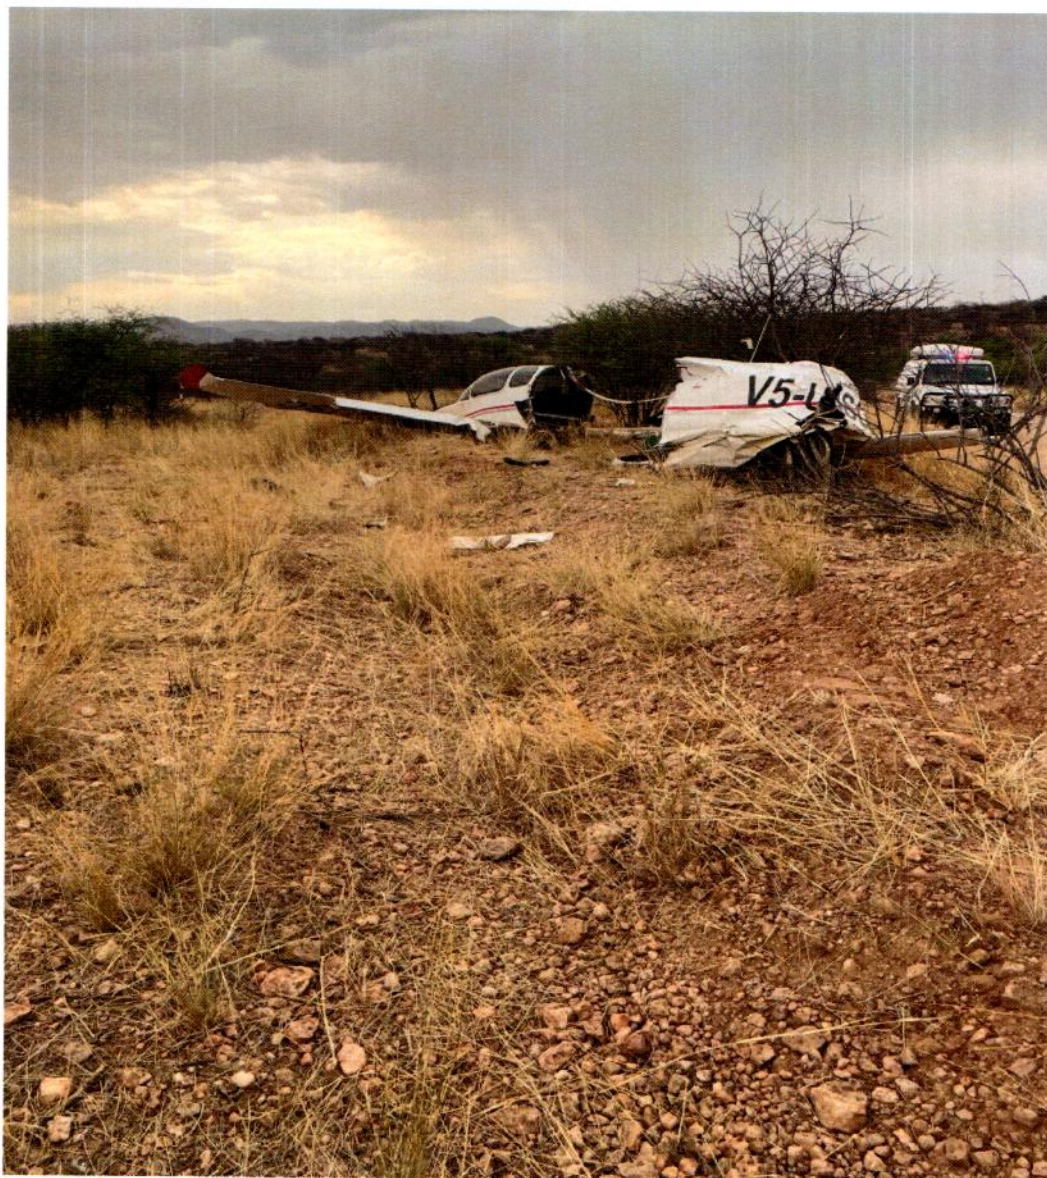
Image 2- Aircraft came to stop next to the road.

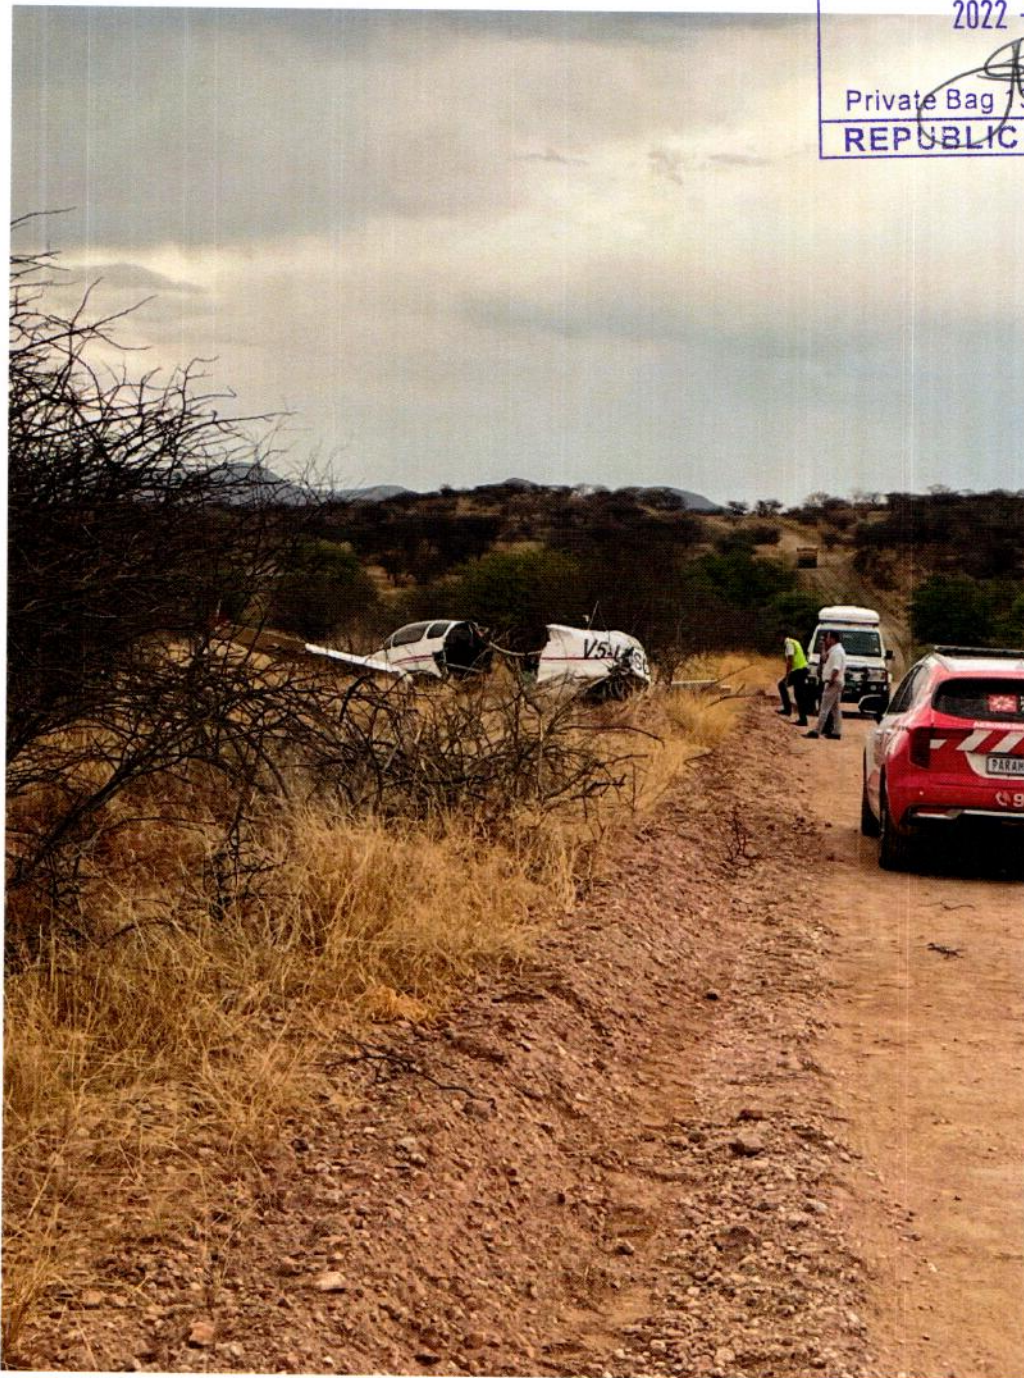
### 1.3.1 The aircraft was destroyed on impact.

*Image 4: Aircraft was destroyed on impact and the tail empennage was torn from the main cabin.*

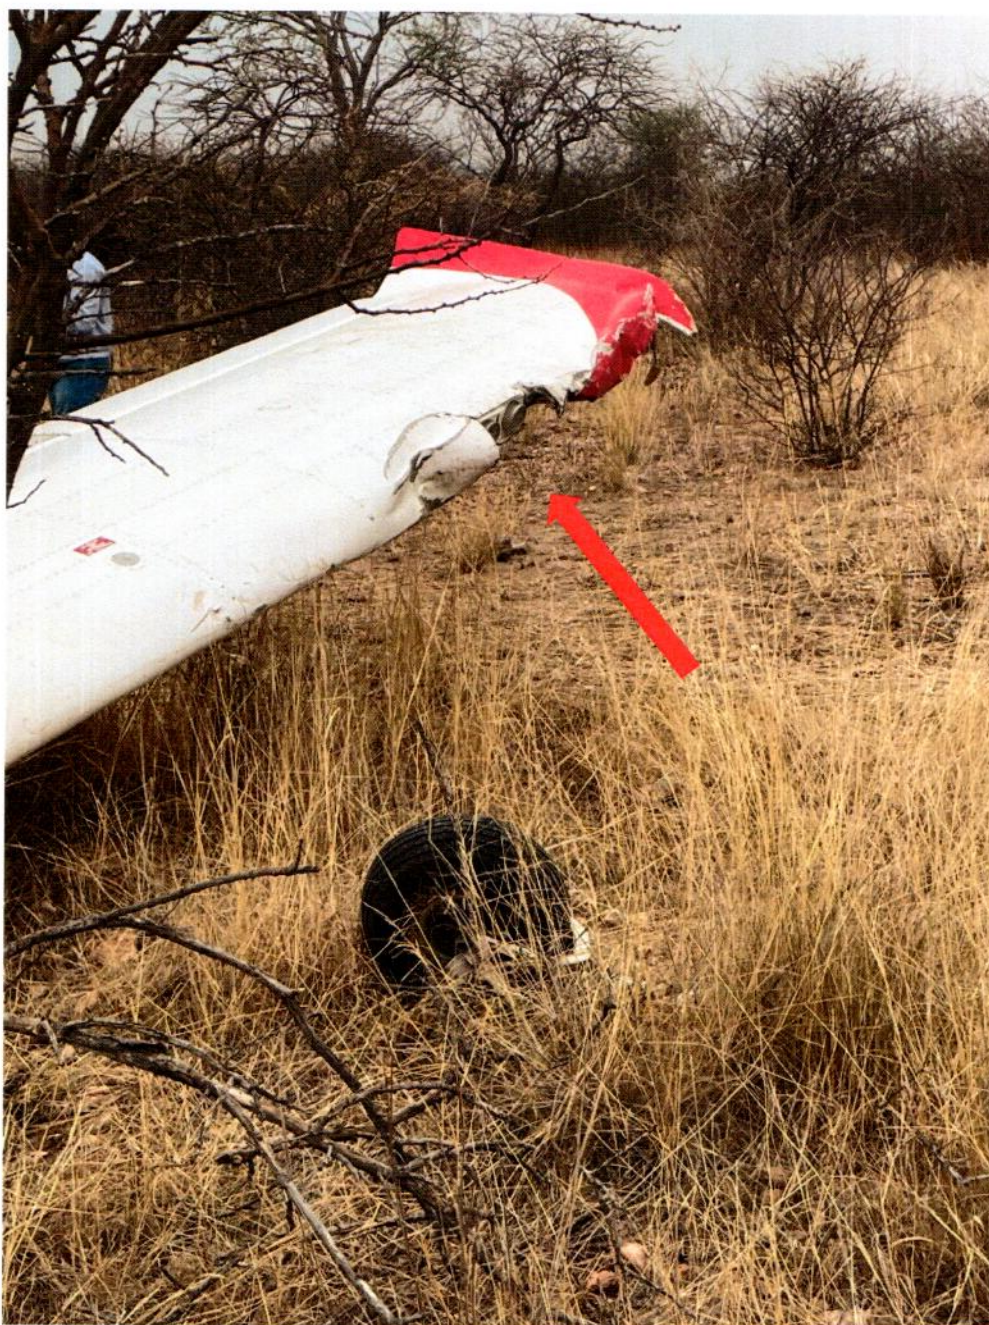
*Image 5: Red arrow shows impact of bushes that struck left wing on landing.*

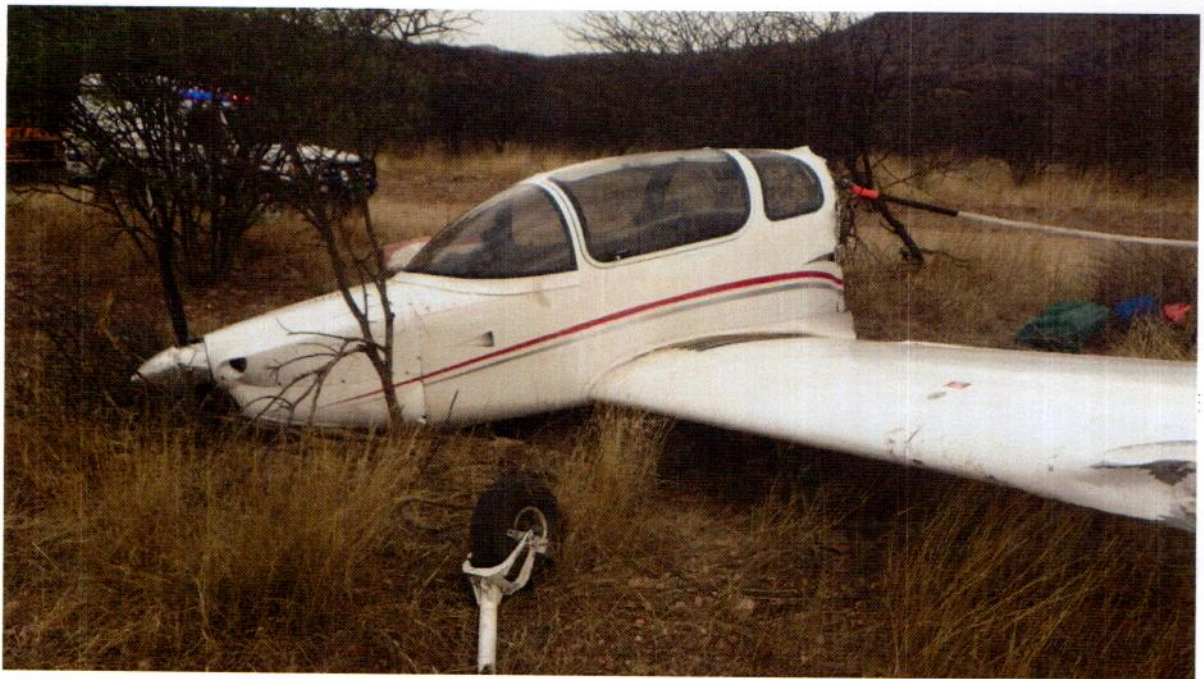
1.15.2 The main cabin section remained intact during the crash landing.

*Image 6- The cabin remained intact and therefore made the accident survivable.*

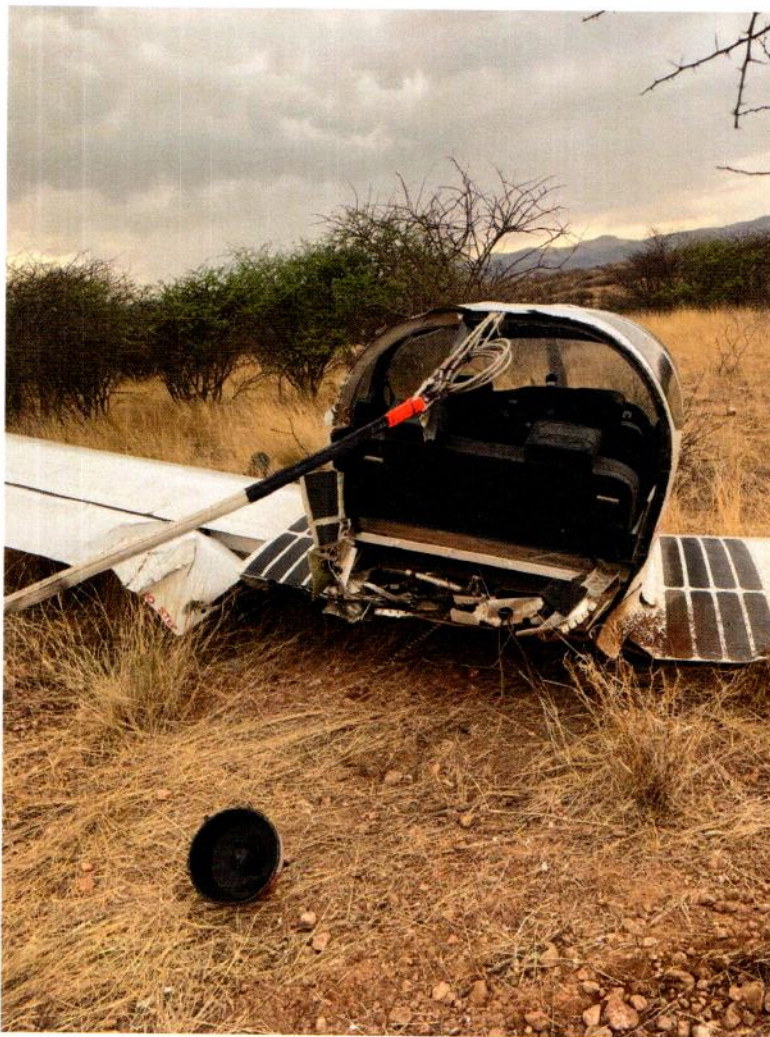
*Image 7- The interior (including the seats) of the cabin remained intact.*
