Accident Reference: ACCID/10282020/02-09

Aircraft Accident Investigation Report

Maule M6 (V5-EMC)

DESCRIPTION OF OCCURRENCE: (LOC-G) Loss of control on ground.

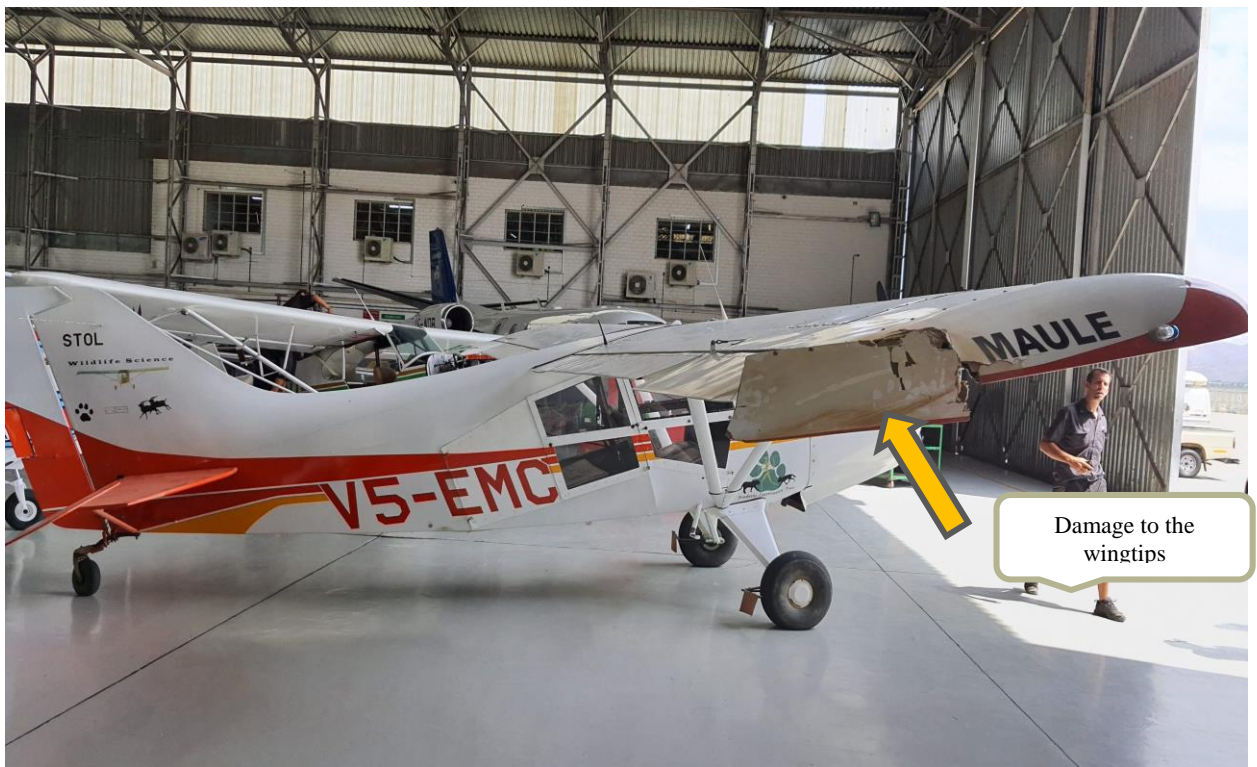
- 1.1.4 During the process, the aircraft's wing tips contacted the ground and the carbon fibre wingtips were substantially damaged.
- 1.1.5 The aircraft was taken to a local Aviation Maintenance Organization (AMO) for further damage assessment and subsequent repair.

Figure 1: The damage at the wing tips...

- They repaired the right-hand wing tip and trailing edge
- They carried out a composite repair on the left wingtip
- They repaired and reskinned the aileron
- They repaired the left-hand wing tip structure.

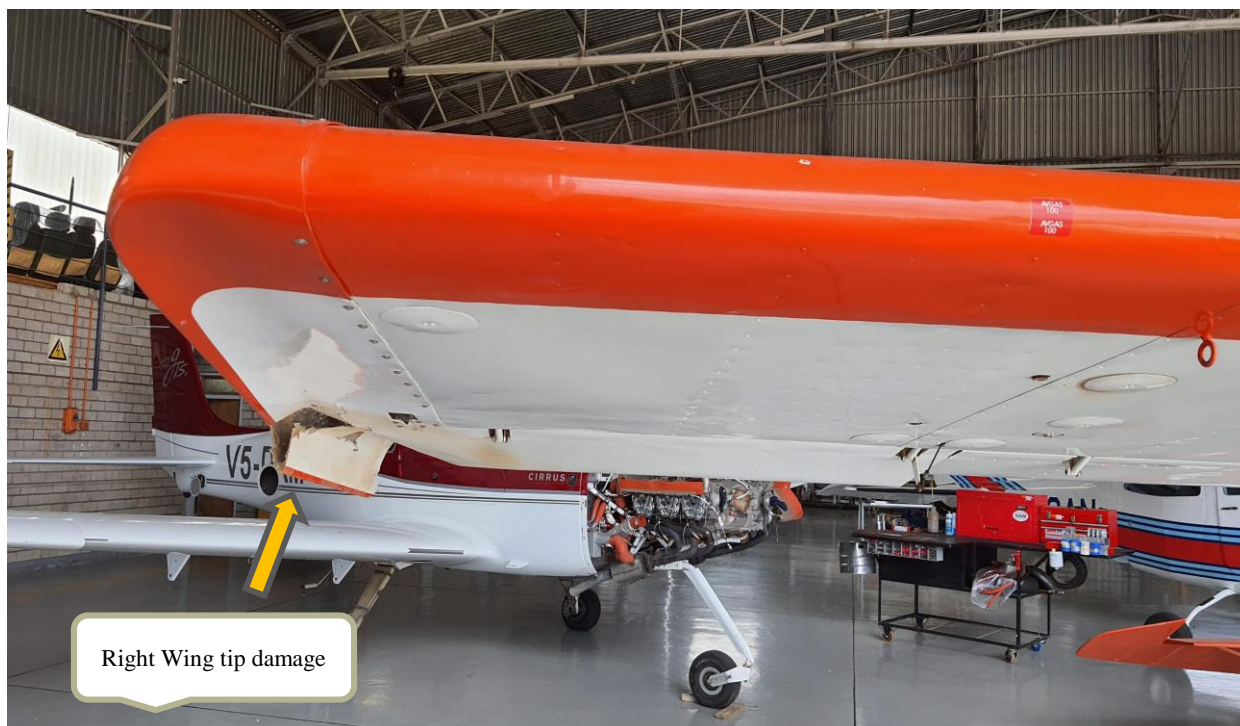
Figure 2: illustrating the carbon fibre wingtip, which was damaged.
