**CIVIL AIRCRAFT ACCIDENT REPORT**

**ACCID/011108/01-12**

<b>OPERATION</b>	<b>:</b>	<b>COMMERCIAL</b>
<b>AIRCRAFT</b>	<b>:</b>	<b>V5-GWH</b>
<b>LOCATION</b>	<b>:</b>	<b>WINDHOEK</b>
<b>DATE</b>	<b>:</b>	<b>11 JANUARY 2008</b>

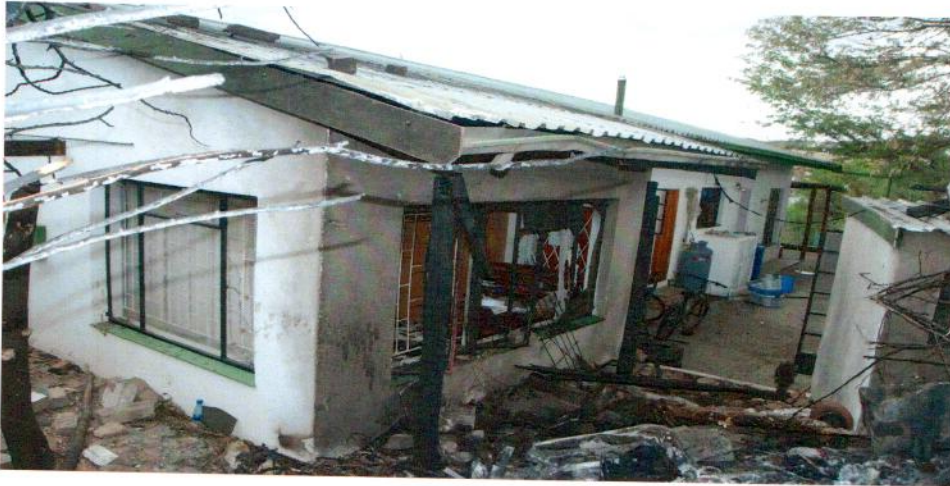
### 1.4 Other Damage

1.4.1 The aircraft smashed through a residential garden wall and exploded into flames. The house sustained fire damage to the wall and windows. Moderate interior damage was caused by the flames. A small house which was located next to the main building also caught fire.

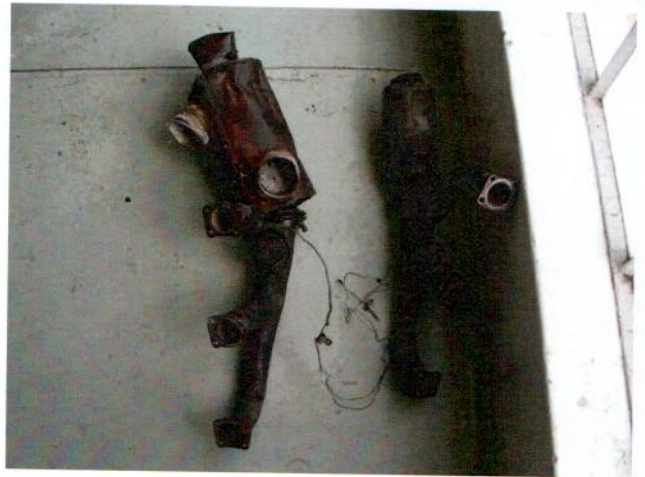
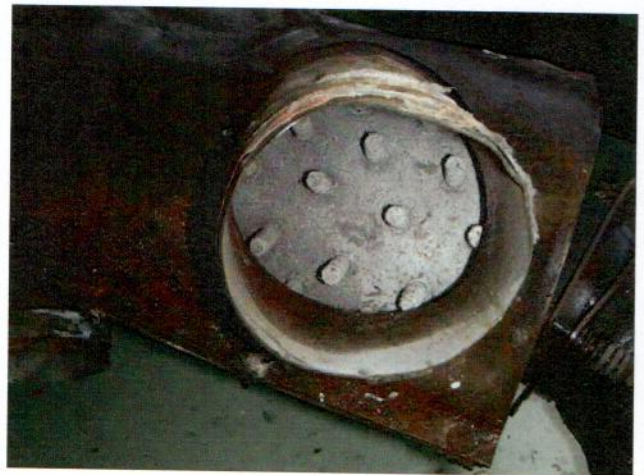
The exhaust system remained attached to the engine. The exhaust pipes and exhaust muffler assembly were bent and deformed and exhibited thermal damage. Corrosion was observed at the muffler. Deformation was observed to the exhaust pipe.

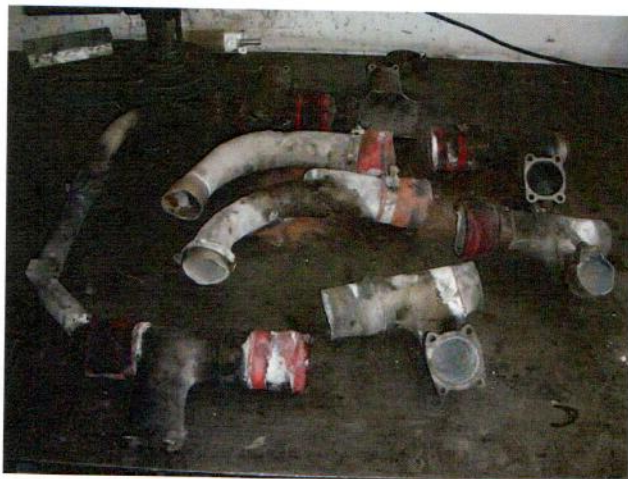
#### Induction System

The induction system remained attached to the engine. The induction tubes were thermally damaged and melted.

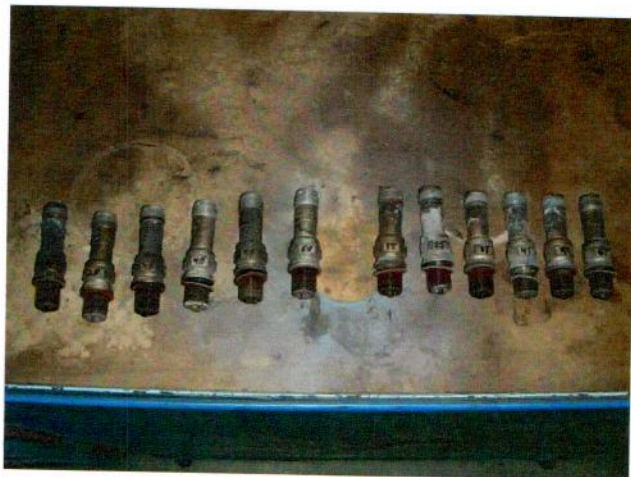
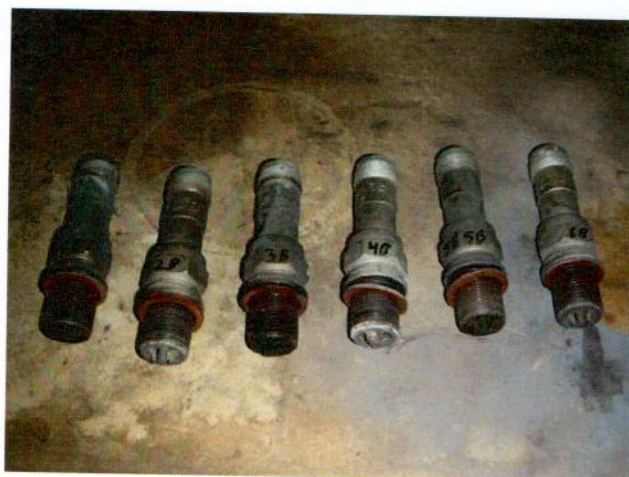
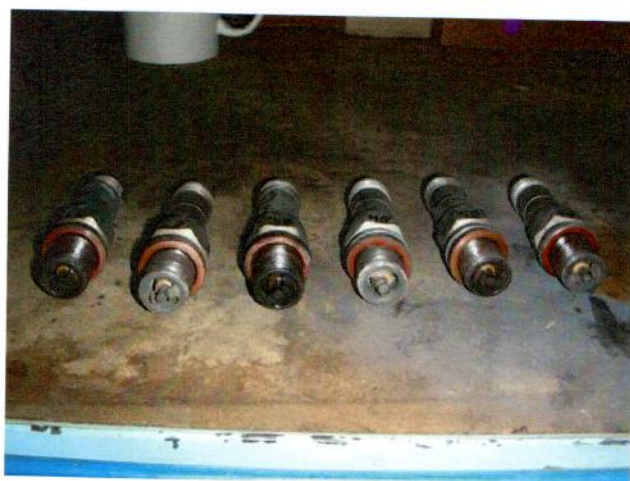
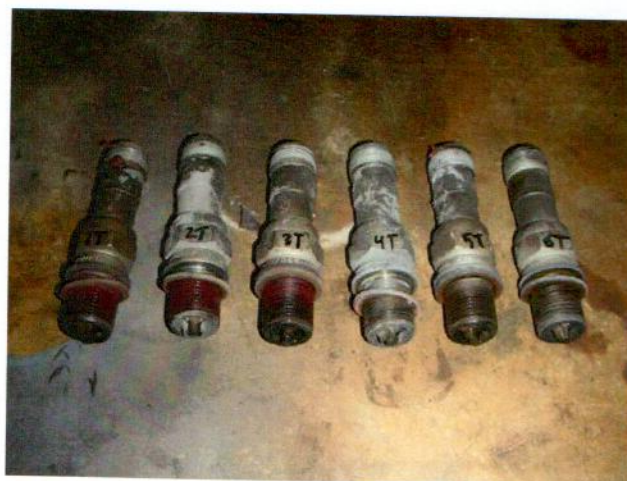
Spark Plugs      Manufacturer: Champion      Part number: RHB-32E

Condition: The spark plugs were intact and secured prior to removal. The top and bottom plugs were inspected and gap checked. They all exhibited thermal damage. The plugs appeared new with the exception of #3 top plug which was worn. All other plugs exhibited normal wear according to the Champion check a plug chart.

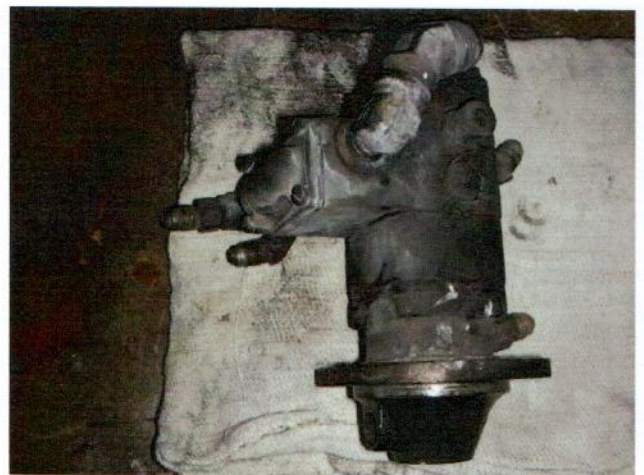
Condition: The fuel pump was intact with thermal damage to the exterior as well as to the interior. The pump drive shaft would not rotate. Air or liquid could be circulated through the pump. The pump disassembly exhibited thermal damage to the vanes. The drive coupling was separated in two sections. The pump exhibited debris that resembled carbon material. The drive coupling and a sample of the debris is to be sent to NTSB for further analysis, according to the CAA-IIC.

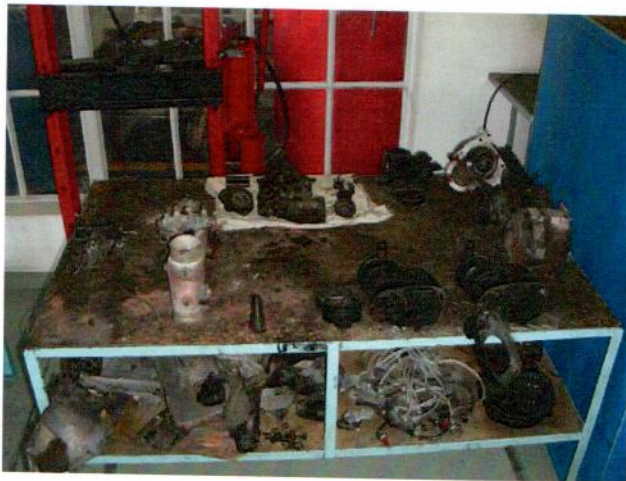
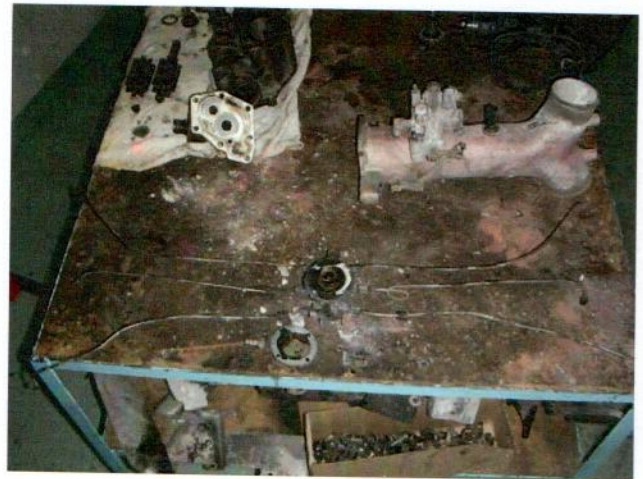
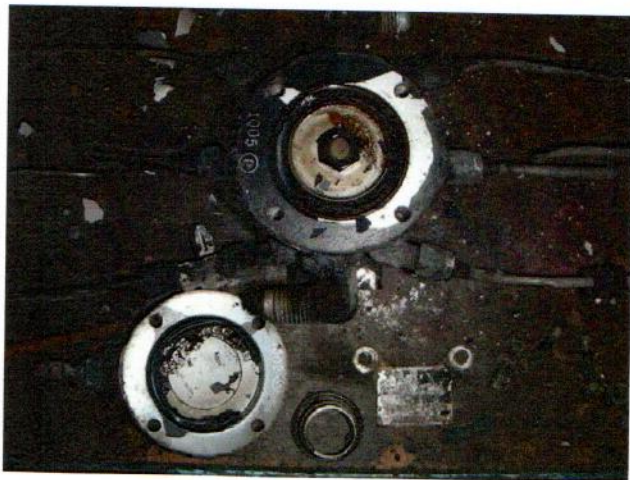
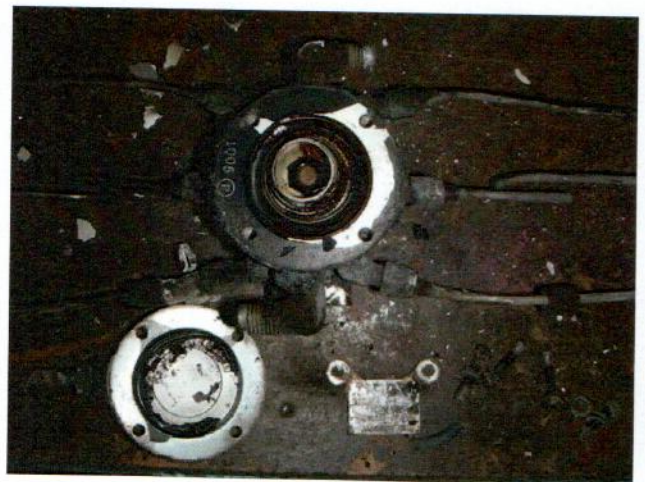
Fuel Manifold Valve    Manufacturer: TCM    Part Number: 631351-17A6    Serial #: H059715LR

Condition:    The manifold assembly was intact. Thermal damage was observed. The TCM lead seal was not observed. The internal gasket, diaphragm and screen was thermally damaged.

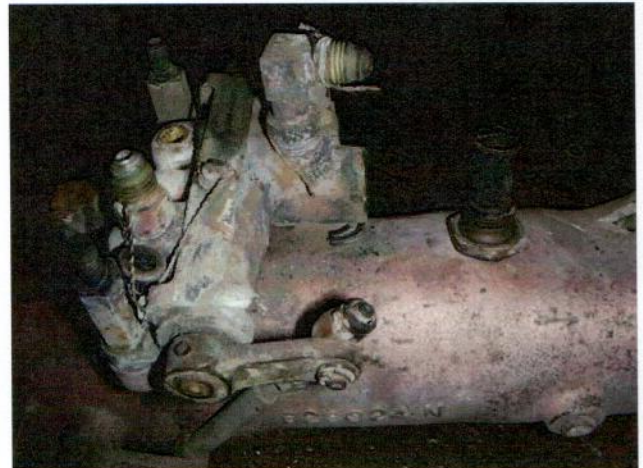
Condition: The throttle body fuel control was intact, although, it was cracked. There was also thermal damage observed to the unit. The throttle plate was stuck open ¼ travel. The throttle and mixture controls were bent and could not move. The screen was clear and thermally damaged.

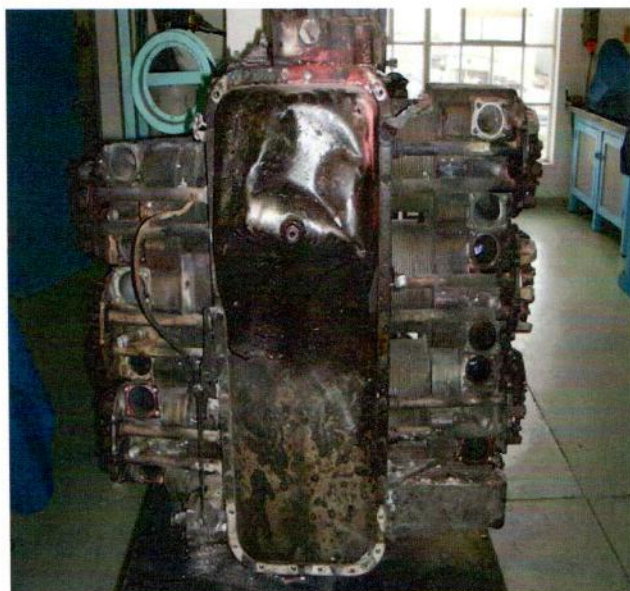
Oil Sump

The oil sump remained attached to the engine. The sump assembly was crushed inwards. The sump was breached. There was thermal discoloration to the outside and the inside of the sump assembly. Only residual oil was observed within the sump. No metal contaminants were observed in the sump.

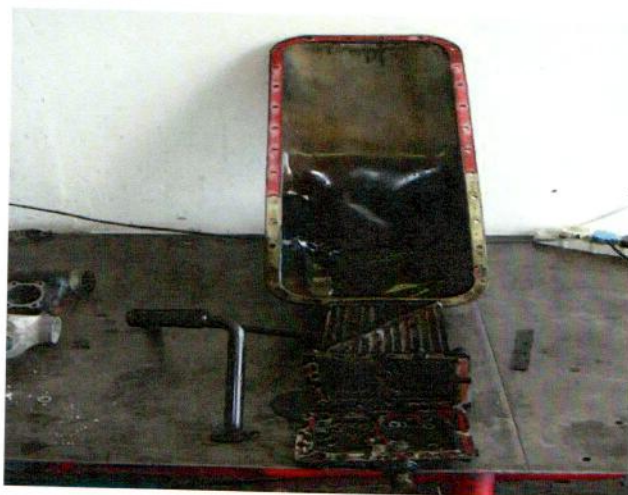
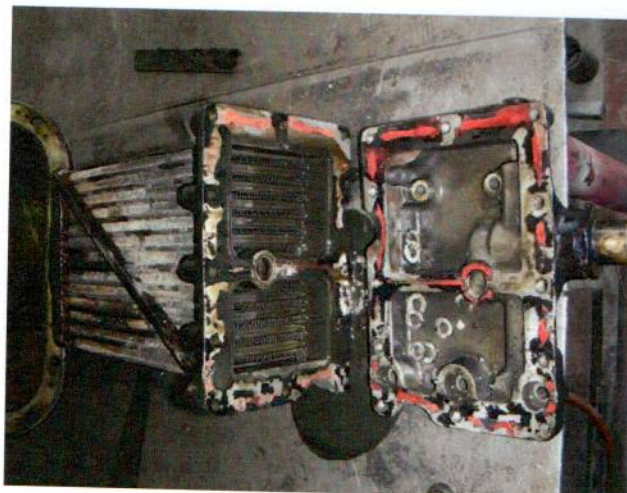
**Oil Cooler** The oil cooler was thermally damaged. It was intact and secured. There was oil inside the oil cooler.

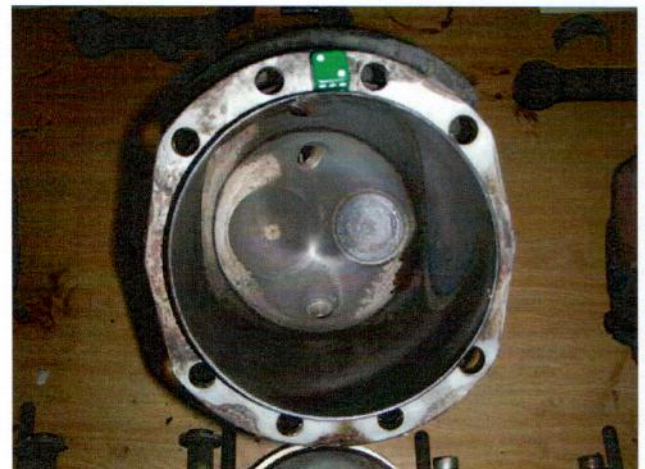
Condition: The cylinder was intact and secured to the engine. There was external thermal discoloration to the barrel and head assembly. The cylinder stud nuts were. Torque putty was not observed on any of the cylinder nuts. The combustion chamber was lightly lubricated and contained light brown deposits. The valves were not removed. The valve faces exhibited light combustion deposits.

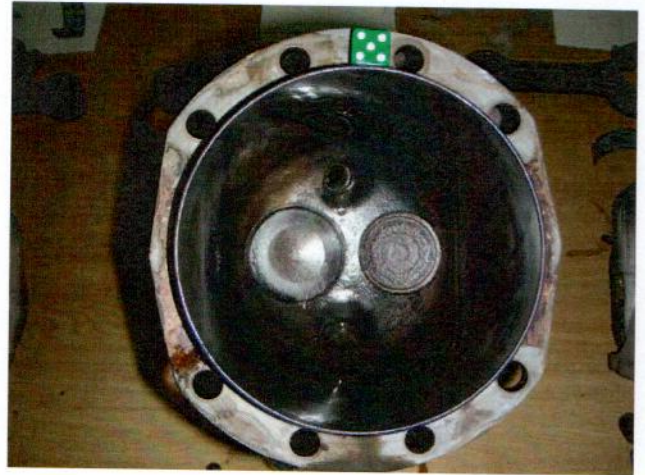
Condition: The cylinder was intact and secured to the engine. There was external thermal discoloration to the barrel and head assembly. The cylinder stud nuts were. Torque putty was not observed on any of the cylinder nuts. The combustion chamber was lightly lubricated and contained light brown deposits. The valves were not removed. The valve faces exhibited light combustion deposits.

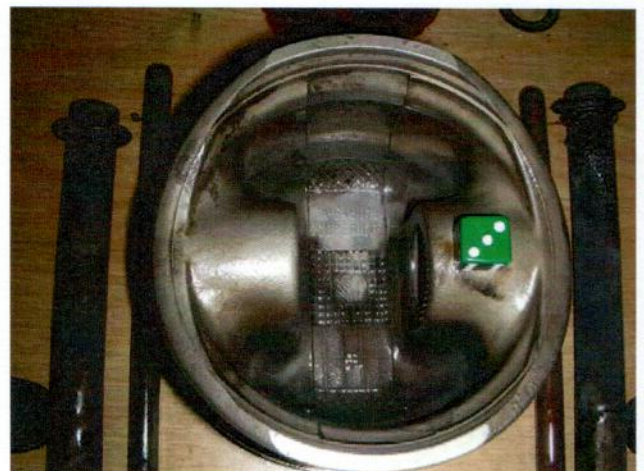
Condition: The piston, pin and rings were intact. The piston exhibited light combustion deposits. The piston skirt visually appeared to have thermal discoloration. The rings were properly offset. The pin was intact and not scored.

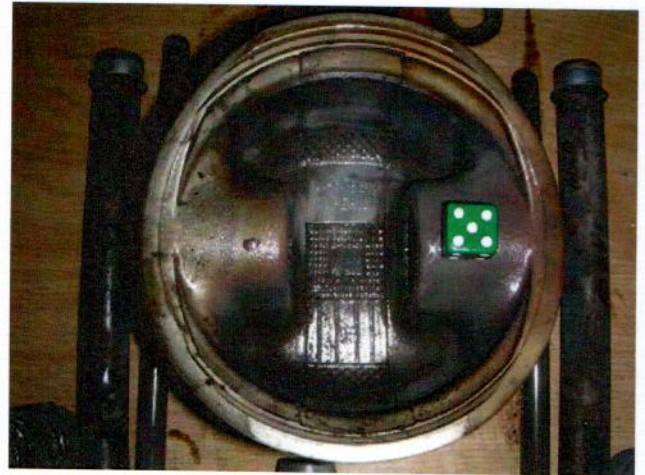
Condition: The piston, pin and rings were intact. The piston exhibited light combustion deposits. The piston skirt visually appeared to have thermal discoloration. The rings were properly offset. The pin was intact and not scored.

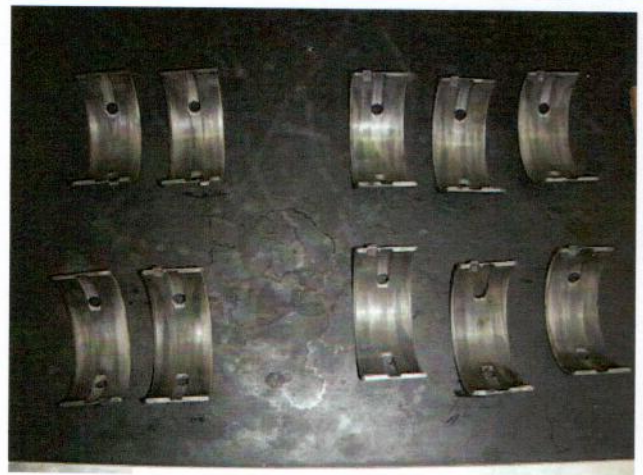
Main Bearing Part Number	Rear	Intermediate	Front
	SA642720	SA642720	SA642720
Condition	DATE CODE: 8-04 The bearings were all intact and light scoring signatures were observed to the bearing surfaces.

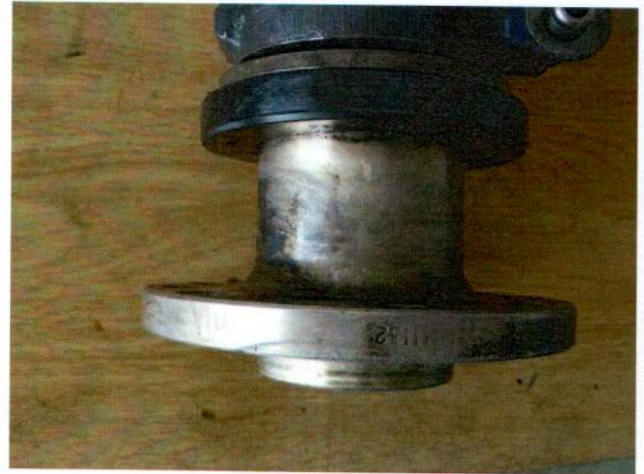
Condition: The crankshaft was intact and exhibited lubrication. The main journals and rod journals were lubricated and slightly discolored. The oil galleries were visually free of obstruction.

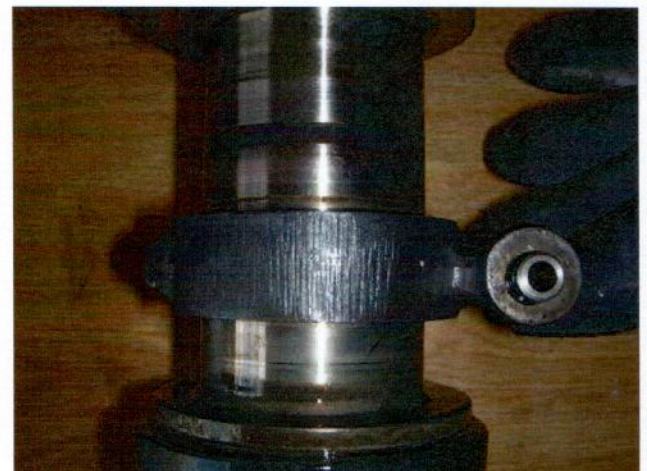
Transfer Collar: P/N: 626737

The transfer collar was intact and no binding was observed.

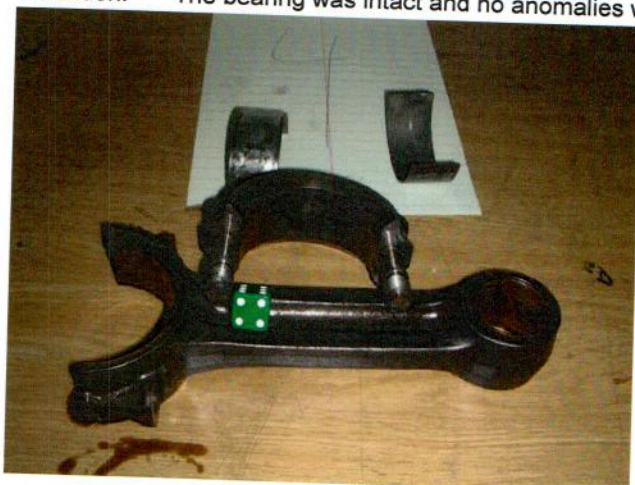
#4 Connecting Rod Bearing

Condition: The bearing was intact and no anomalies were visually observed.

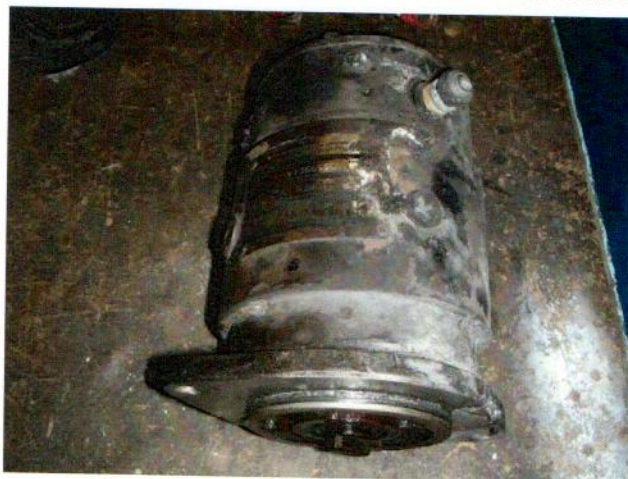
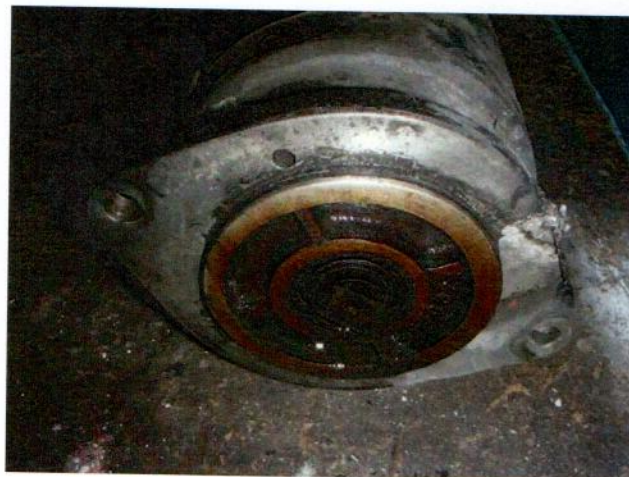
Condition: The starter was intact, although some case damage was observed and exterior thermal damage was observed. The starter shaft rotated without any binding. The wires were melted.

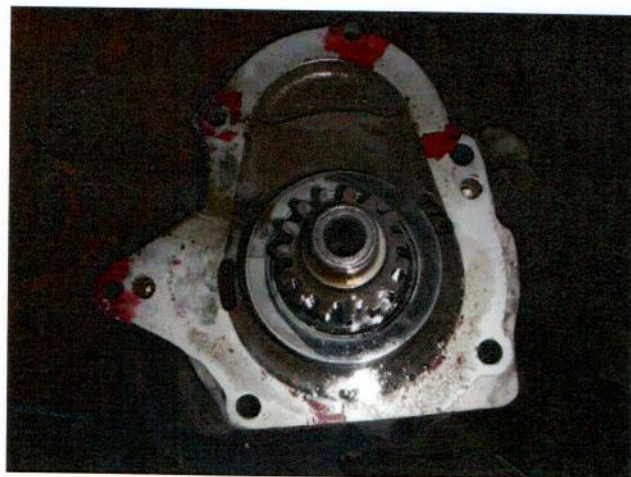
**Starter Adapter** Part Number: Illegible.

**Condition:** The adapter was intact. The internal gear and clutch was intact and the shaft rotated. Signatures of lubrication was observed. The pulley was damaged.

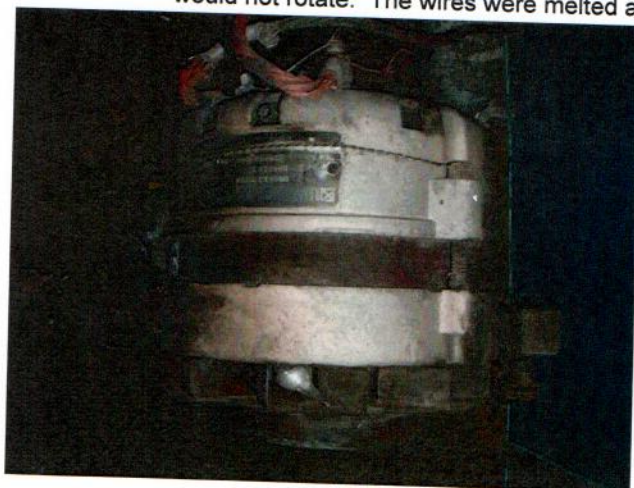
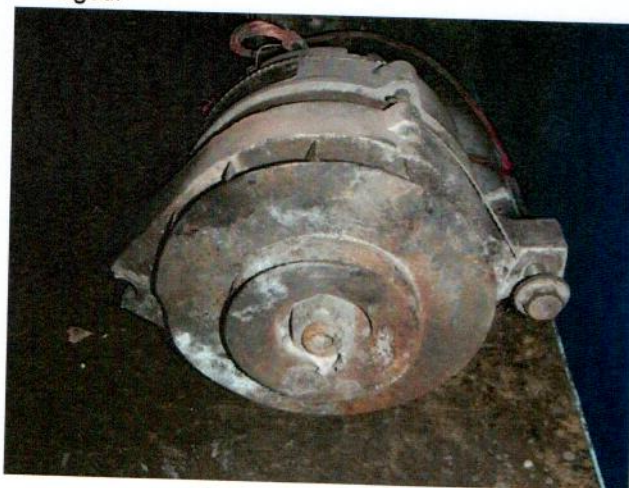
Condition: The alternator was intact. Thermal damage and corrosion was observed to the exterior. The pulley would not rotate. The wires were melted and damaged.

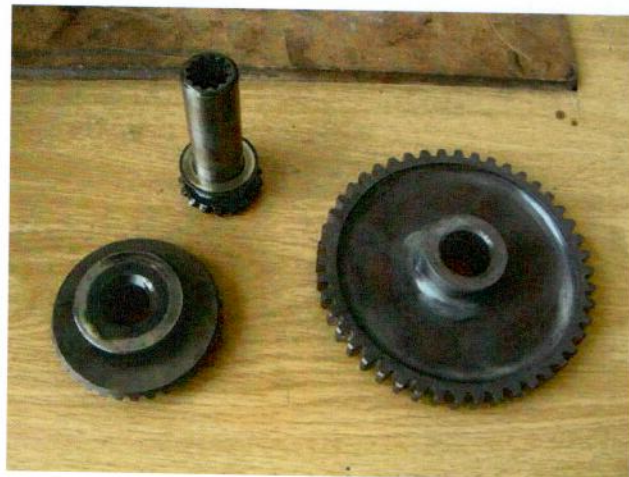
**Accessory Gears** All accessory gears were observed intact and all gear teeth were observed intact.

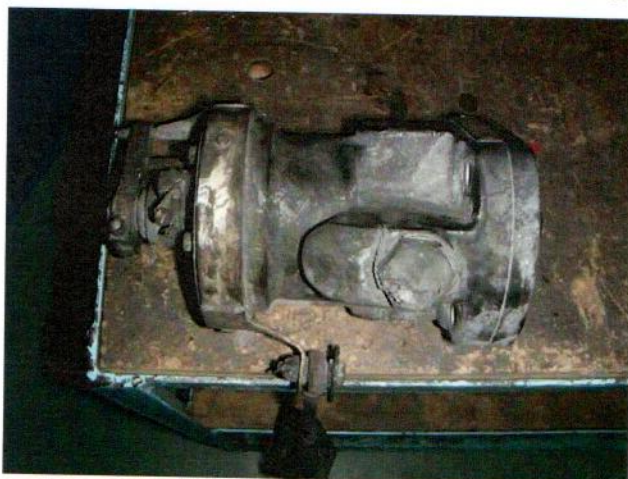
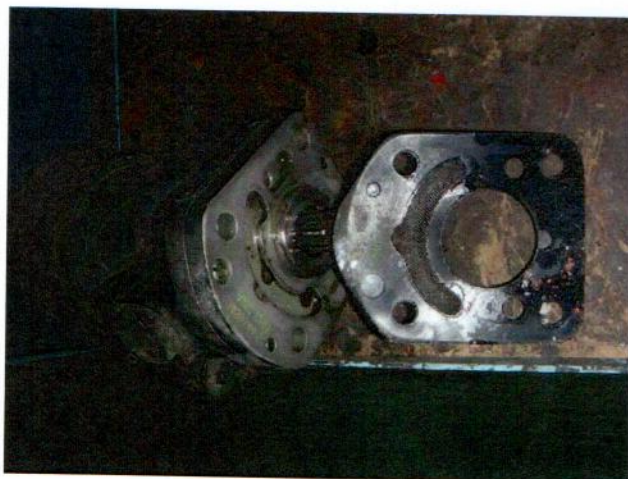
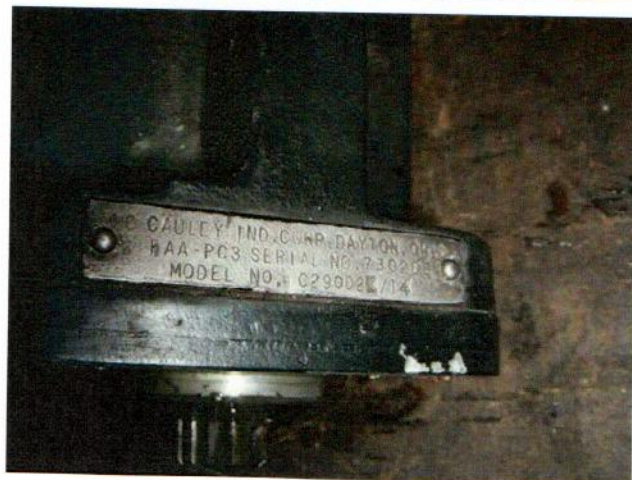
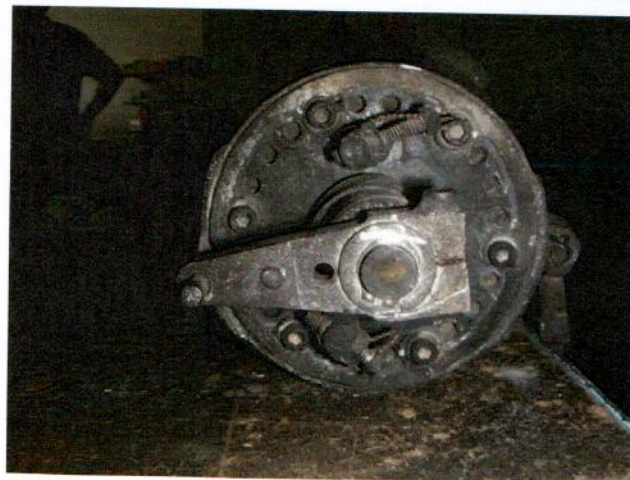
#### Propeller Governor

Condition: The McCauley governor was intact and thermally damaged. The propeller governor cable was damaged. The shaft rotates freely. The gasket and screen were intact and clear of debris.

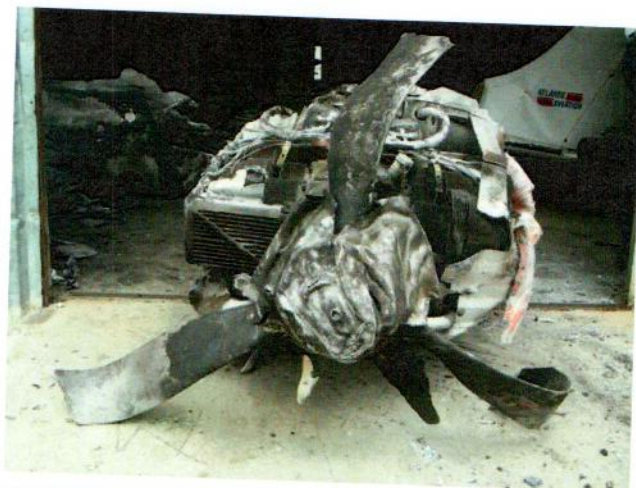
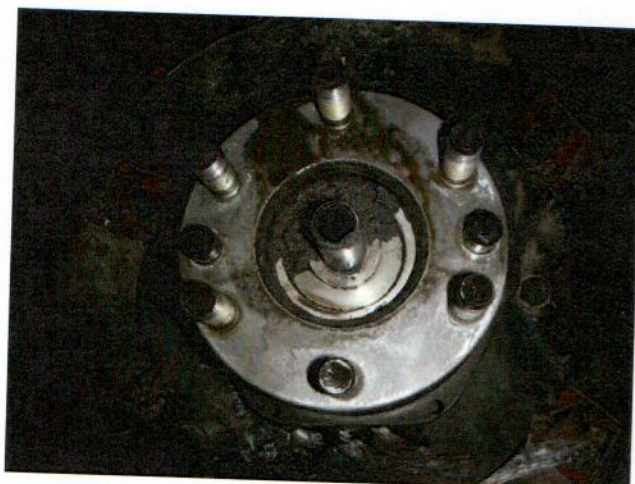
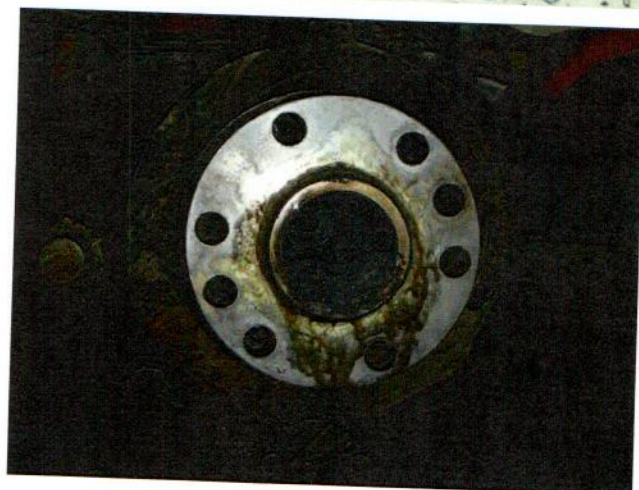
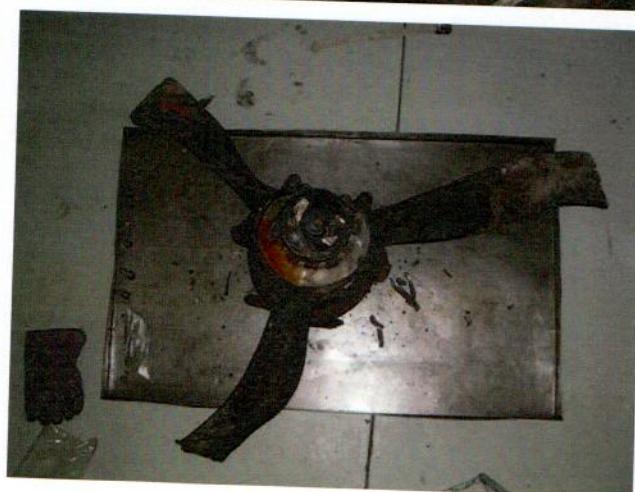
Propeller: MFG/Model: Hartzell / PHC-J3YF-IRF S/N: F7691 HUB S/N: FP718A

Condition: The propeller remained attached to the crankshaft flange. The hub assembly was crushed aft and twisted around the propeller hub. The propeller exhibited thermal damage. The three blades were attached although loose in the hub. All three blade tips separated. One separated tip section was located ~350-400 meters from the wreckage site, according to the CAA-IIC. The section was curled and exhibited heavy gouging and scoring signatures in a chordwise direction. The three blades exhibited curling, S-bending, twisting and chordwise scoring. There was also forward and aft bending signatures to the blades. The large quantity of sludge was observed inside the crankshaft flange.
