**DIRECTORATE OF AIRCRAFT ACCIDENT  
INVESTIGATION**

**CIVIL AIRCRAFT ACCIDENT REPORT**

**ACCID / 040816 / 1-04**

<b>OPERATION</b>	<b>:</b>	<b>PRIVATE</b>
<b>AIRCRAFT</b>	<b>:</b>	<b>V5-HFW</b>
<b>LOCATION</b>	<b>:</b>	<b>8.7 NM SE OF EROS AIRPORT</b>
<b>DATE</b>	<b>:</b>	<b>08 APRIL 2016</b>

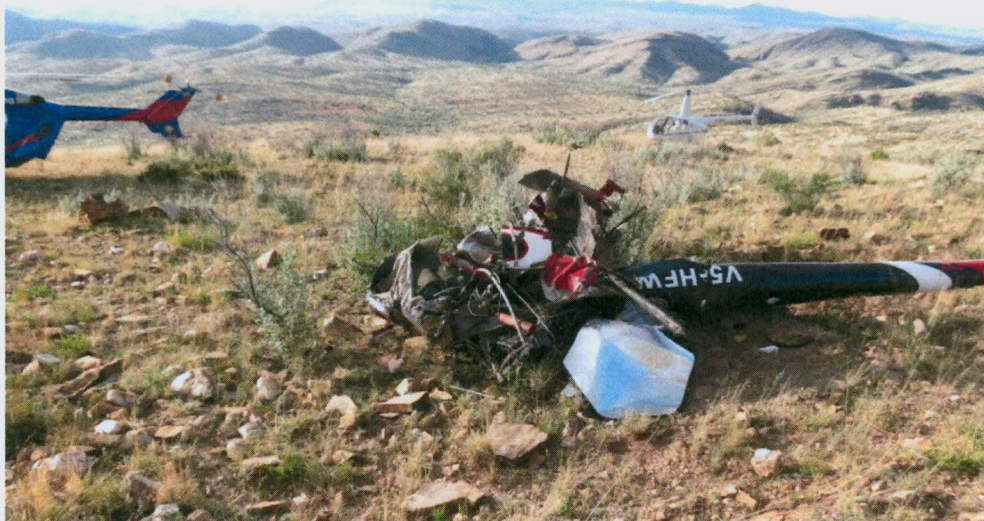
Image 1

### 1.3.1 The helicopter was destroyed on impact.

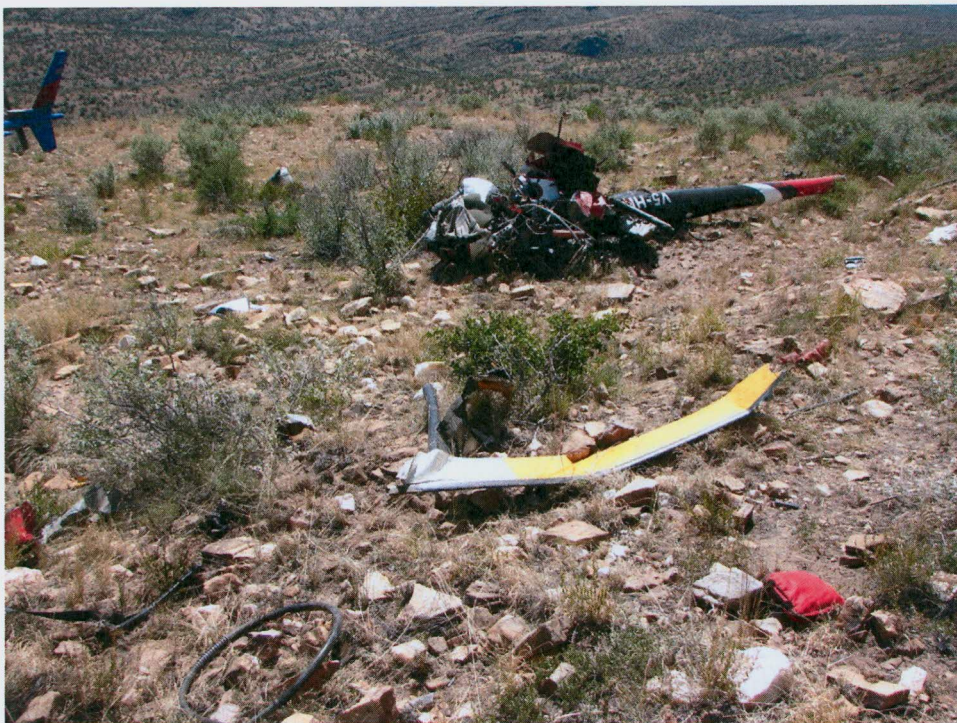
Image 6

1.12.2 Main Wreckage – after stumbling 76m from impact.

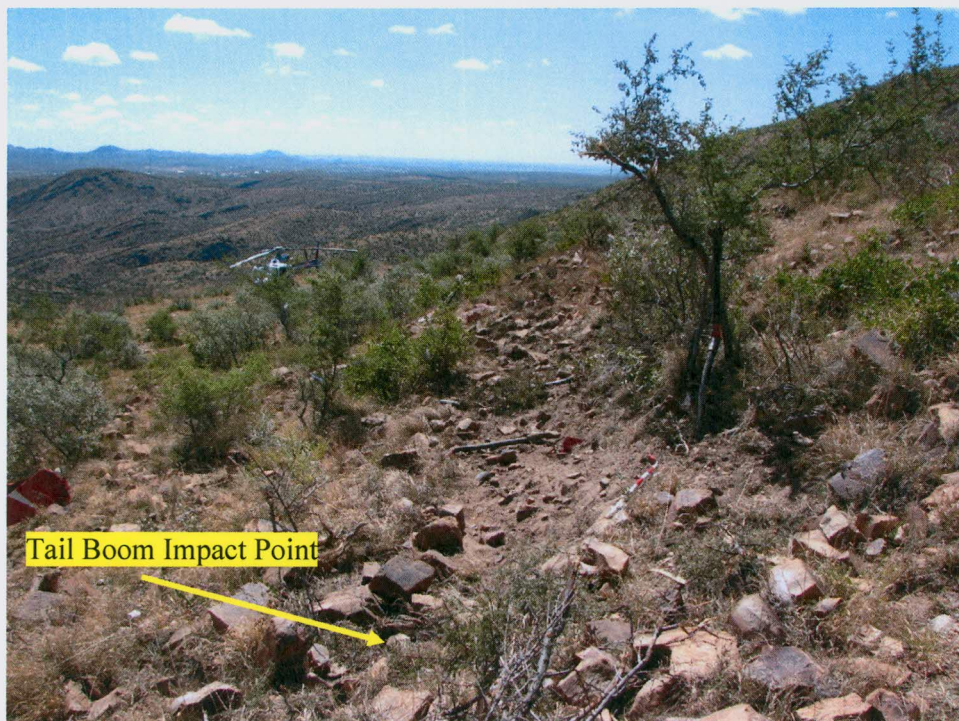
Image 7

1.12.3 Point of impact

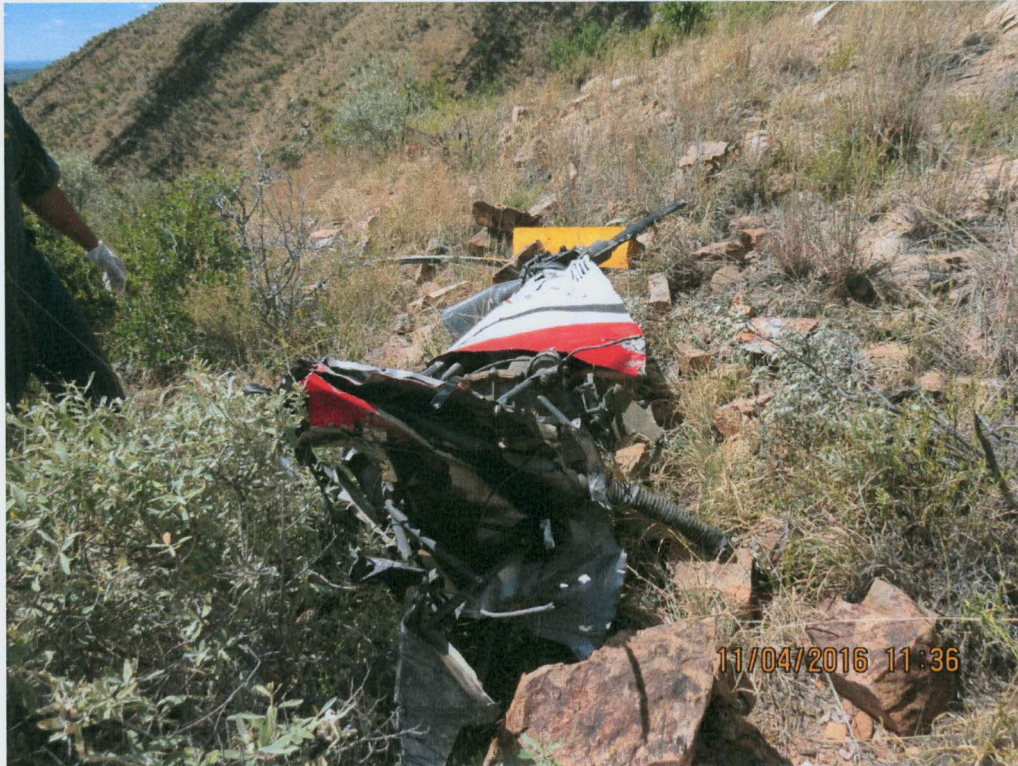
Image 8 - Rotor mast and gearbox found 117 meters from impact point

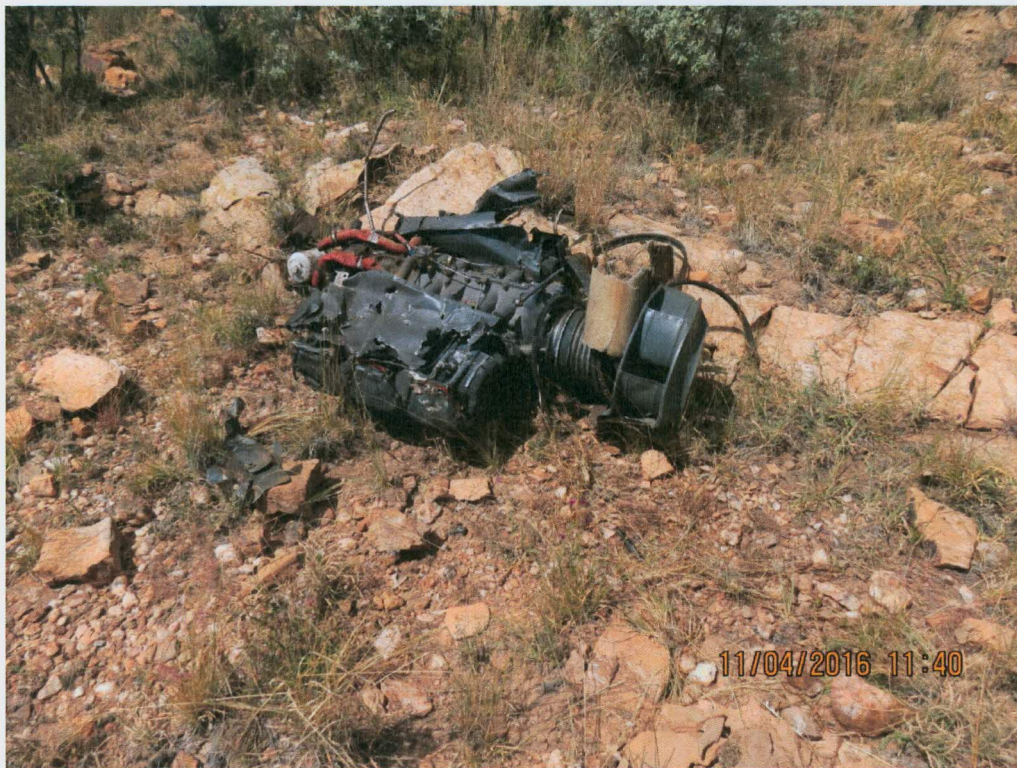
Image 9 - Engine found 117 meter from impact point and 10 meters from rotor mast.

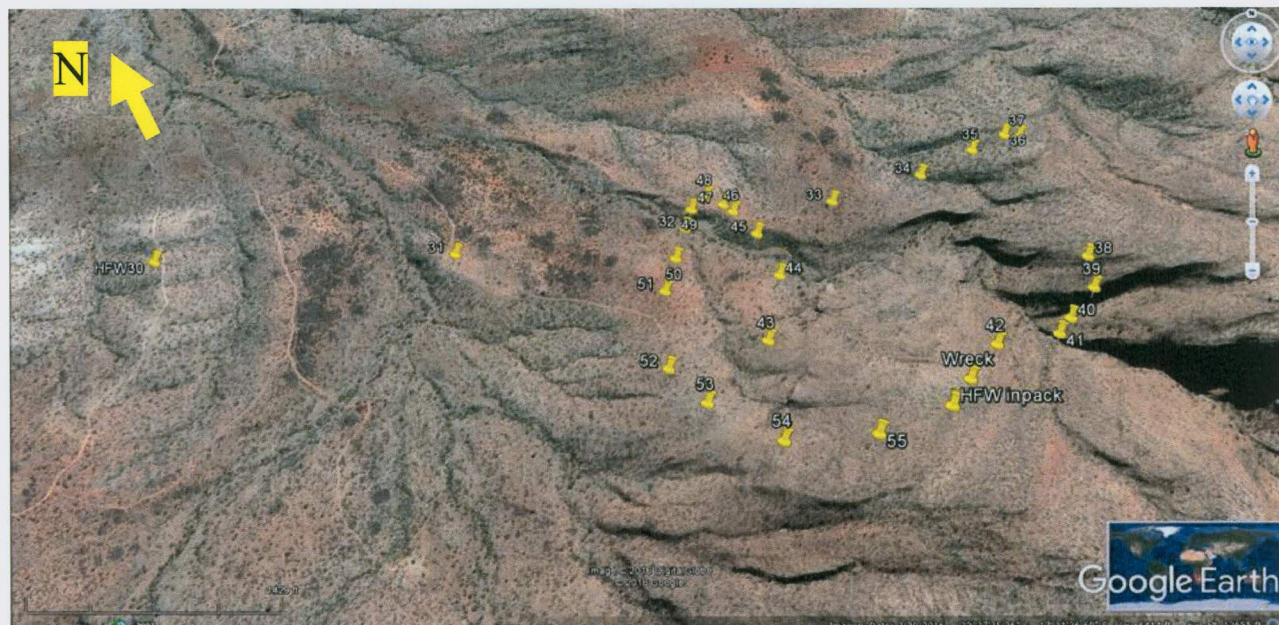
Image 14 – Obtained from Google Earth.

- 1.18.4 The flight path of the helicopter for the last 120 seconds ( POINT 30 to point 55 extract from above data in para 1.18.3 ) imposed on a google map image of the terrain where the accident took place. Note: This image does not reflect a 3 D version of the flight path.

- 2.5 When the speed dropped off to almost in a hover ,the helicopter turned again abruptly onto a southerly direction picking up speed while descending in a slow left turning manoeuvre reaching the VNE speed again before crashing into the mountain on a easterly heading.
