CIVIL AIRCRAFT DRAFT ACCIDENT REPORT

ACCID/050622/01-02

Aircraft Accident Investigation Final Report

BELL 206B V5-HIR

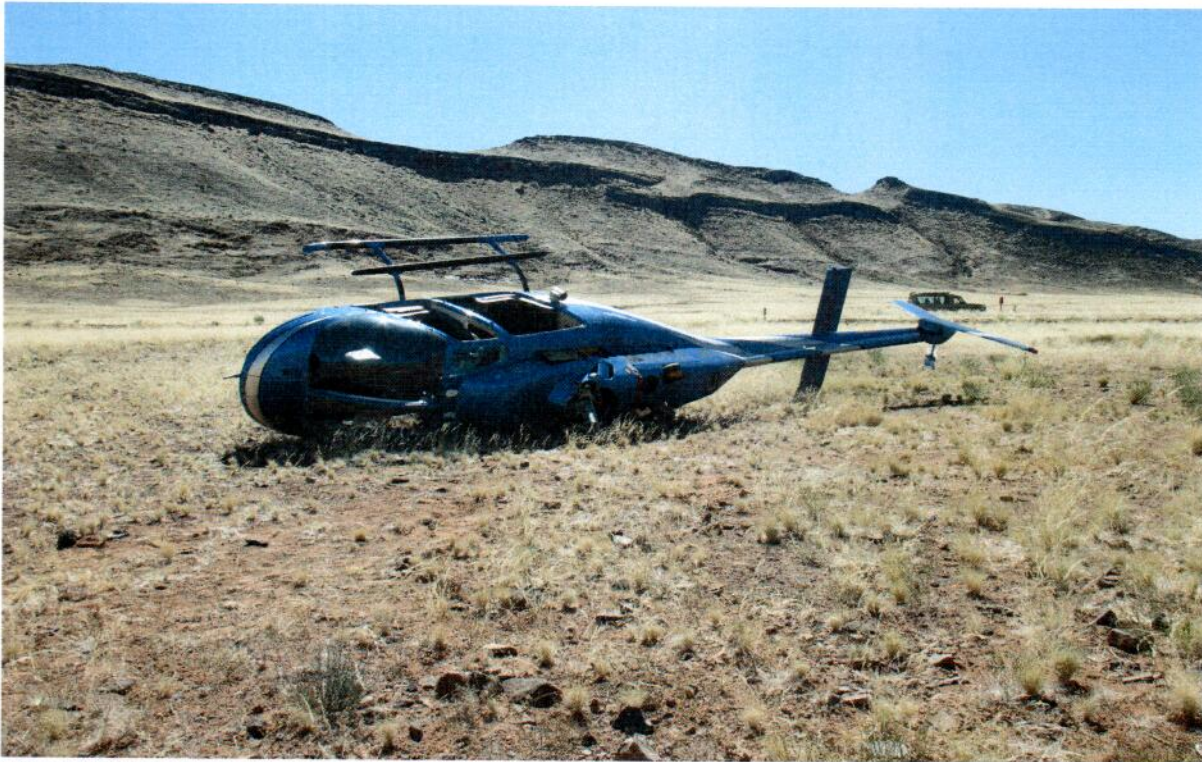
The helicopter sustained damage to the main transmission system, fuselage and windscreen.

Figure 1: Picture showing damage to the aircraft especially to the main transmission system.

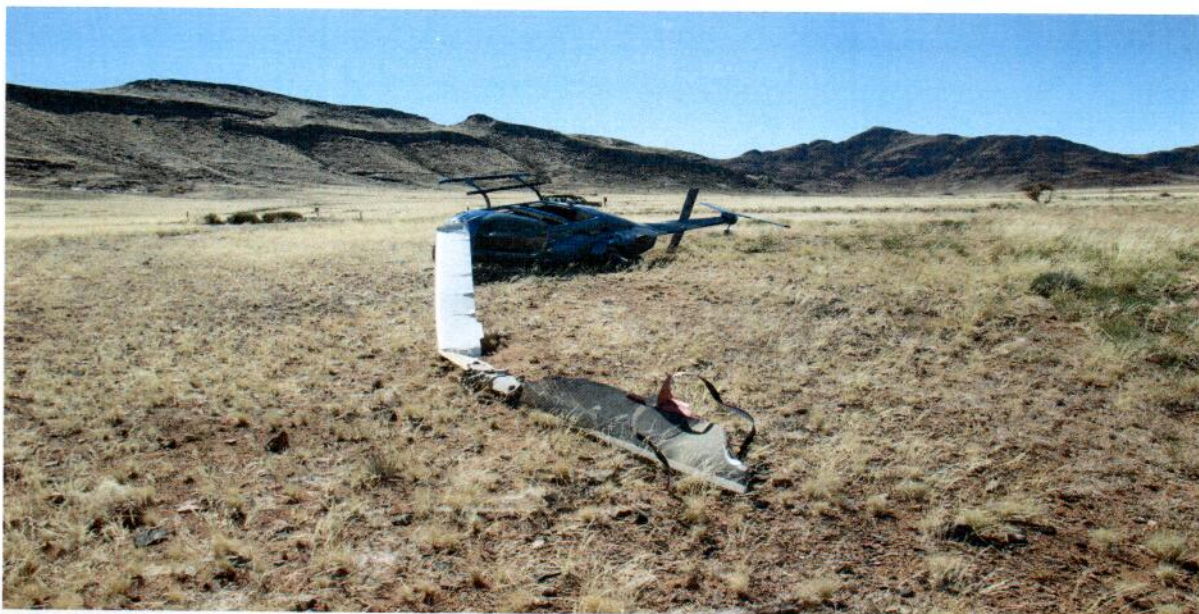
Figure 2: Picture showing the rotor head that broke off from the mast.

The accident occurred at a Sossusvlei Desert Lodge. The helicopter's two main rotor blades struck a parked vehicle, top lost control and impacted the ground with the left hand skid and roll to the left. The rotor head with the two blades attached broke off from the main transmission system and was found 5 meters from the wreckage at 11 O'clock. One rotor blade broke into half and the other piece was found around 50 meters from the wreckage at 3 O'clock.

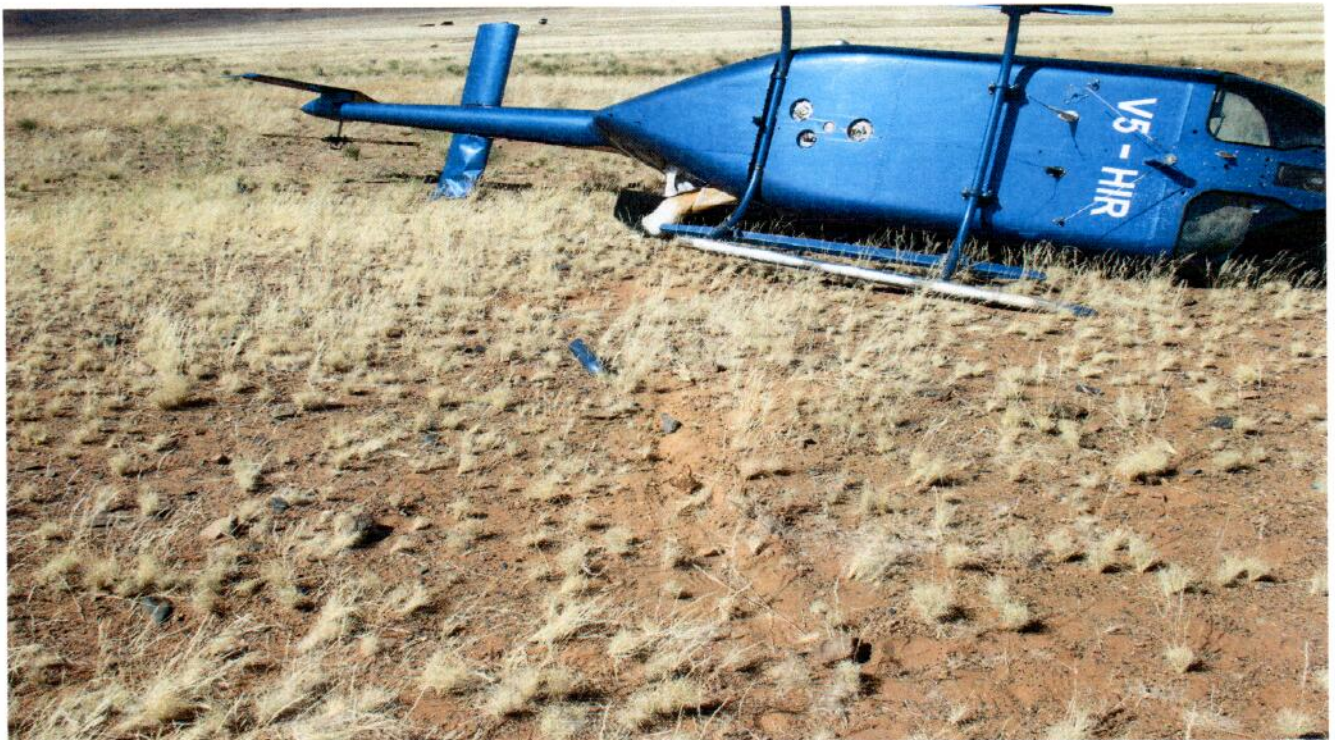
Figure 3: Picture showing a little damage to the belly and horizontal stabilizer

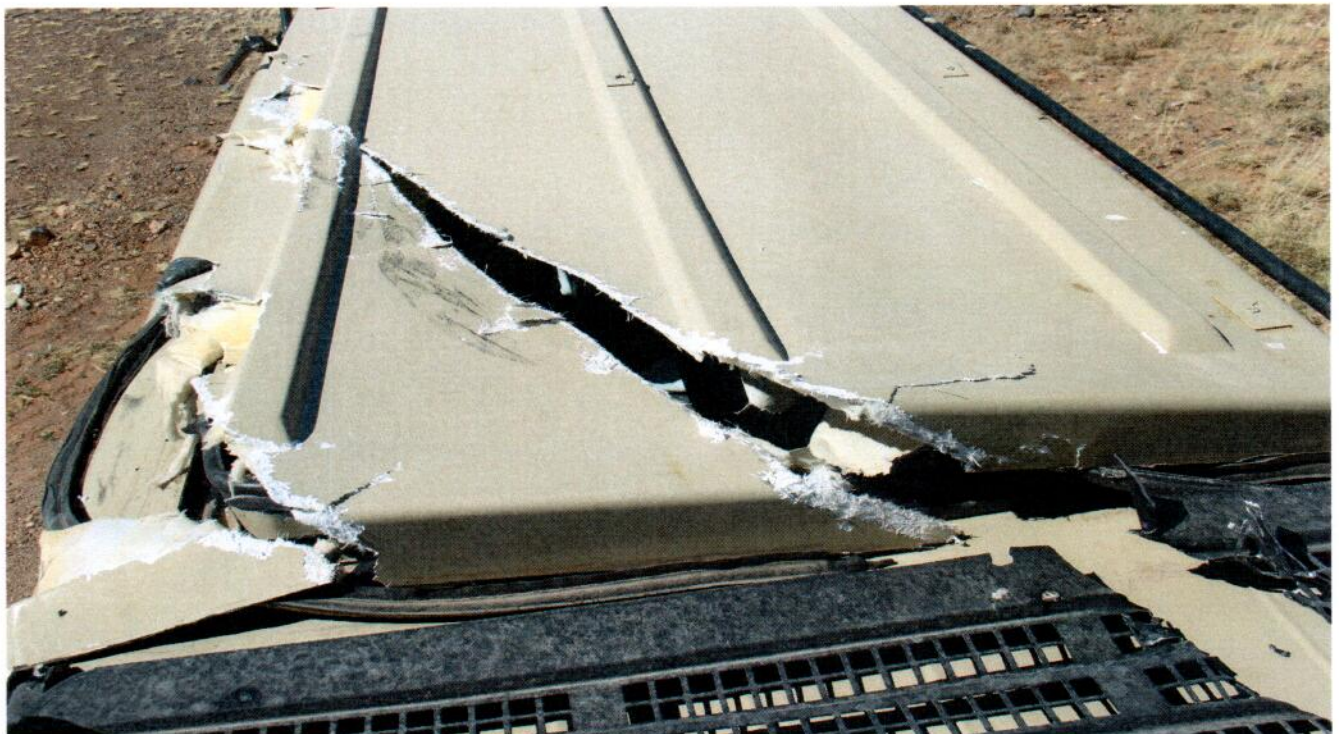
- 1.4.1 The vehicle was damage at the top side but no injuries to the passengers that were in the Vehicle.

Figure 4: A picture showing the top of the vehicle that was damage by the two main rotor blades.

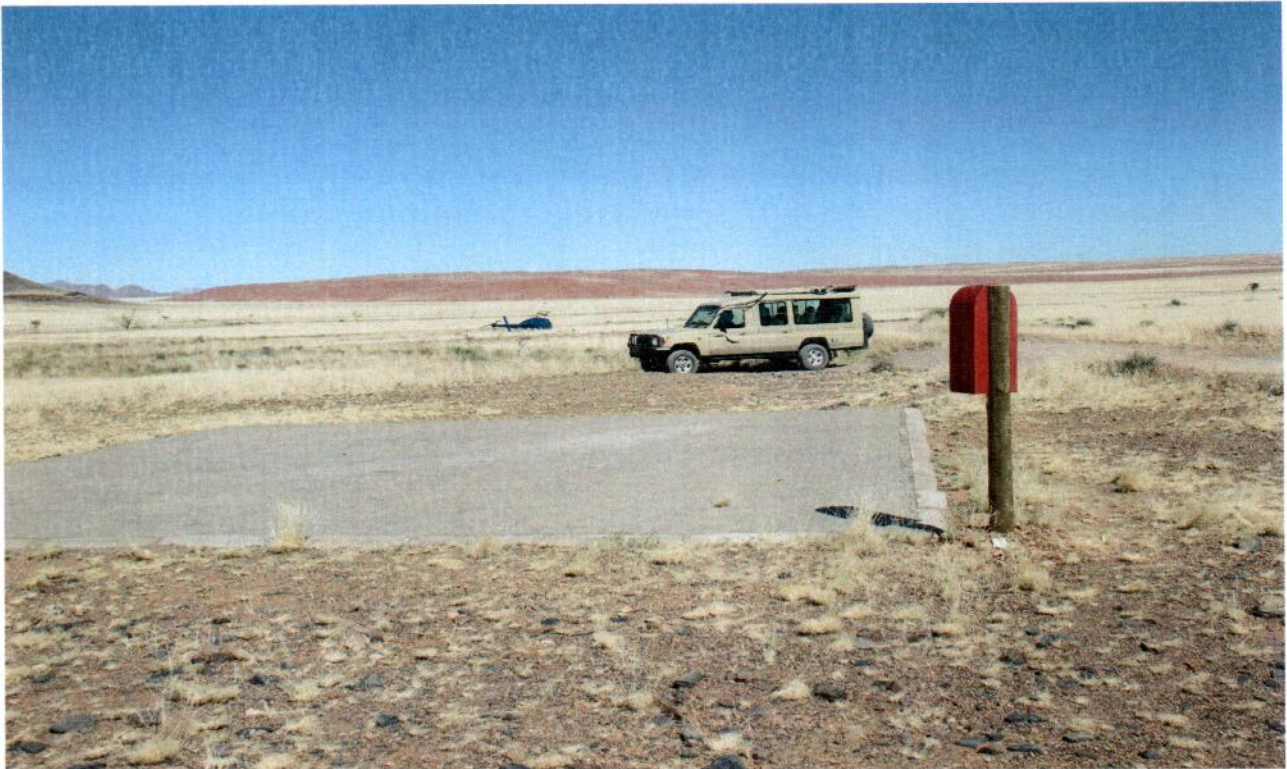
Figure 6: picture showing the helipad and the park Vehicle that was struck by the helicopter blades

4.1 DAAII recommend that Sossusvlei Desert Lodge to develop and implement helicopter Operation safety guidelines.

The Sossusvlei Desert Lodge has developed the Helicopter Operational Safety guidelines. See appendix 1 attached

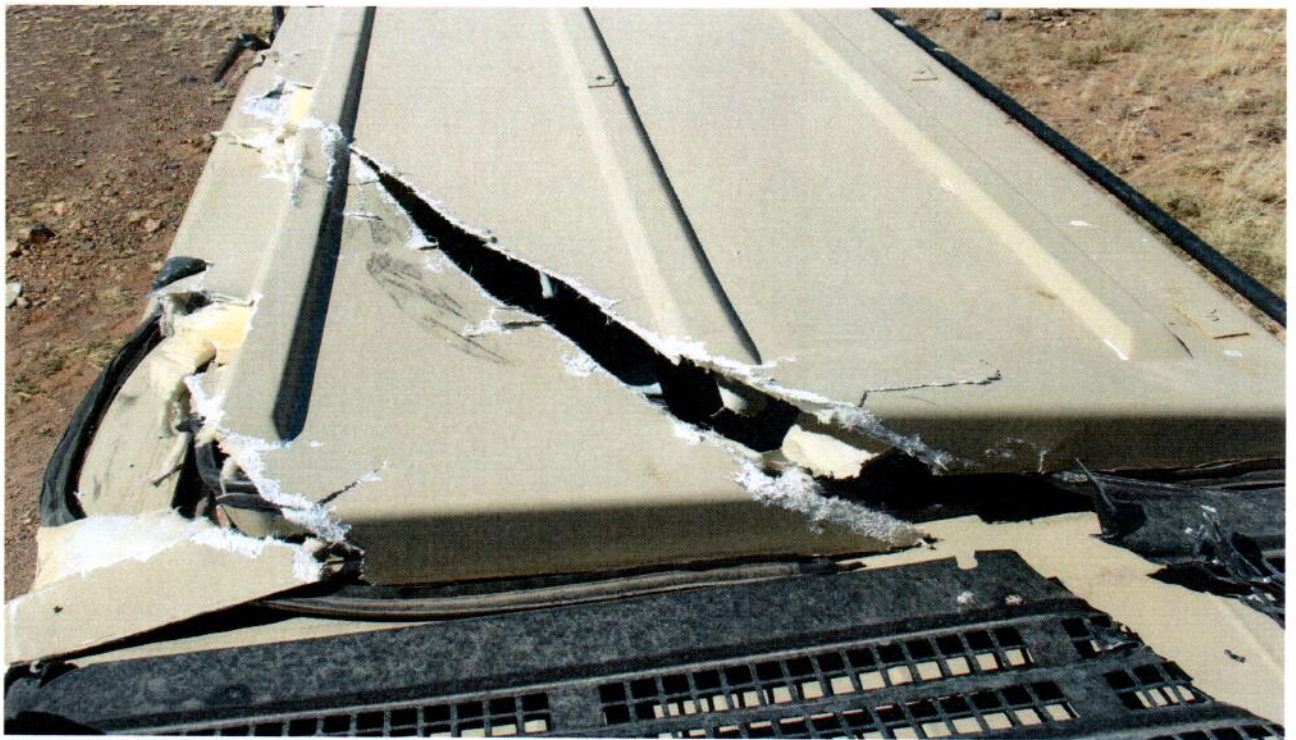
Figure 7: Picture showing the Vehicle top that was struck by the two main rotor blades

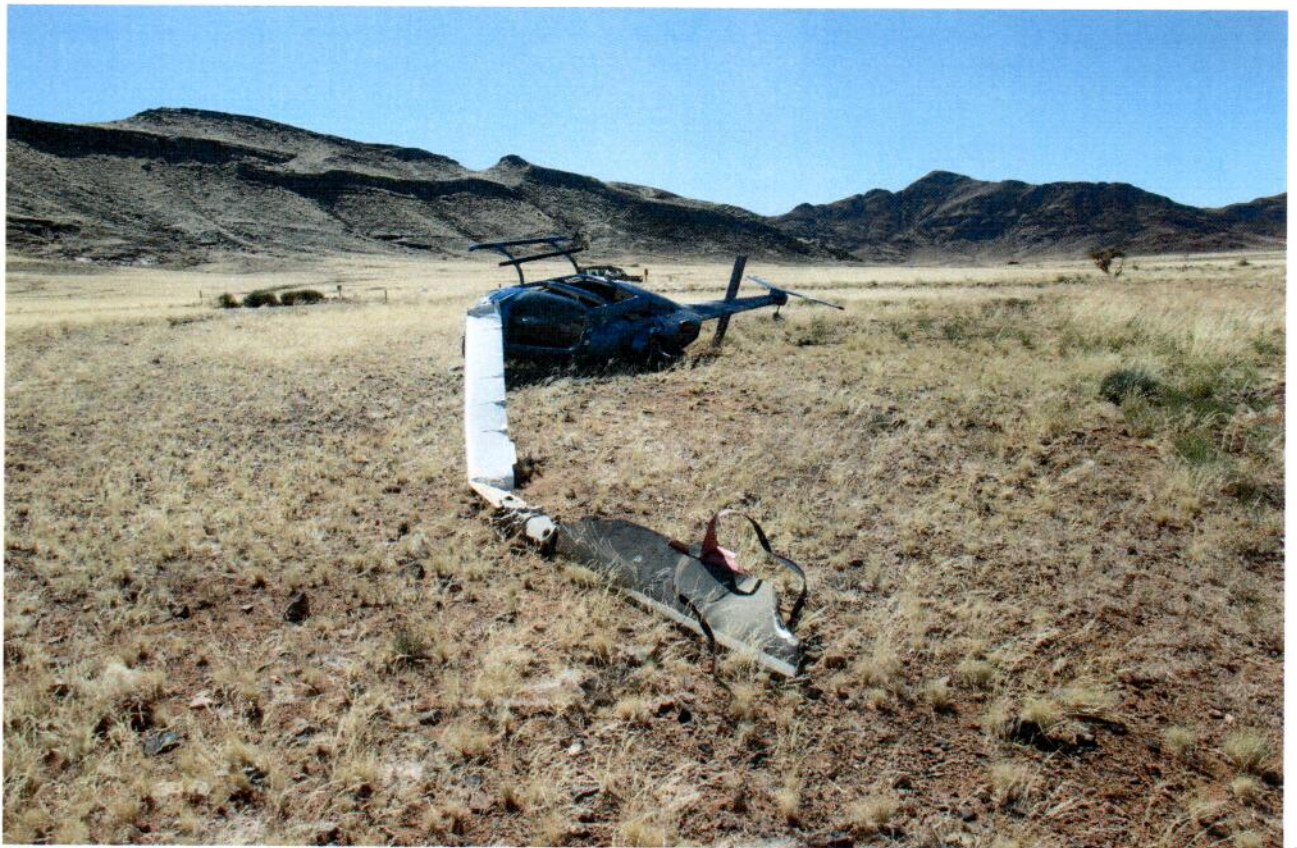
Figure 8: Picture showing the rotor head at 5 meters from the wreckage
