Accident Reference: ACCID/082821/01-01

Aircraft Accident Investigation Final Report

ROBINSON R44 V5-HJL

DESCRIPTION OF OCCURRENCE: Helicopter Collision with Terrain

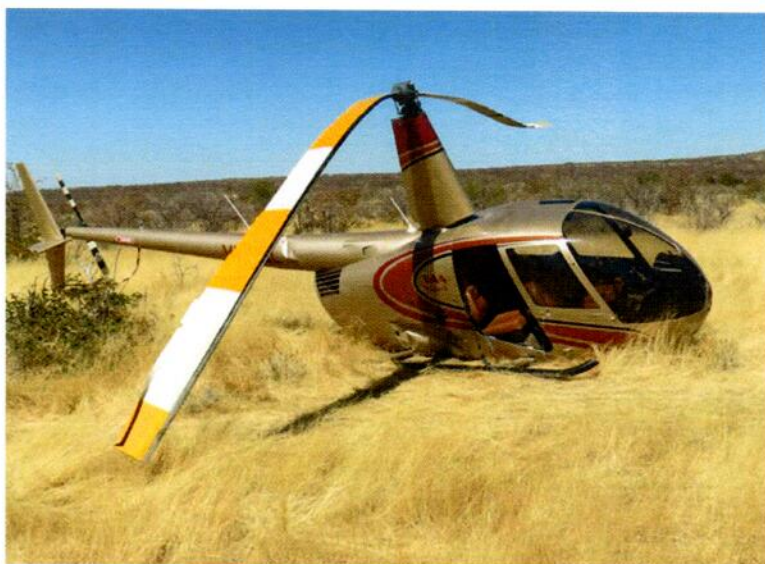
Figure 1: The R44 helicopter as it came to rest. Blades drooping.

The accident occurred at farm Karros 34.6km from Kamajab town. The helicopter right skid was broken, its main rotor blades exhibited huge drooping. One of the blade trailing edges was bent forward.

- 2.8. The main rotor system displayed signature of extreme coning, this indicated that the rotor speed had decayed so much that the rotor blades most probably was not driven by the transmission at the time of impact with the terrain.
The main rotor blades did not touch the tail boom.
Blade no 1 was bent backwards outboard of the trim tab and blade no two's trailing edge had damages which could not be explained at the time, if the blade got damaged in flight the deformation on the training edge would have caused severe dynamic imbalance of the rotating components that could lead to catastrophic failure of the main transmission.
