**CIVIL AIRCRAFT ACCIDENT REPORT
ACCID/032420/01-01**

AIRCRAFT : V5-HOZ

LOCATION : TSUMEB AIRFIELD

DATE : 24 MARCH 2020

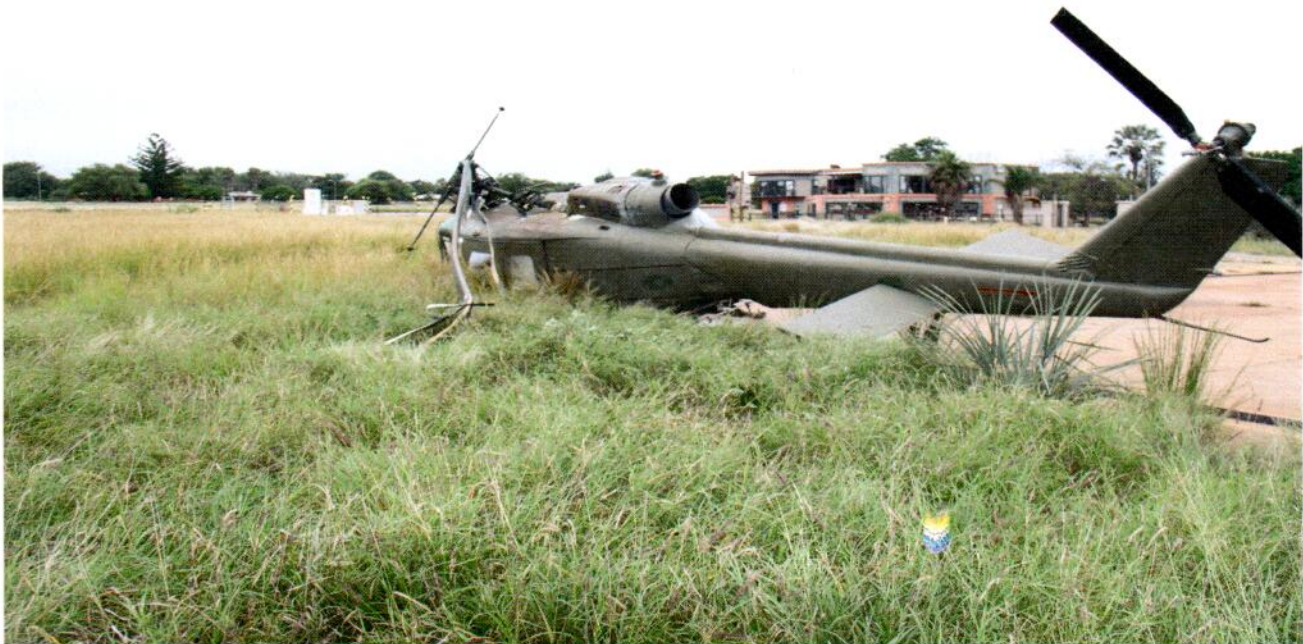
- 1.3.1 The helicopter was substantially damaged.

FIGURE 1: Photo showing the helicopter was substantial damage especially the transmission support platform.

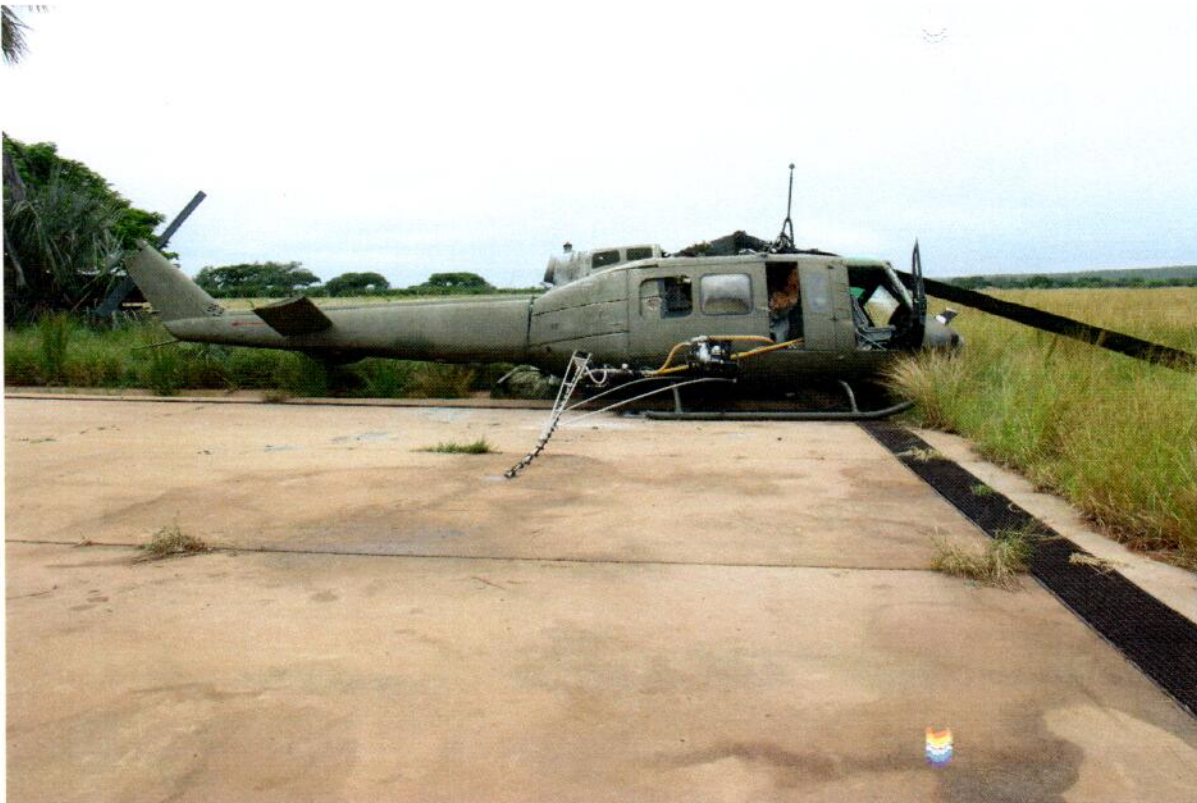
FIGURE 2: Photo showing the helicopter lying on its port side after the crash.

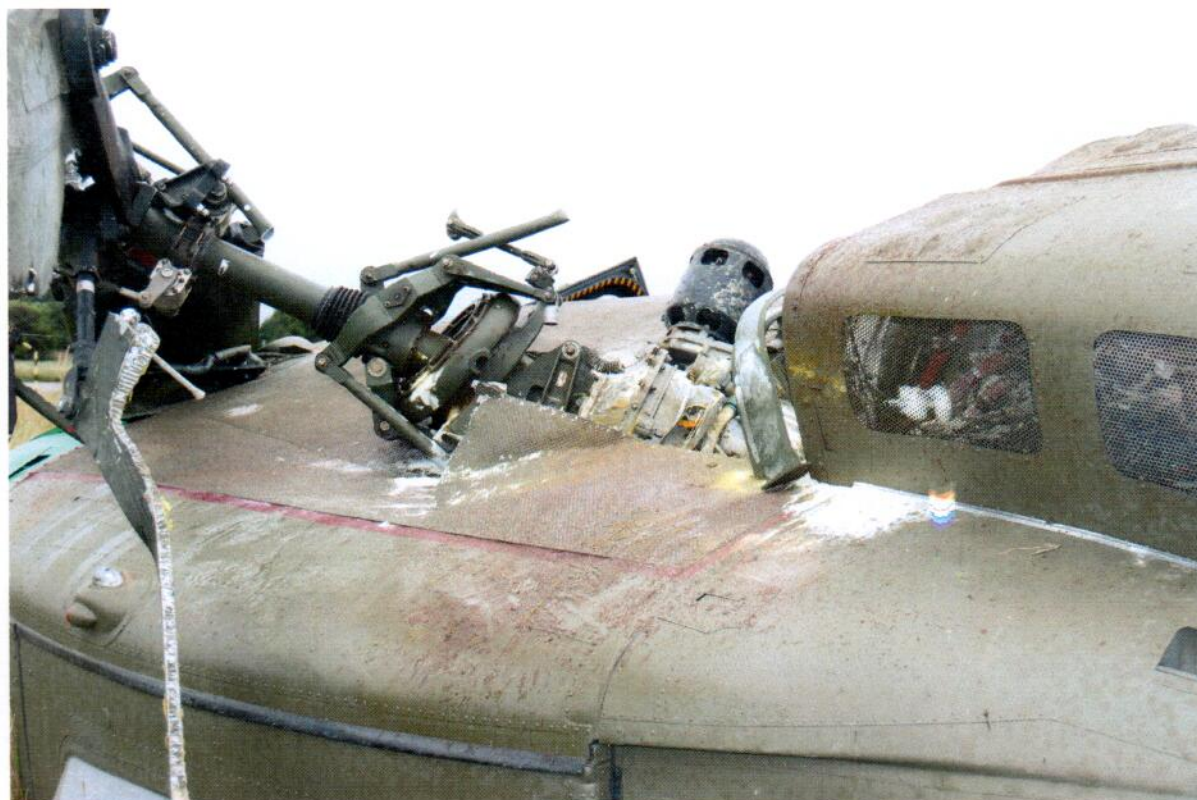
FIGURE 3: Photo showing the damage of the rotor blades, the broken transmission support platform and broken pitch change links.

- 1.12.1 The helicopter impacted the ground with the main rotor blades first, and finally rested on the port side. Small pieces that detached from the wreckage were found distributed within 8 meters radius from the main wreckage. The helicopter was in landing configuration. There was no engine or mechanical defect prior to the accident. The impact with the ground damaged the aircraft main rotor blades, landing skids, the transmission support platform, windscreen and other structural damage could be observed on the aircraft structure. The main gear box has been broken off completely from its attachment and tilted 90° toward the nose of the aircraft. All the pitch change links have been broken off from their attachments.

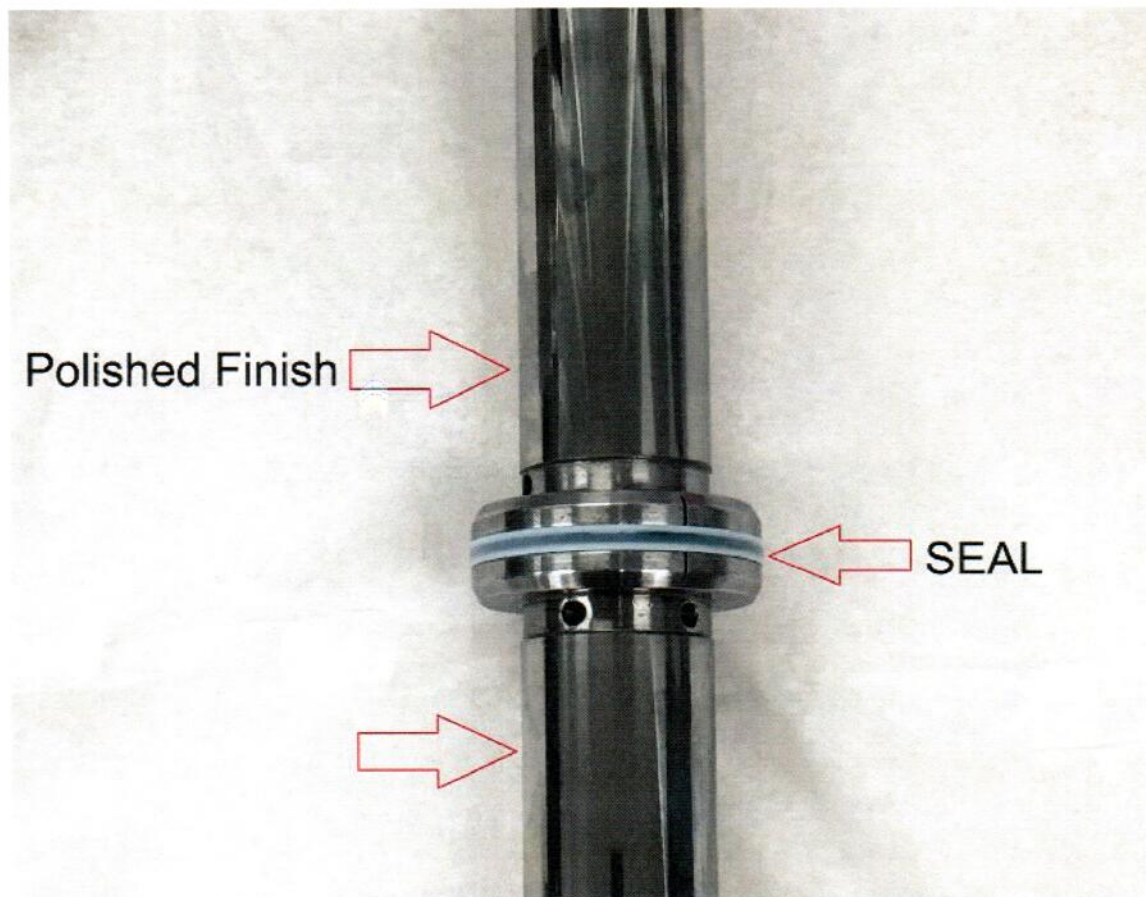
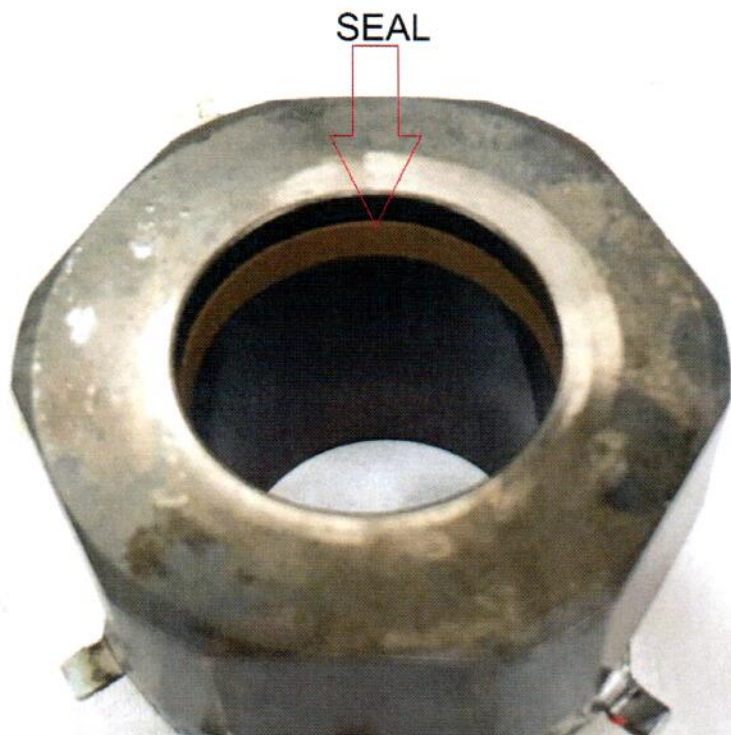
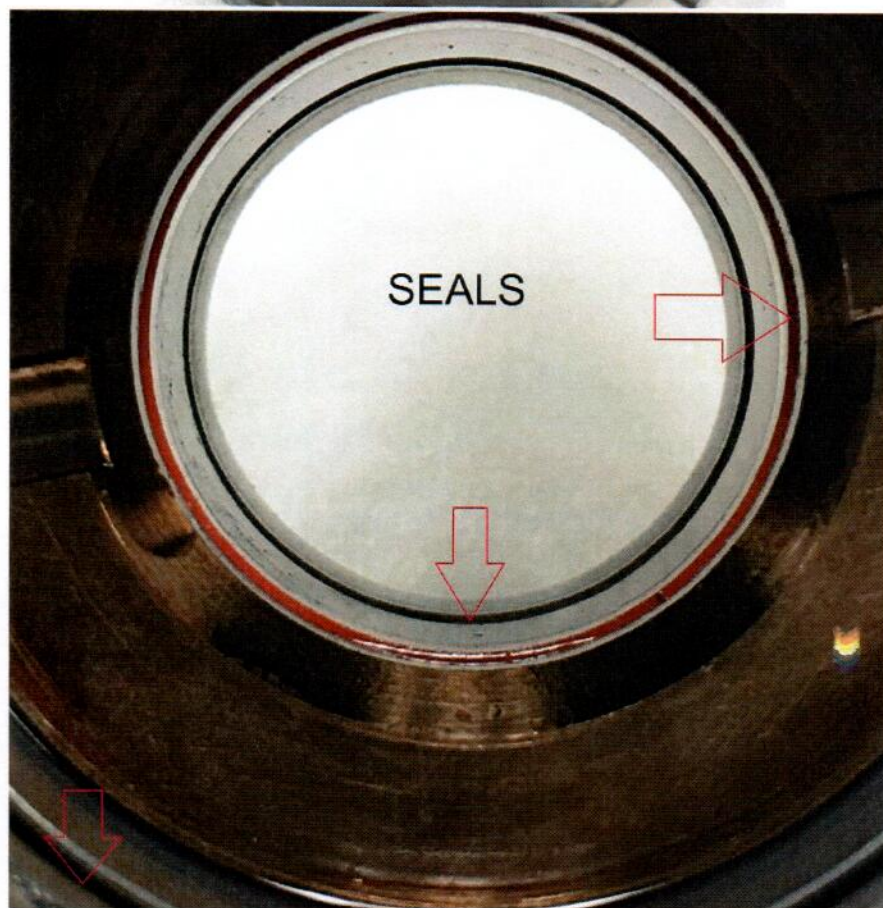
The Servo-Actuator was tested according to the requirements of the Assembly, Test, and Inspection Procedure. Although the unit failed leakage tests 60.5 and 60.7.2, it was functional and performed as intended.

To further investigate the leakage, the unit was disassembled, and the seals were inspected. The visual examination found the seals in good condition with no problems noted. However, an examination of the Piston found a polished finish with no evidence of cross-hatching, which is typical of a Woodward Piston. It is suspected that the Piston may have been replaced at some point by a third-party repair facility. An overly polished Piston is most likely the cause of the leaking noted during test.

Regardless of the leaking issue and possible Piston replacement, the unit performed according to the design requirements.
