<b>Ministry of Works and Transport</b>			<b>ACCID/102418/1-01</b>	
<b>DIRECTORATE OF AIRCRAFT ACCIDENT INVESTIGATION</b> <b>ACCIDENT REPORT – EXECUTIVE SUMMARY</b>						
<b>Aircraft Registration</b>	V5-HSF	<b>Date of Accident</b>	24 October 2018	<b>Time of Accident</b>	8:10 UTC	
<b>Type of Aircraft</b>	ROBINSON R44 HELICOPTER		<b>Type of Operation</b>	Private		
<b>Pilot-In-Command License Type</b>	PPL-HELICOPTER		<b>Age</b>	31	<b>License Valid</b>	Yes
<b>Pilot-In-Command Flying Experience</b>	Total Flying Hours		69.0	<b>Hours on Type</b>	69.0	
<b>Last point of departure</b>	Eros Airport (FYWE)					
<b>Next point of intended landing</b>	Farm Elisanor No. 85					
<b>Location of the accident site with reference to easily defined geographical points (GPS readings if possible)</b>						
During lift off at Eros Airport Northern Hangars helipad      S 22° 36' 45 "    E 017° 4' 73 "						
<b>Meteorological Information</b>	Wind: East N/E, Wind speed: 13-15 kts gusty, Visibility: CAVOK, Temperature 28°C, Cloud cover: None, Cloud base: None, Dew point: Not known.

# AIRCRAFT ACCIDENT REPORT

**Name of Owner** : H.B. Simon  
**Name of Operator** : H.B. Simon  
**Manufacturer** : Robinson Helic

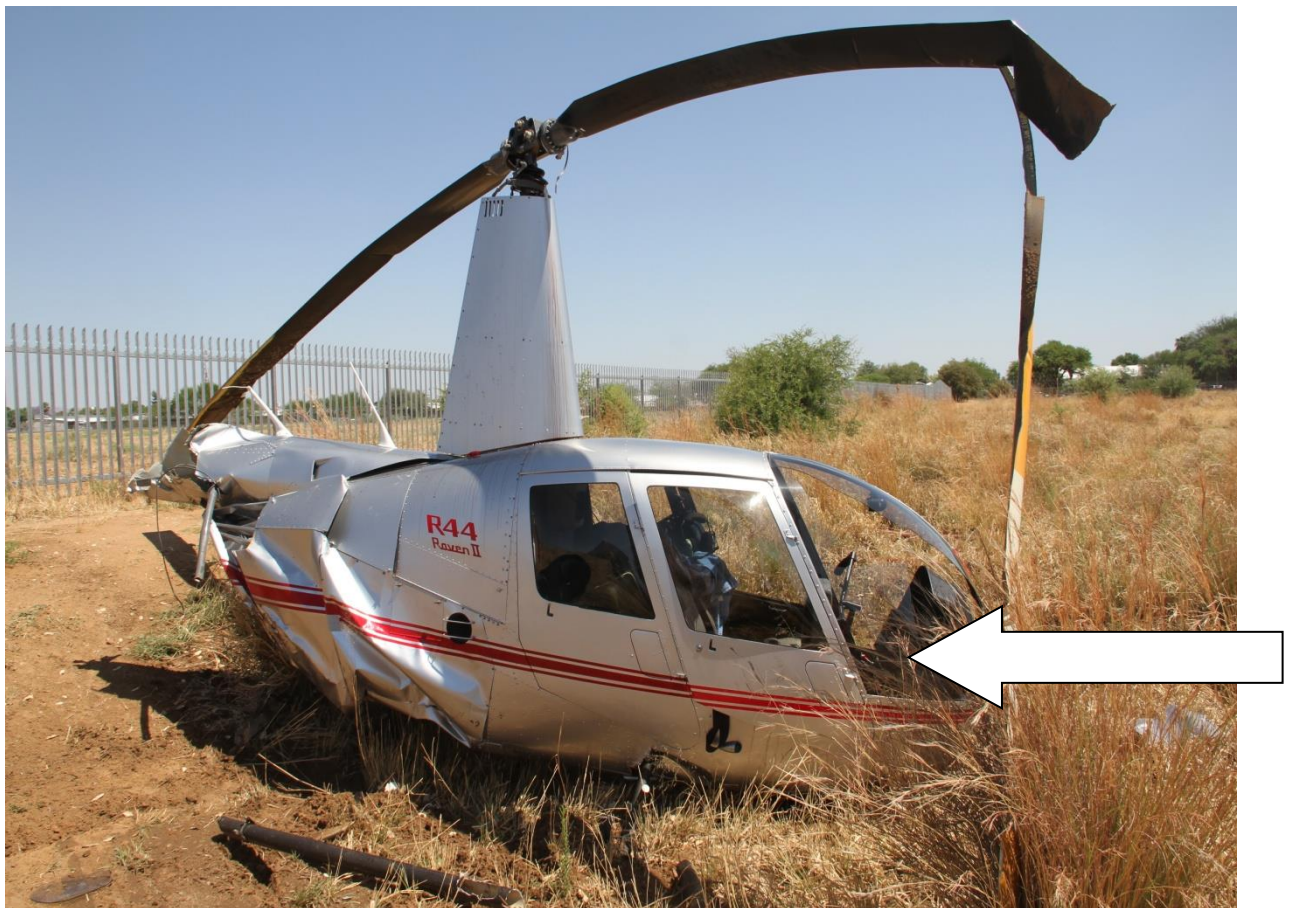
**Figure 1.** The photo indicating the wreckage of V5-HSF where it came to a halt after the accident. The arrow pointed at the shattered windscreen.

1.12.1 The helicopter suffered substantially damages when it impacted the ground. The windscreen was shattered due to impact forces. All the landing skids were found broken off and the whole tail section separated from the main wreckage.

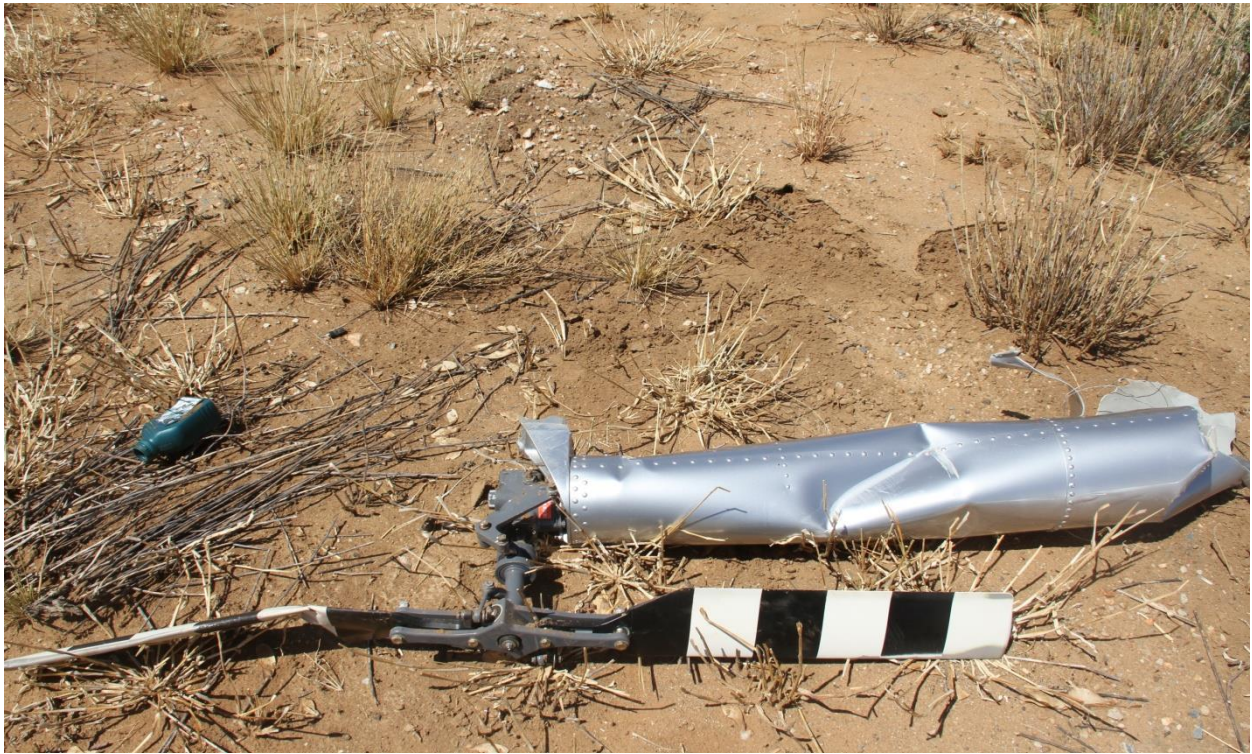
- 1.3.1 The helicopter was substantially damaged due to the impact when its tail struck the ground.

**Figure 2.** A photo showing the piece of the tail boom and the tail rotor.

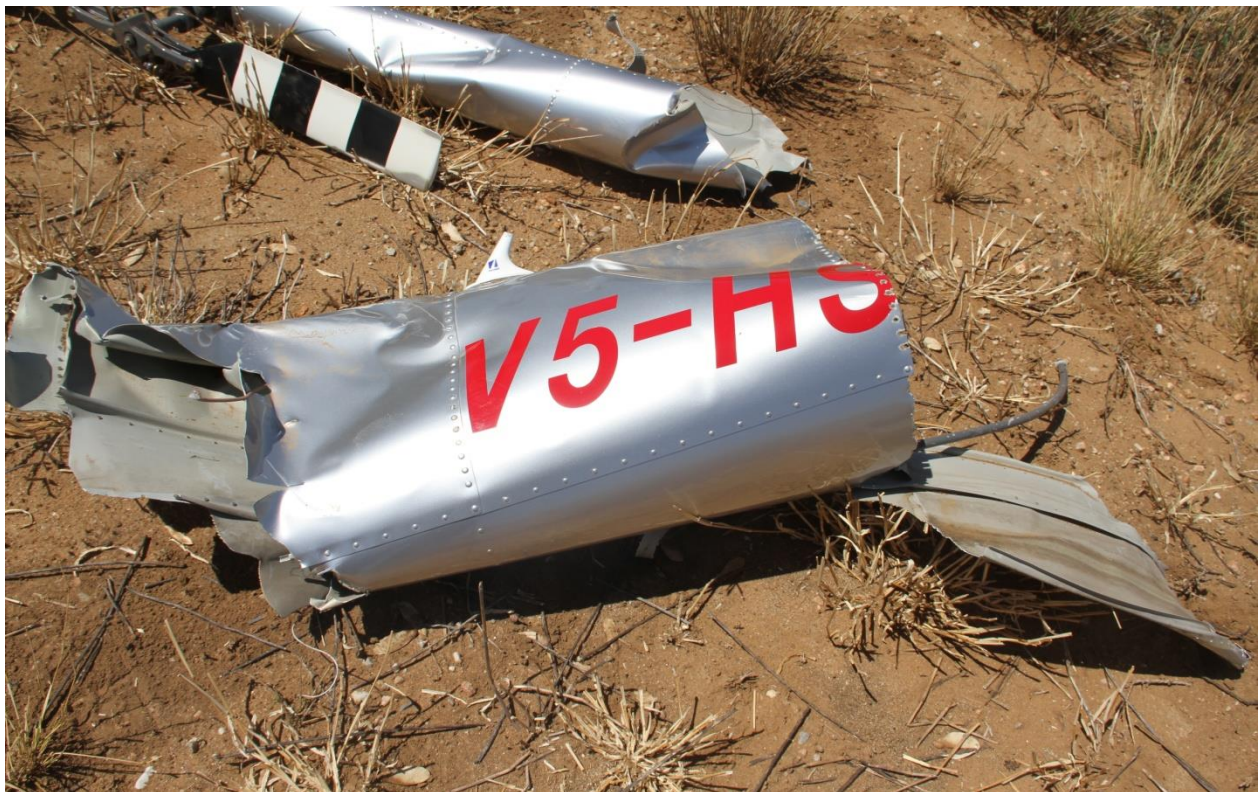
**Figure 3.** Other pieces of the tail boom as well as the tail rotor.

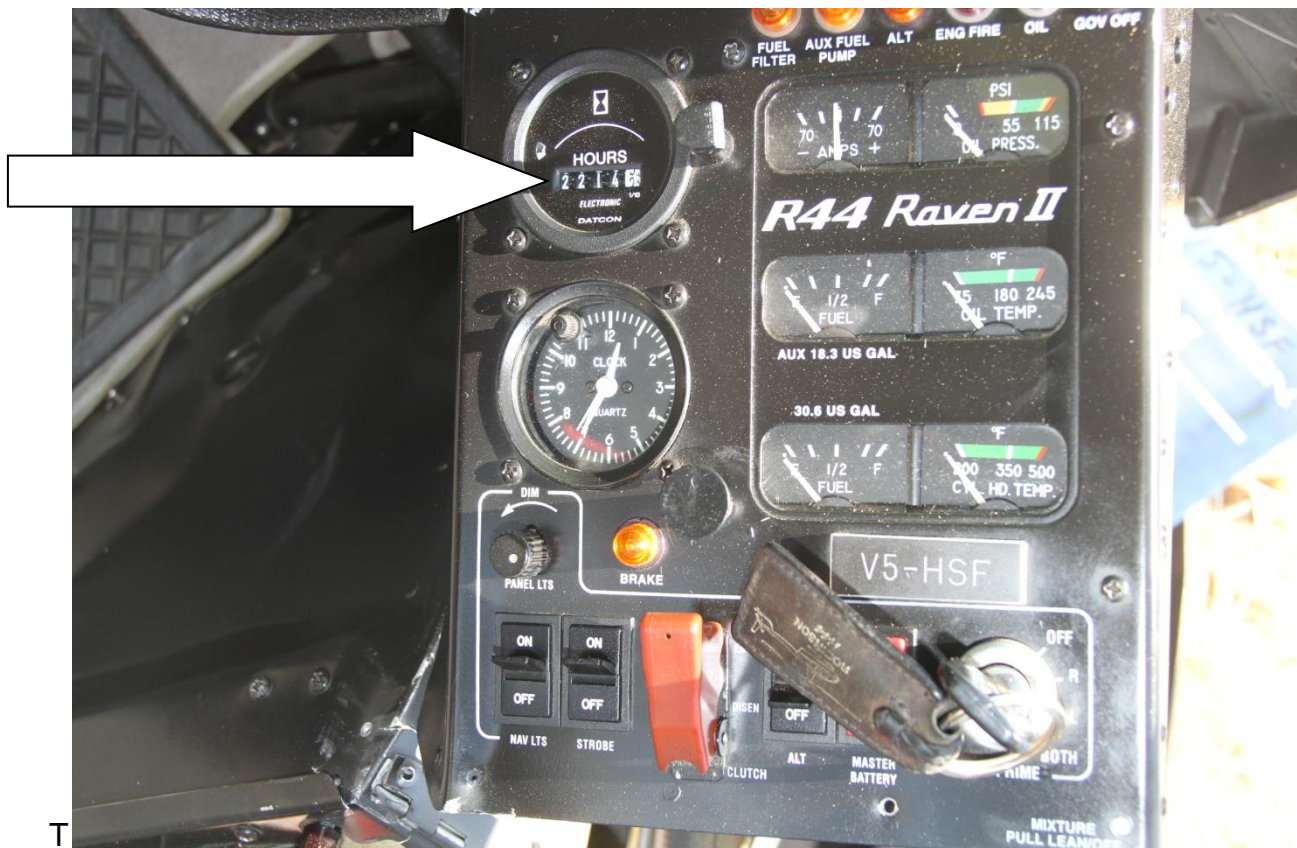
**Figure 4.** A photo indicating some of the cockpit instruments indications. The arrow points at the Hobbs meter reading which reads 2214.3 Hobbs at the time of the accident.

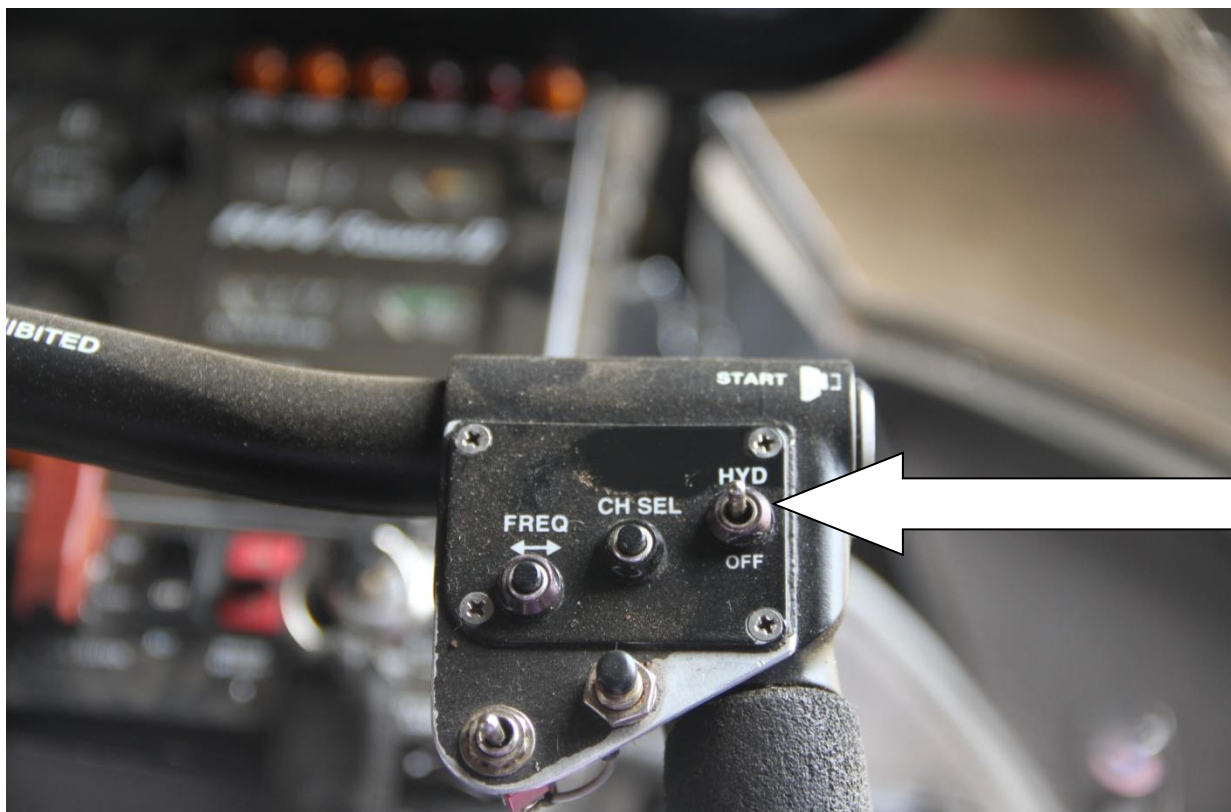
**Figure 5.** The photo indicating the position of the Hydraulic switch on the right end of the cyclic. The arrow indicating that the Hydraulic switch was switched "ON" during the accident.

- 1.18.4 The Hydraulic Switch on the right hand side of the pilot's cyclic control grip which is used to energizes the solenoid that opens a valve on the reservoir and pressurizes the system, was found switched "ON" at the time of the accident.

- 2.9 There is a hydraulic switch on the right hand (R/H) side of the pilot's cyclic control grip which is used to energize the solenoid that opens a valve on the reservoir and pressurizes the system. In normal operation this switch is always switched "ON", the position in which it was found when the helicopter crashed.

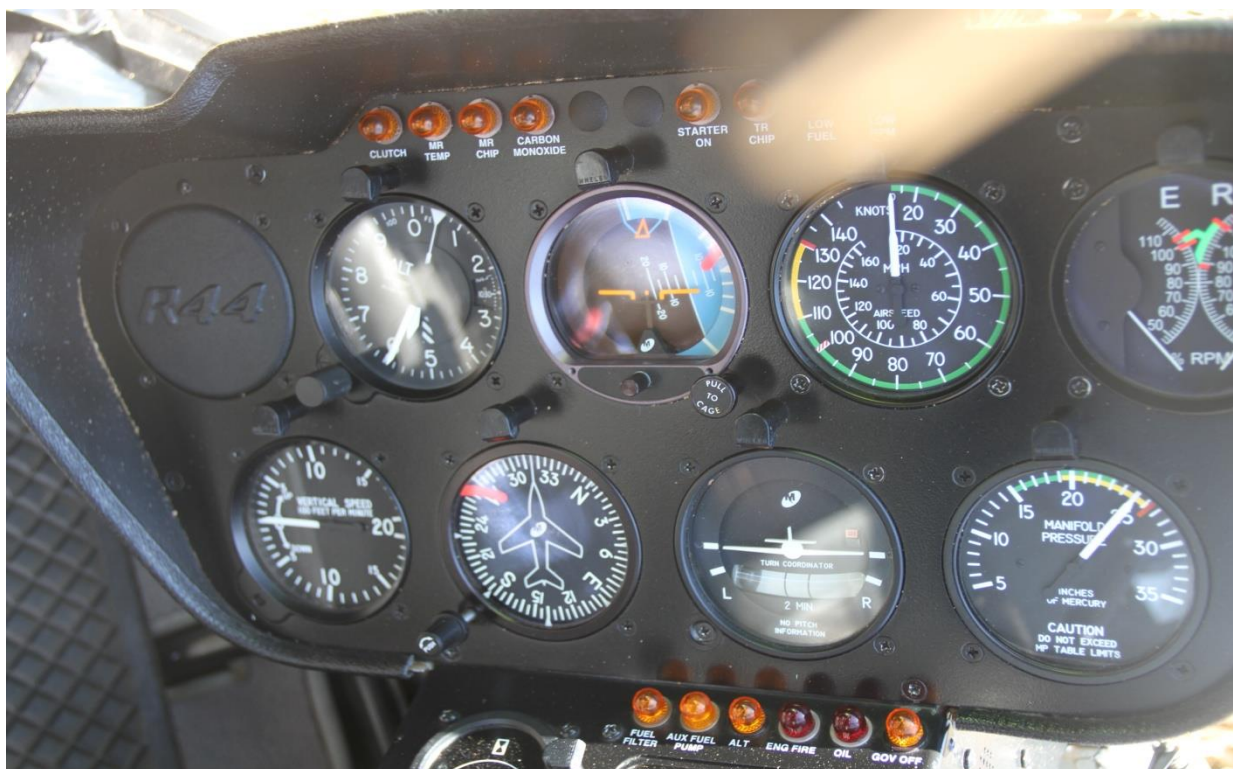
**Figure 6.** The photo indicating some other cockpit instrument indicators.

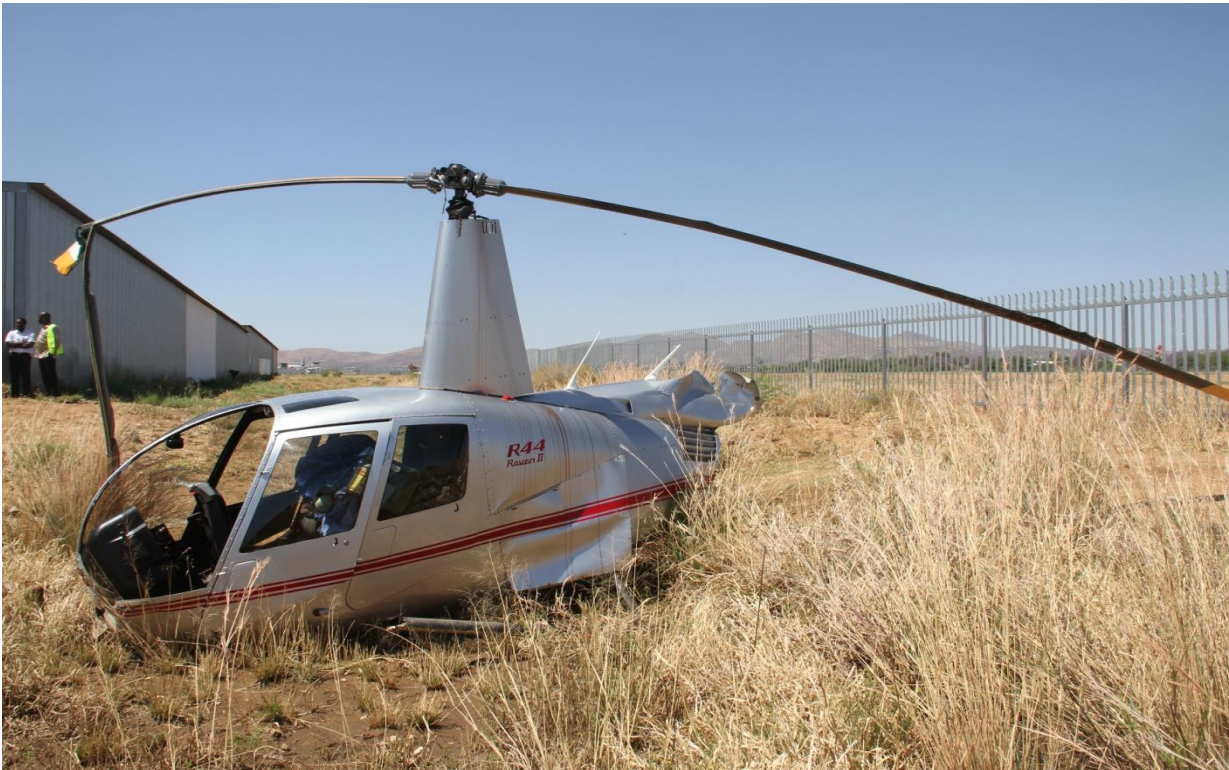
**Figure 7.** Another view of V5-HSF wreckage after the accident at Eros Airport's northern hangars.

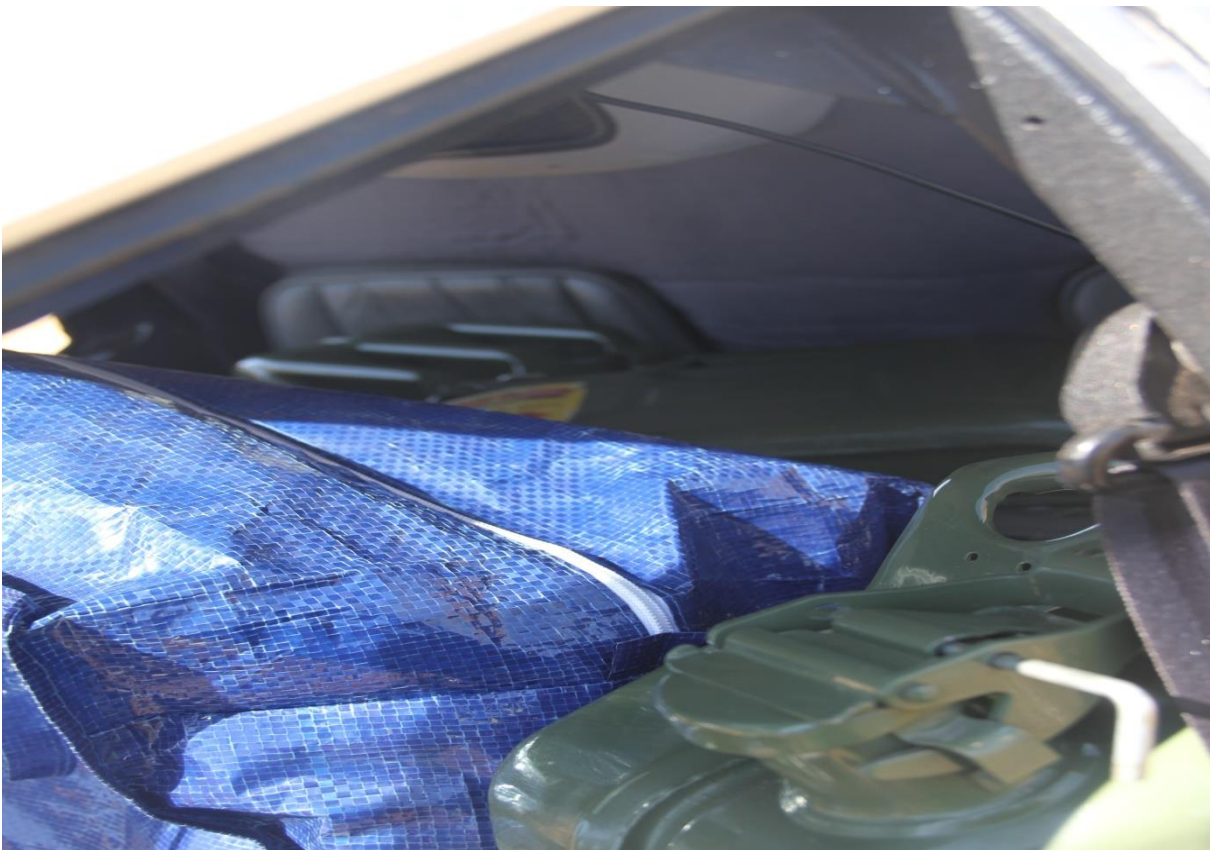
**Figure 8.** A blue bag containing the fuel pump. Some of the 13 jelly cans that were carried onboard behind the rear seats were also visible in the photo.

- 1.18.1 During the investigation, it was found that there were 7 x 10 litres empty jelly cans, 6 x 20 litres jelly cans of which three (3) were filled with Avgas 100LL, a bag containing the fuel pump, a rifle as well as a bag containing the pilot's personal clothes. All the above mentioned items were carried in the cockpit at the back of the rear seat.

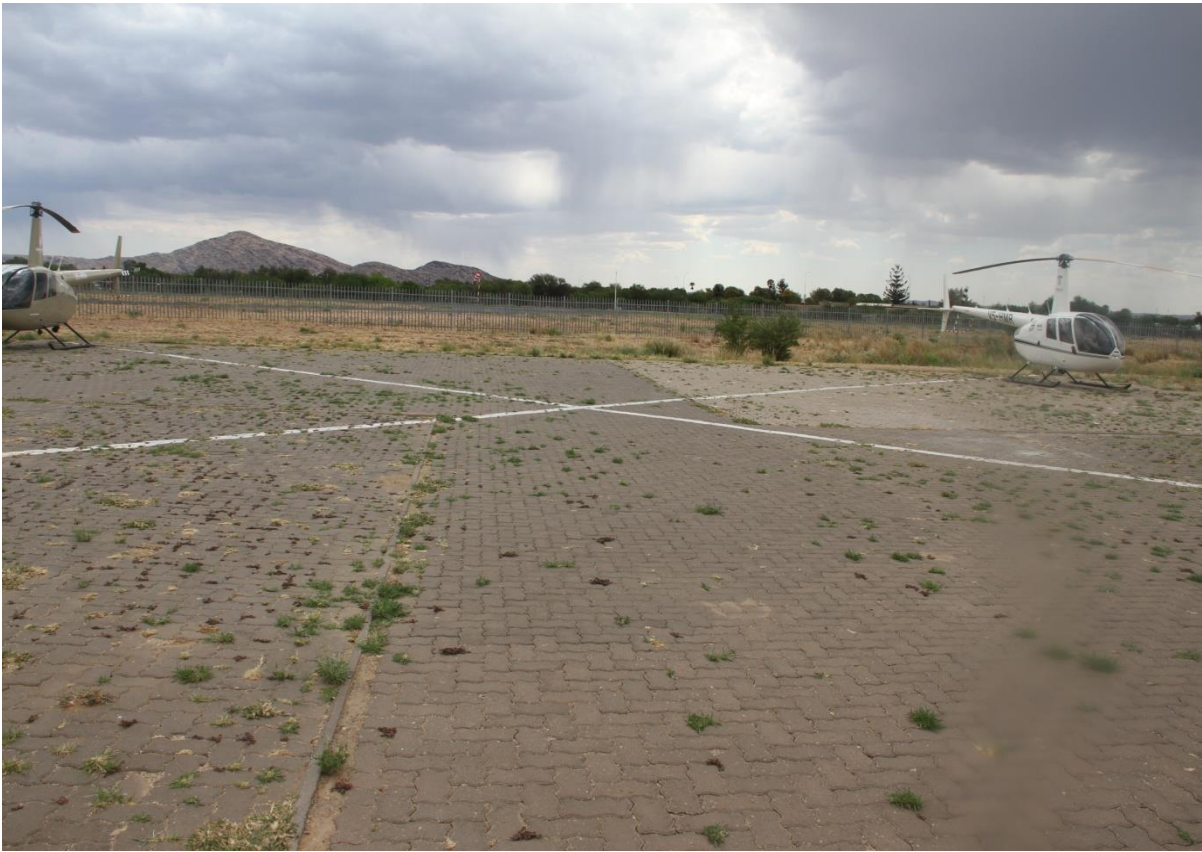
**Figure 9.** A photo indicating the closed helipad at Eros Airport Northern Hangars with some helicopters still parked on it.

- 2.6 Although Namibia Airport Company (NAC) reported that the helipad at Eros Airport's northern hangars has been closed for some years back, there are still no measure in place to restrict the helicopter operators not to land and take off from that helipad.

Namibia Airport Company need to take appropriate measures when it comes to the usage of the helipad at Eros Airport's northern hangars which they stated that it has been closed for several years, but still allow helicopters to land, refuel and take-off from it.

The investigation also recommended that NCAA should take appropriate action to make sure that NAC put up strictly measures in place when it comes to the use of the northern hangar helipad not to allow helicopter pilots to make use of it anymore.
