# DIRECTORATE OF AIRCRAFT ACCIDENT INVESTIGATION CIVIL AIRCRAFT ACCIDENT REPORT ACCID/12518/01-01

AIRCRAFT : V5-HTM

LOCATION : OUTJO AIRFIELD
DATE : 25 JANUARY 2018

# DIRECTORATE OF AIRCRAFT ACCIDENT INVESTIGATIONS ACCIDENT REPORT – EXECUTIVE SUMMARY

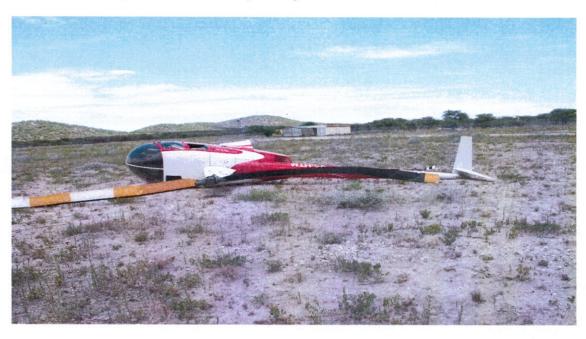
#### 1.3.1 The helicopter was substantially damaged.

FIGURE 1: Figure showing the helicopter lying on its port side after the crash.

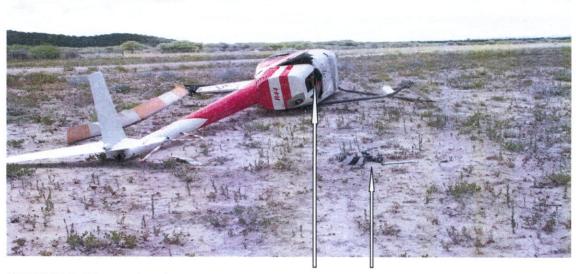
**FIGURE 2:** Photo showing the damage on the belly, broken off starboard skid and a detached tail rotor system.

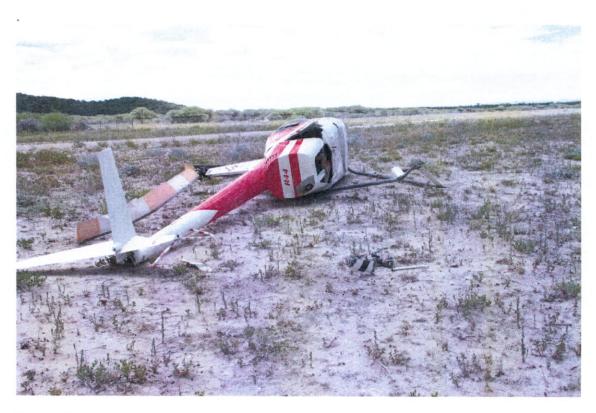
1.12.1 The airfield where the accident occurred was flat ground and had a gravel runway. The airfield is at elevation (AMSL) of 4344ft with two runways. The runways direction and measurements are as follow: 15/33 measuring 1788 meter and 06/24 measuring 1244 meters both runway surfaces are gravel. The helicopter did not take-off from either runway it took off from the helicopter parking close to the hangar facing East direction. The distance from take-off point to the first impact is about 60 meters. The helicopter impacted the ground with the starboard skid first, overturn and finally rested on the port side. Parts that detached from the wreckage were found along the flight path direction and were distributed within 20 meters radius from the main wreckage. The helicopter was in a take-off configuration. There was no engine or mechanical defect prior to the accident. The impact with the ground damaged the aircraft carbon fibre structure, landing skids, the main rotor and tail rotor blades.

**Figure 4.** A photo showing where the helicopter finally came to rest lying on the port side.
