**Directorate of Aircraft Accident and Incident
Investigations**

Aircraft Accident Investigation Final Report

V5-HVD NEAR HEJA LODGE

Helicopter Collision with Terrain
Private Flight
Mc. Donnell Douglas, 1997 MD 600N Helicopter,
V5-HVD near Heja lodge, Windhoek
16th July 2020

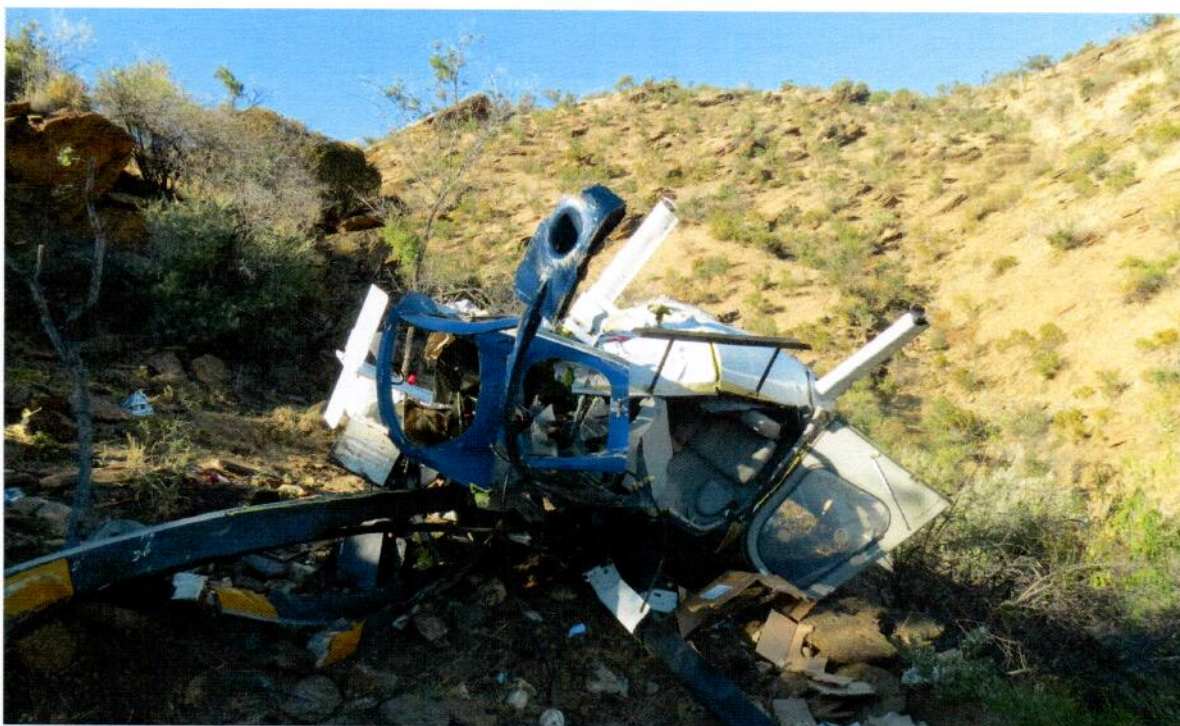
1.3.1 The aircraft was destroyed

Figure 4: View of the wreckage after the accident

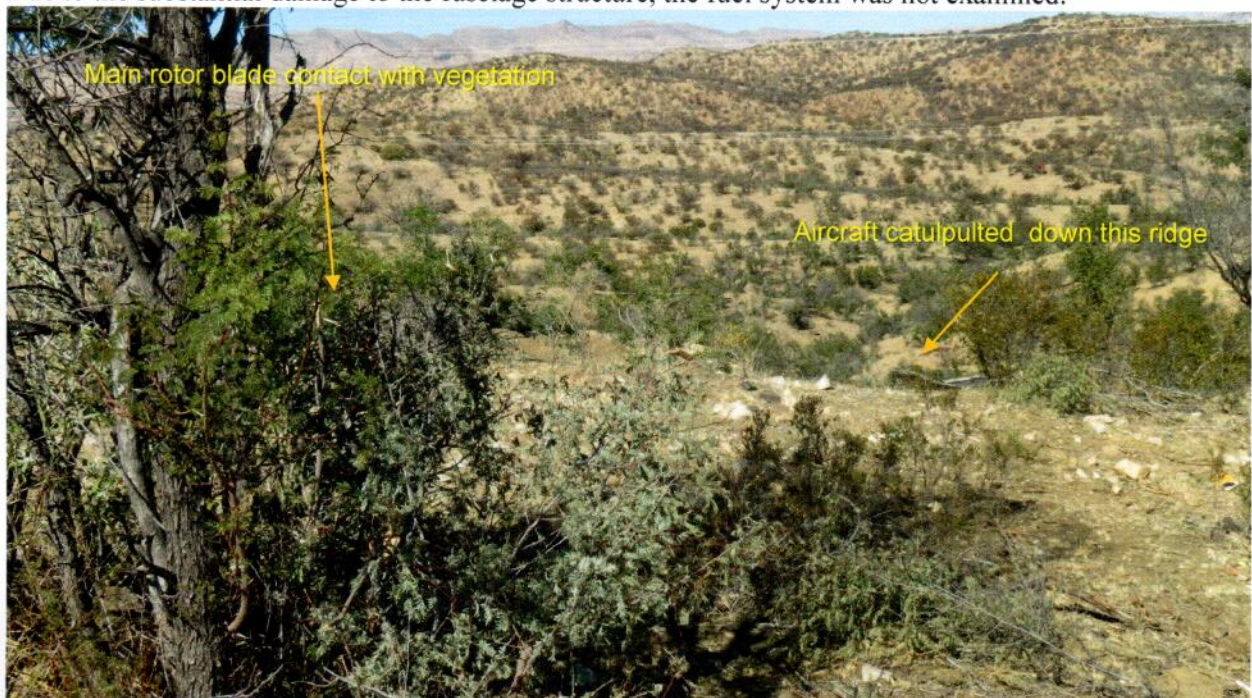
All six blades exhibited warping and wrinkling of the skin and varying degrees of trailing edge separation. Varying degrees of bending at or near the root end of the blades was observed. Minimal rotational damage was observed on the blades

Figure 8: *Depicting where the rotor blades first hit the vegetation before the helicopter tumbled downhill.*

- 2.5. Propeller blade limited damage and twist were consistent with the engine not producing sufficient power on impact or the main rotor not engaged to the engine.

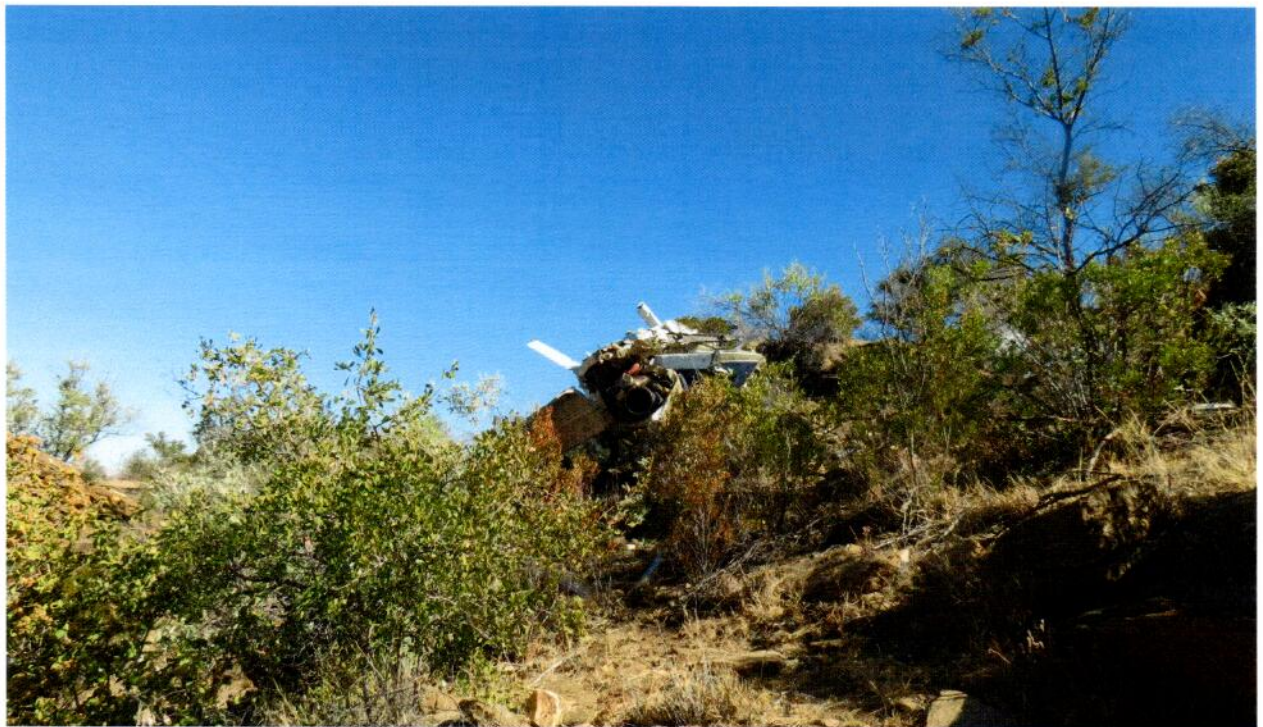
The aircraft first impact, with terrain was with left skid approximately 25° along the longitudinal axis. The initial point of ground impact was by the left skid about 1852 meters above sea level (asl). The helicopter belly impacted the ground about 11.45 meters upstream. The impact marks of the left wing tip were approximately 32m from the main wreckage. The aircraft left undercarriage ripped off first followed by the left rudder pedal unit approximately 5 meters upstream, the nose section subsequently hit the ground catapulting the helicopter forward over the ridge and coming to rest upside down halfway downhill on a huge rock approximately 3.9 meters from the top of the cliff.

Figure 9: *Depicting the aircraft as it came to rest halfway down a steep ridge.*

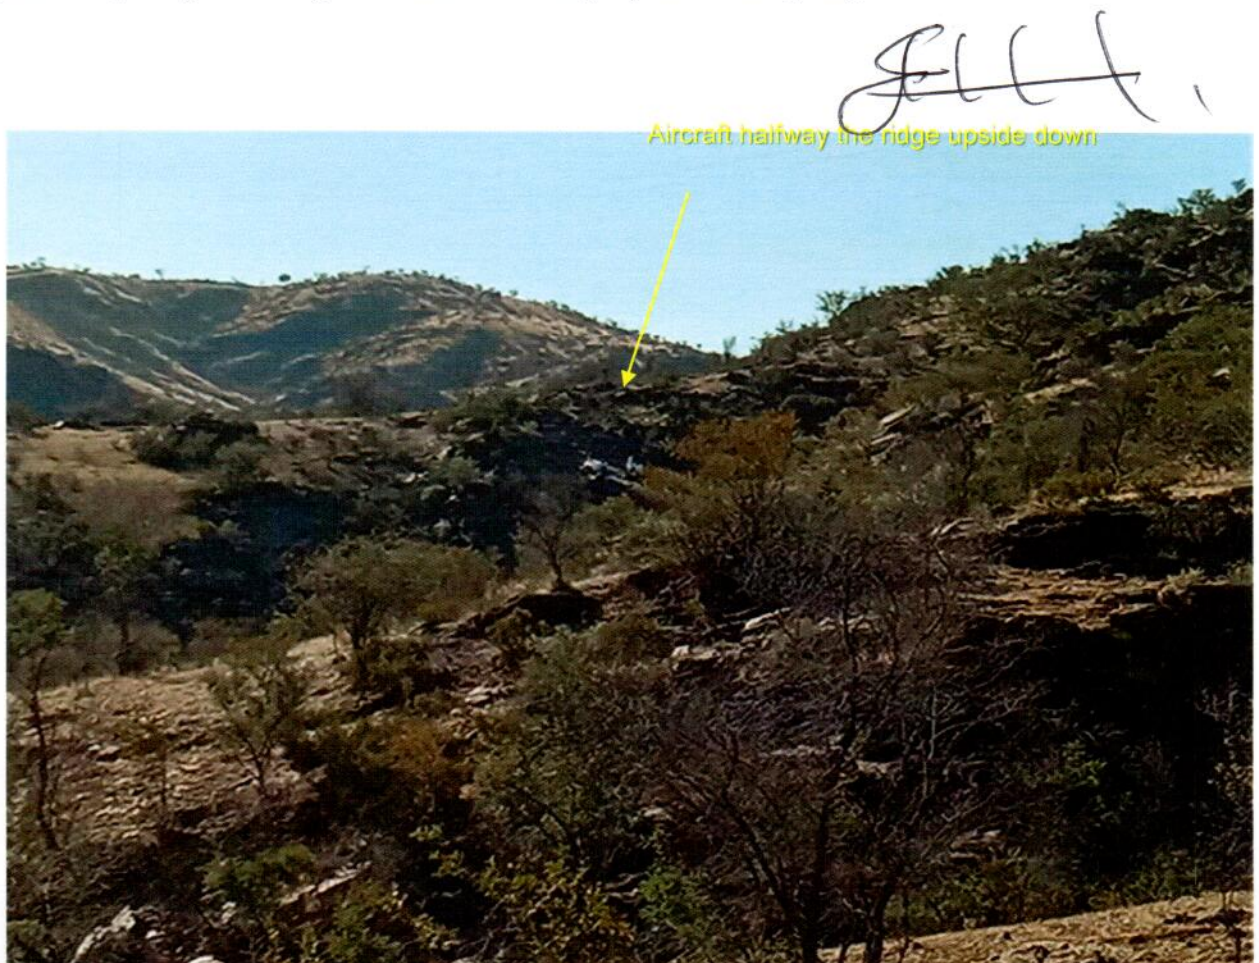
Figure 10: *Depicting the wreckage site over a difficult terrain*

The main cabin was extensively compressed reducing the livable area significantly.

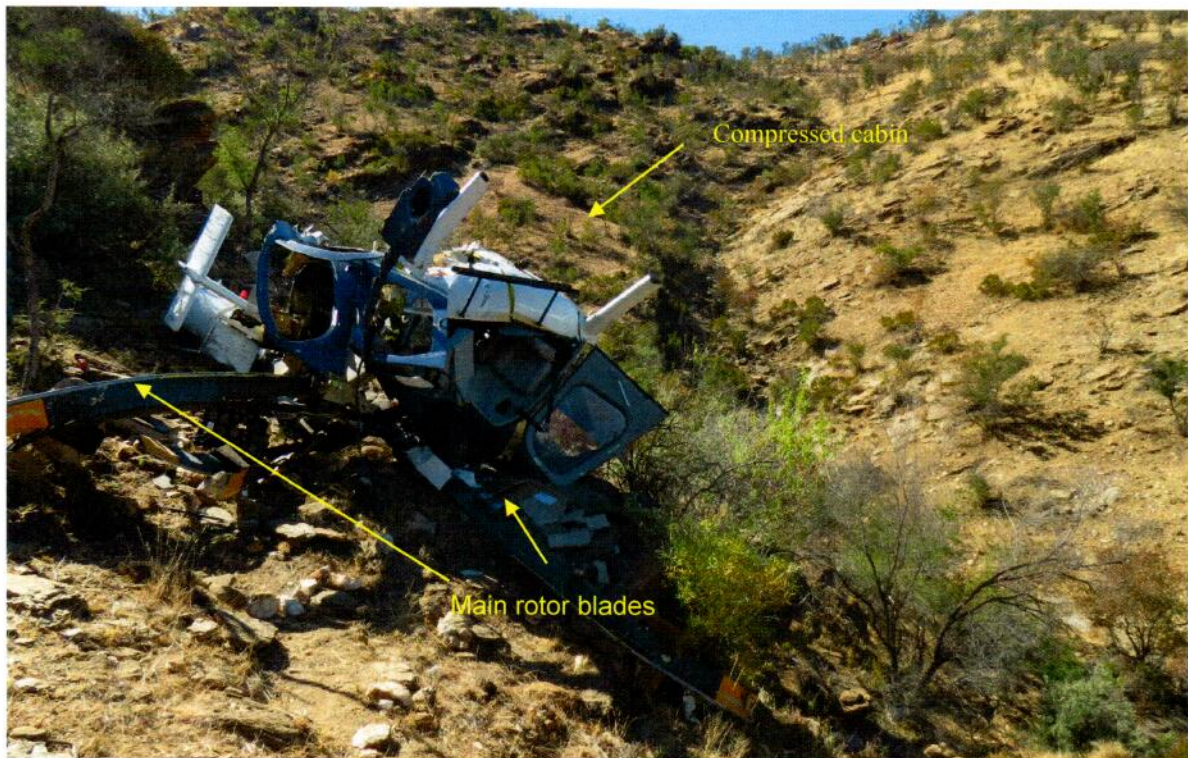
Figure 11: *Depicting the wreckage site over a difficult terrain*
