### RE: CIVIL AIRCRAFT ACCIDENT REPORT

## DIRECTORATE OF AIRCRAFT ACCIDENT INVESTIGATION ACCIDENT REPORT – EXECUTIVE SUMMARY

<b>Aircraft Registration</b>	V5-JAG	<b>Date of Accident</b>	15 October 2016	<b>Time of Accident</b>	11:37 UTC
<b>Type of Aircraft</b>	CESSNA 210N	<b>Type of Operation</b>	Charter		
<b>Pilot – In - Command License Type</b>	CPL	<b>Age</b>	26	<b>License Valid</b>	Yes
<b>Pilot – In - Command Flying Experience</b>	Total Flying Hours	529.1	<b>Hours on Type</b>	37.6

# AIRCRAFT ACCIDENT REPORT

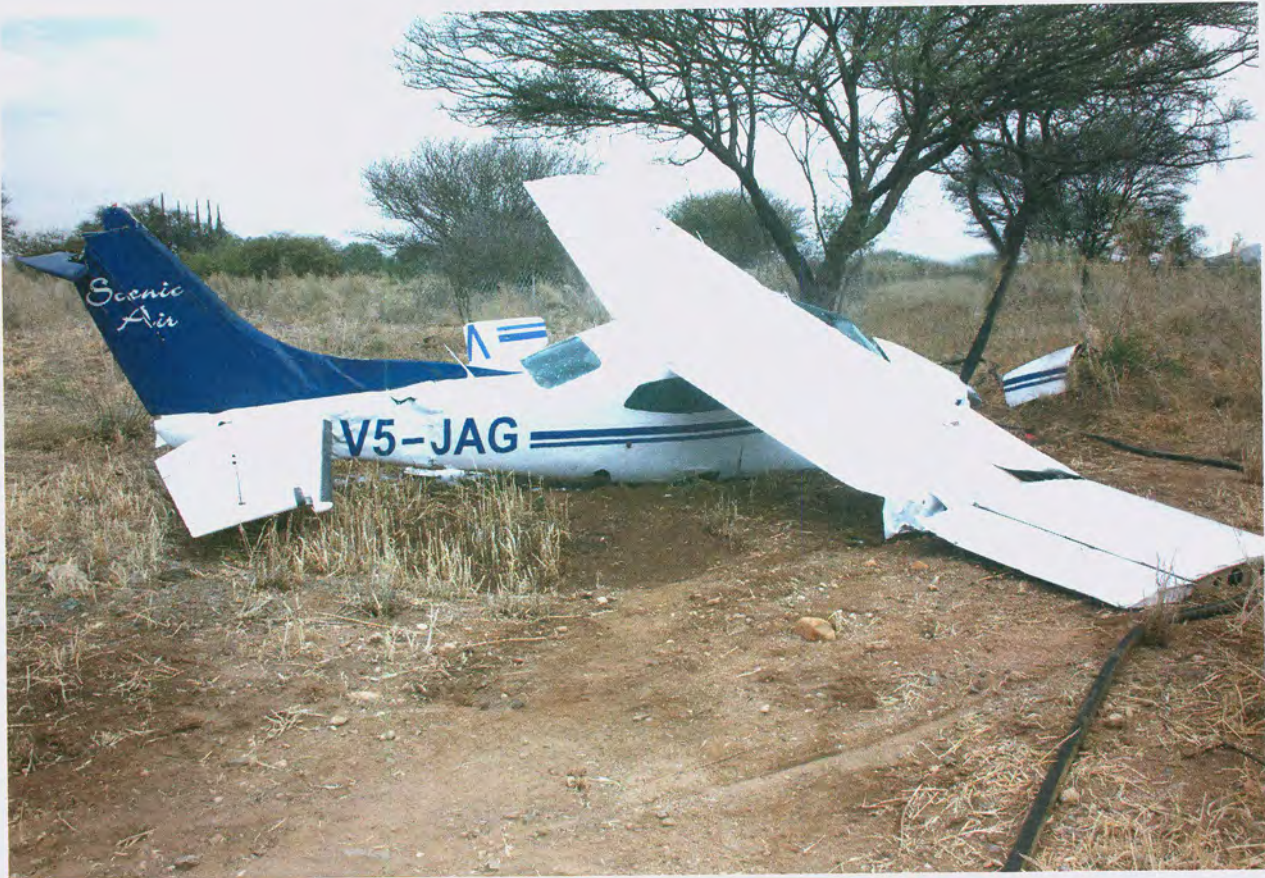
1.12.2 The aircraft ploughed approximately 10 meters before hitting a tree and turned 30 degrees to the left and was found facing to the western direction. The right hand wing and the right hand main wheel impacting the ground hard which caused the wing to break in the middle and bent rear ward. The right hand main wheel broke off due to hard impact and was found lying some few meters from the main wreckage. The front wind screen popped out on the right hand side.

**Figure 1: The wreckage came to rest facing in a westerly direction.**

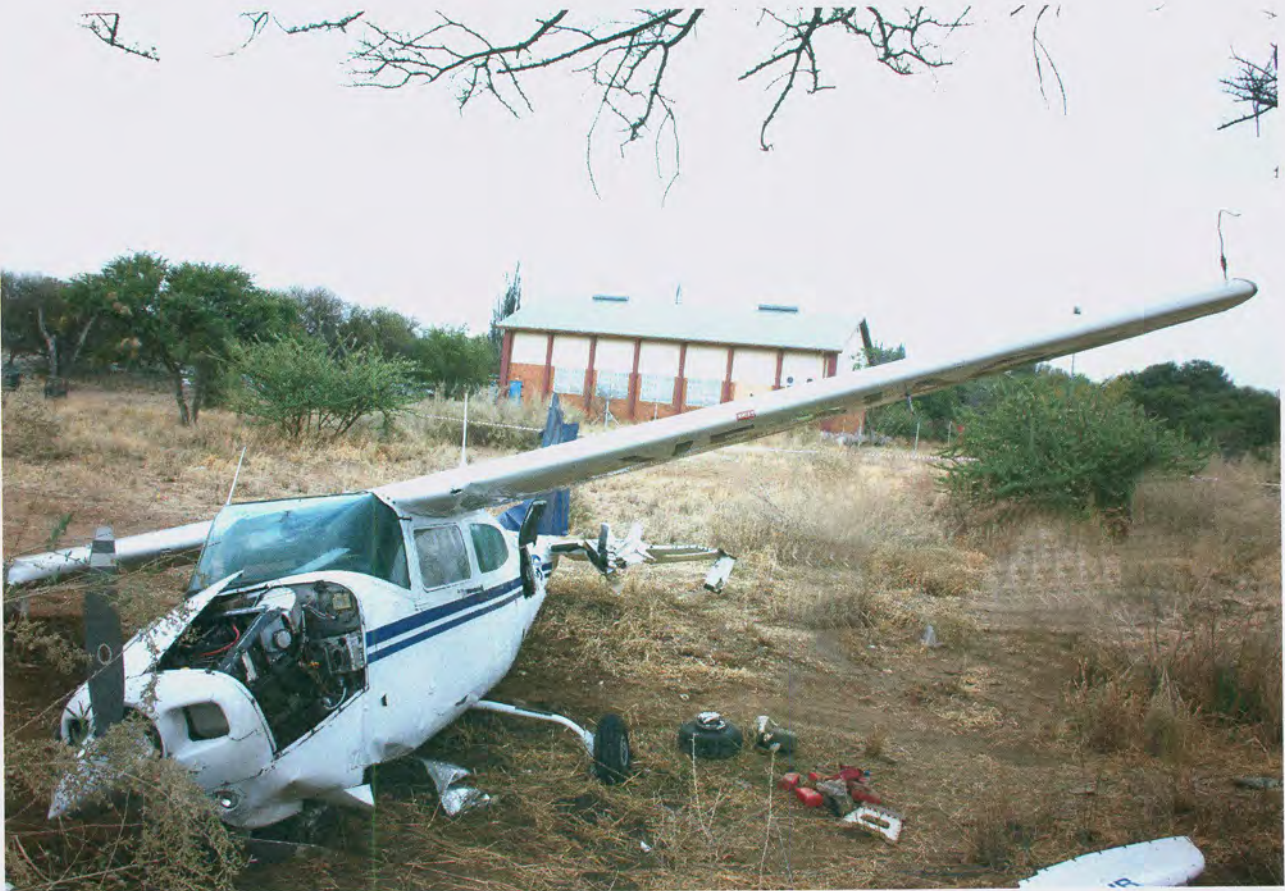
**Figure 2: Another view of the wreckage at the accident site.**

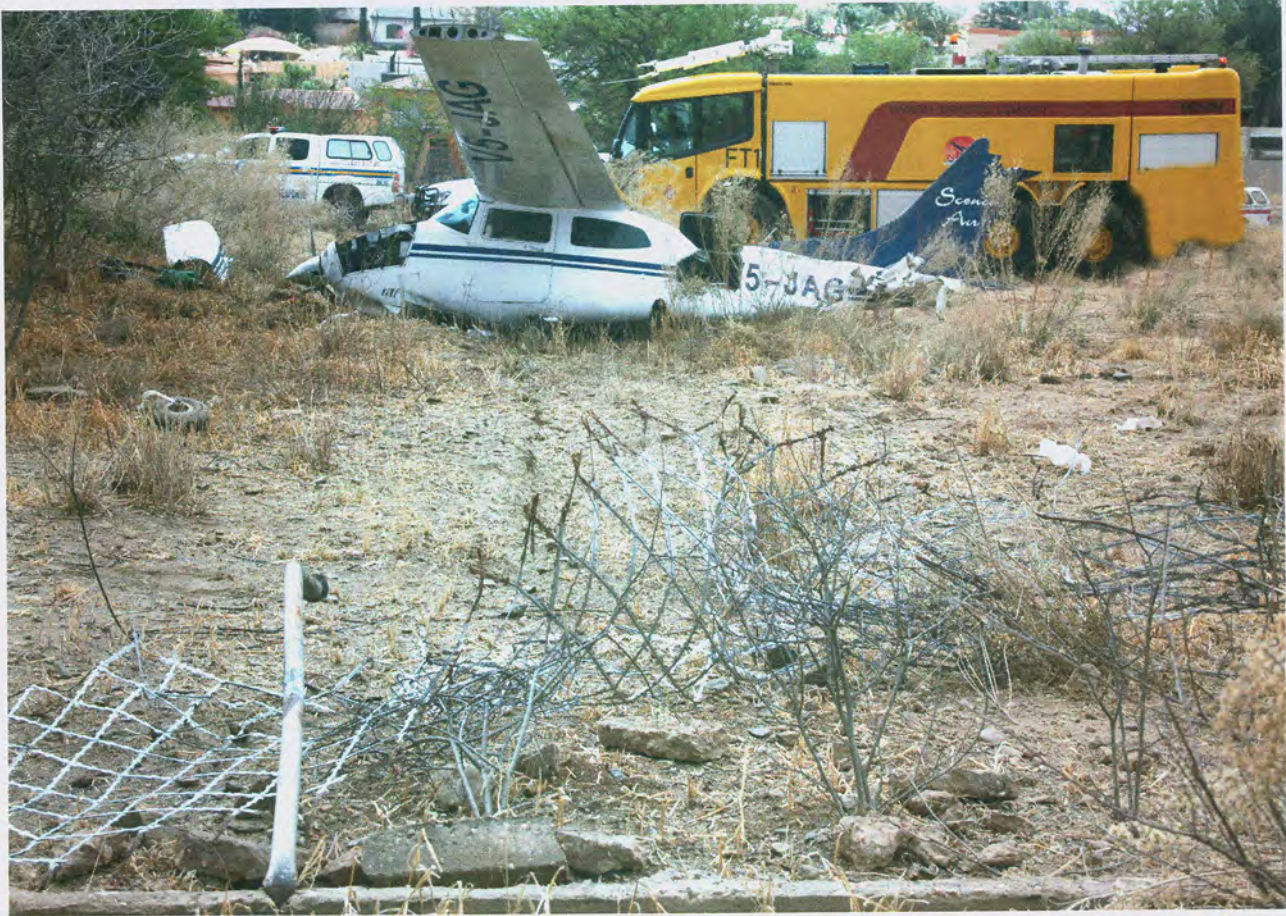
1.4.1 There were some damages to the boundary fence in which the aircraft impacted before hitting a tree.

1.12.3 The site where aircraft crashed contained some trees and a lot of shrubs with thick grass. The fence in which the aircraft impacted span from east to the western direction in front of the building that can be seen in the photo on page 5 of this report.

Figure 3: Damaged fence during impact sequence.

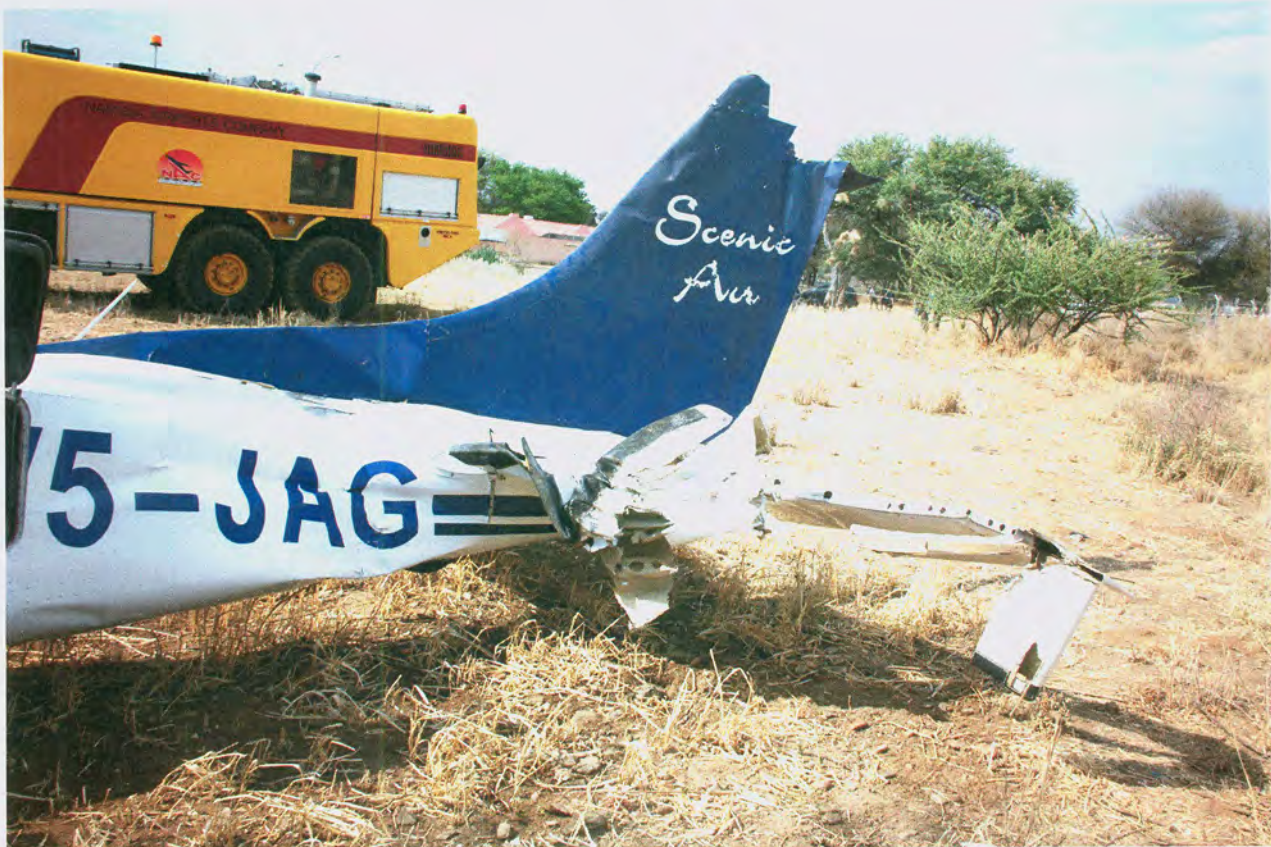
1.12.1 The aircraft first impacted the boundary fence nose dive from the southern direction before hitting a tree with the left hand vertical stabilizer. The nose wheel broke off during impact and was found lying approximately 13 meters south west of the main wreckage.

Figure 4: The damaged tail section.

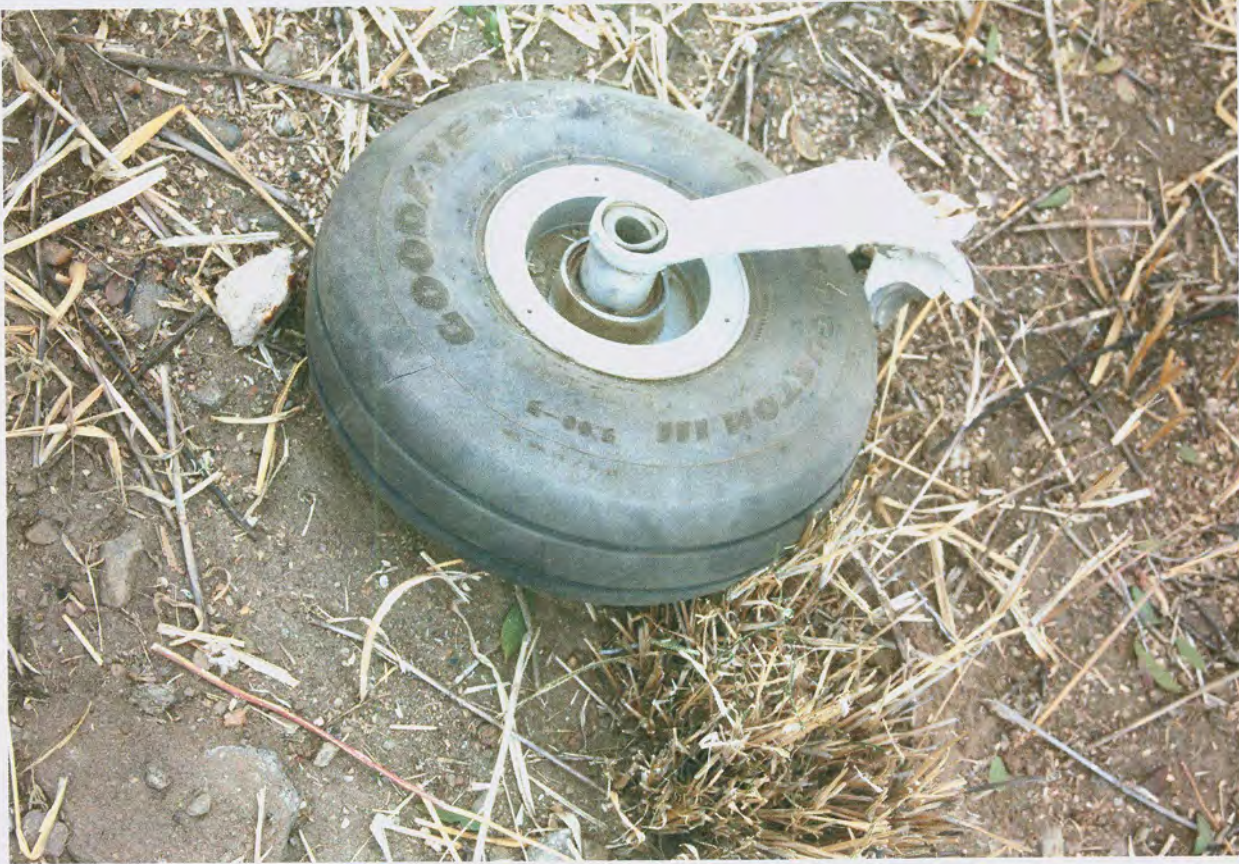
**Figure 7: The nose wheel broken off due to high impact forces.**
