CIVIL AIRCRAFT ACCIDENT REPORT

ACCID/083022/01-03

**AIRCRAFT
REGISTRATION : V5-LMK**

CESSNA 210N V5-LMK

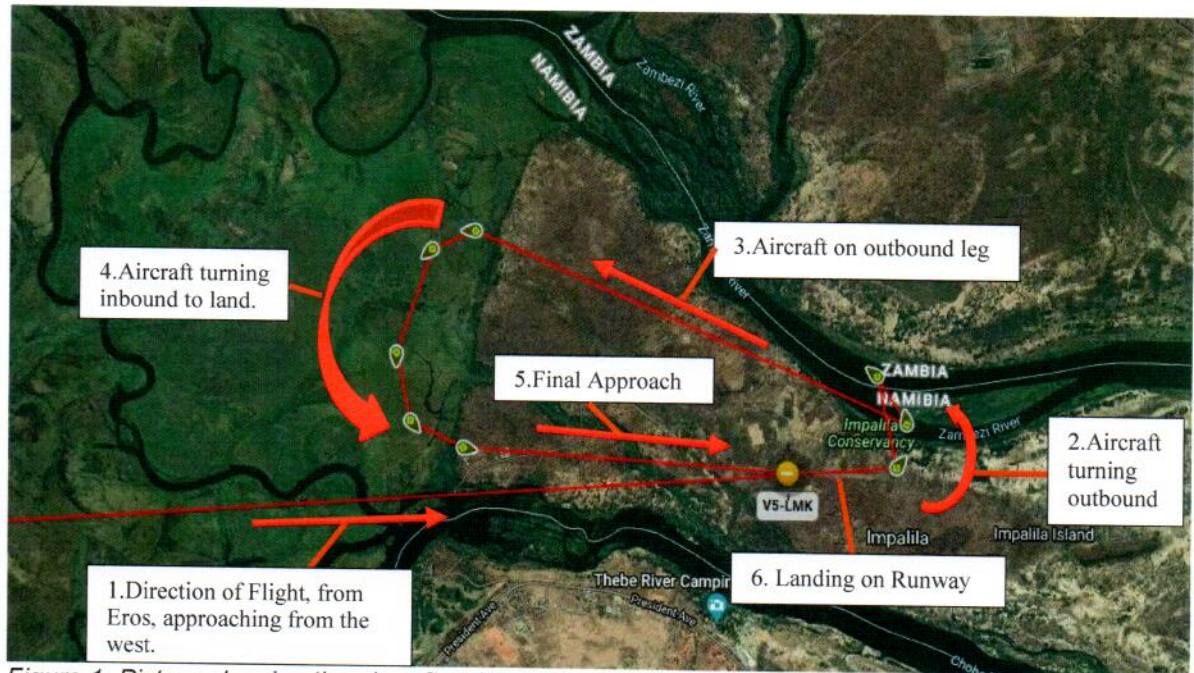
- 1.1.2. The passengers were already waiting at the airstrip and observed the approach and landing. The aircraft landed in an easterly direction on Runway (RWY) 10. On landing the aircraft ballooned and finally came to a full stop at the end of RWY 10 (Threshold 28). After the aircraft came to a stop and switched off, the passengers were driven to the aircraft for boarding. When they arrived at the aircraft the driver opened the aircraft door and spoke to the pilot, thereafter loading of luggage and the boarding commenced.

Figure 1: Picture showing the aircraft arriving at Impalila Island airstrip, this includes the approach and landing (Sequence from 1 to 6). The Aircraft did one circuit before landing. (source: spider track fitted in the aircraft by Aircraft AMO)

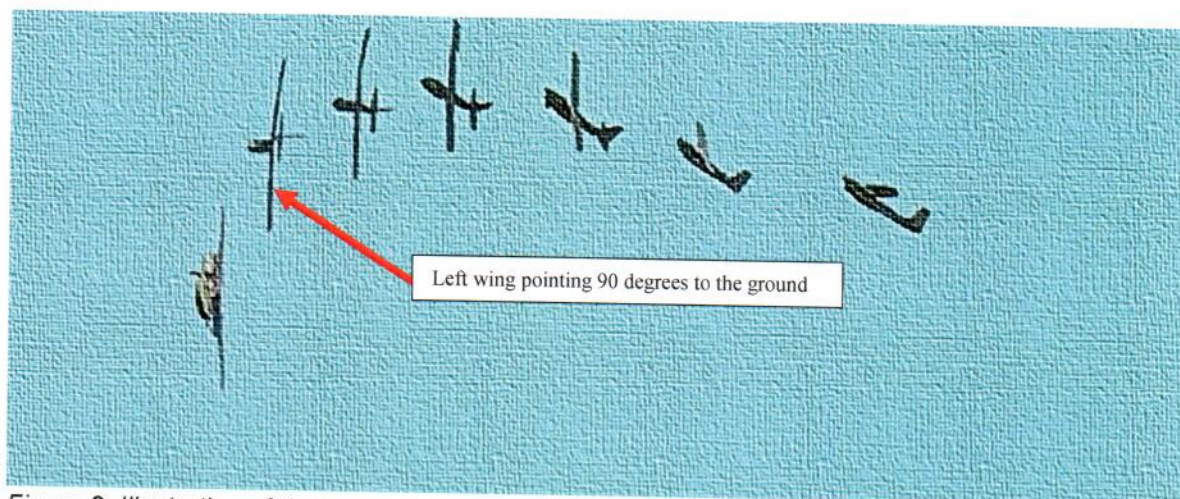
- 1.1.6. Another eyewitness who was standing close to where the aircraft crashed said he heard the aircraft departing from behind the tree line (he could not see the RWY from where he was standing, because of the trees blocking his view). Shortly thereafter he saw the aircraft appearing from behind the tree line retracting the landing gear. According to eyewitness shortly after the landing gear were retracted the aircraft turned to the left. The bank angle to the left increased until the left wing tip clipped a tree next to the river and crashed.

Figure 2: Illustration of the manoeuvres made by the aircraft according to the eyewitnesses.

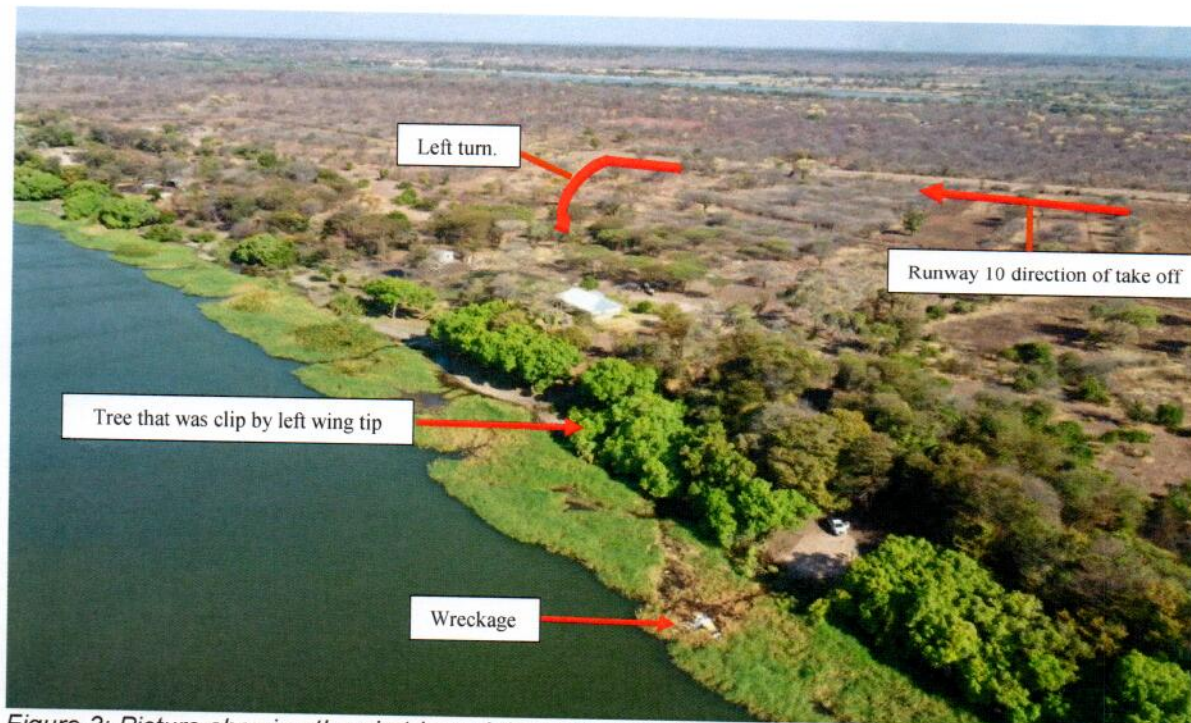
Figure 3: Picture showing the airstrip and the sequence of manoeuvres made by the aircraft.

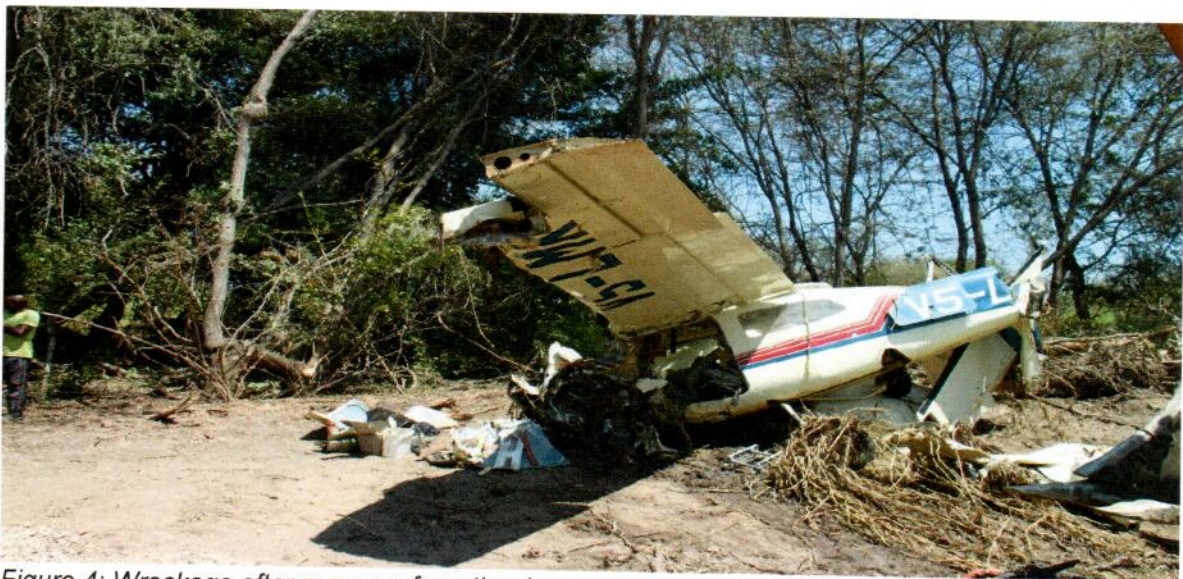
- 1.3.1 The aircraft was destroyed.

Figure 4: Wreckage after recovery from the river.

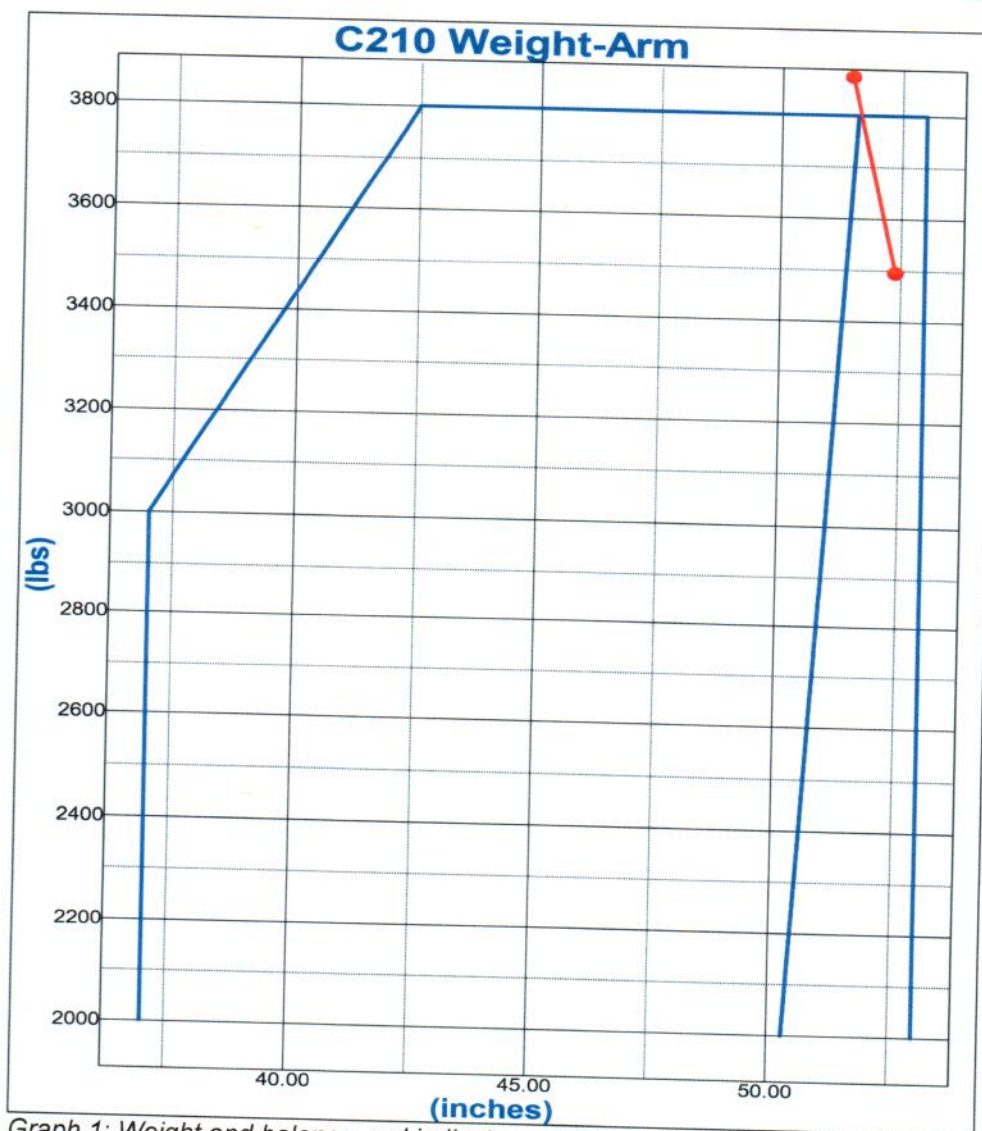
- 1.6.3.1. According to the data below on the weight and balance chart and graph the aircraft took off from Impalila airstrip with 75 lbs more than the aircraft maximum take-off weight.
- 1.6.3.2. The operational flight plan log was recovered from the wreckage by the investigators. In the operational flight plan log the pilot recorded the following before take-off from Impalila Airstrip:

Graph 1: Weight and balance, red indicates outside the safe envelop.

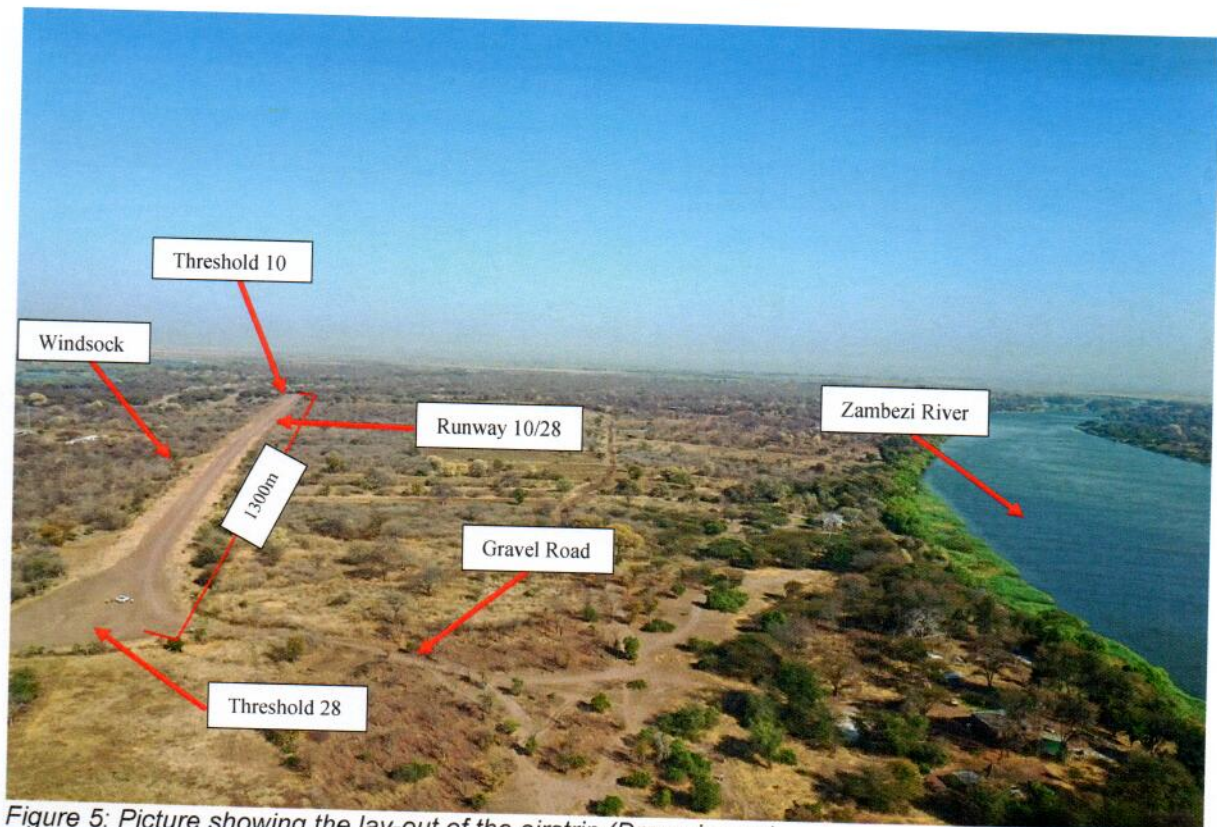
Figure 5: Picture showing the lay-out of the airstrip (Drone image).

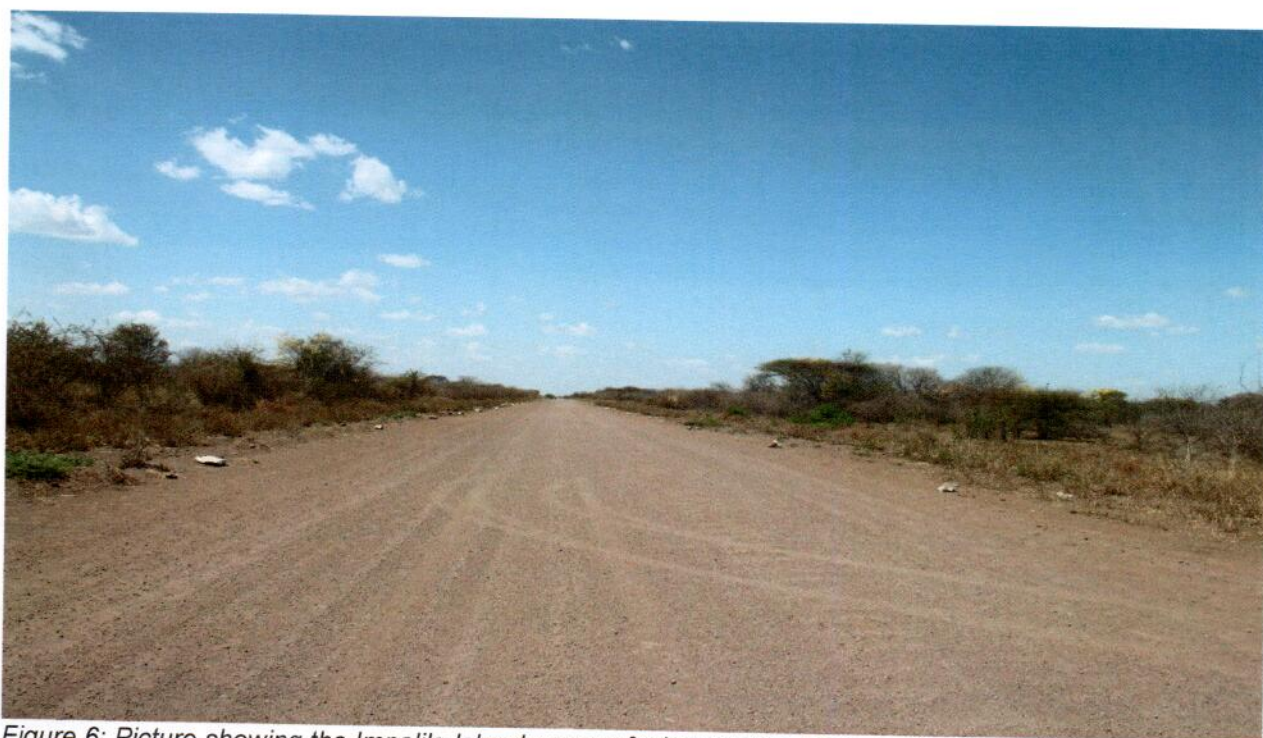
Figure 6: Picture showing the Impalila Island runway facing into the Easterly direction (This was also the take-off direction of the accident flight).

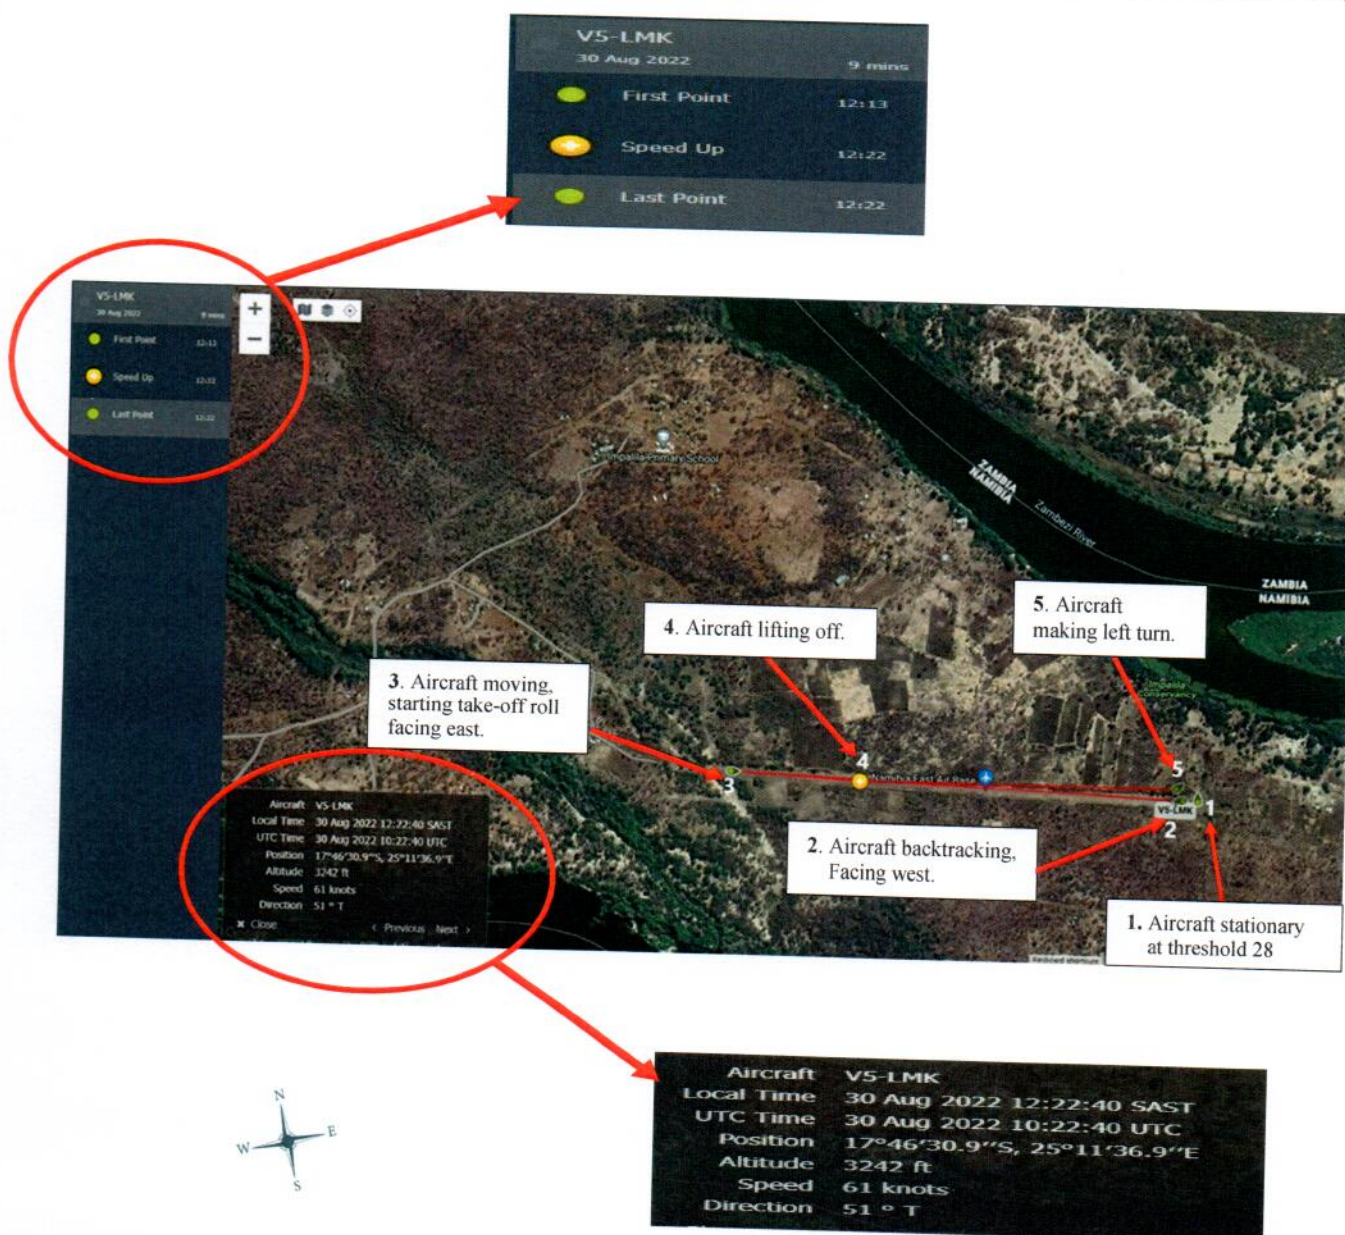
Figure 7: Insert showing the spider track data for the accident flight. Note: Numbers 1-5, showing speed, heading and elevation at the different positions. (source: spider track fitted in the aircraft by the Aircraft AMO).

Figure 8: Picture showing data from the spider track pertaining to the accident flight (source: spider track fitted in the aircraft by the Aircraft AMO).

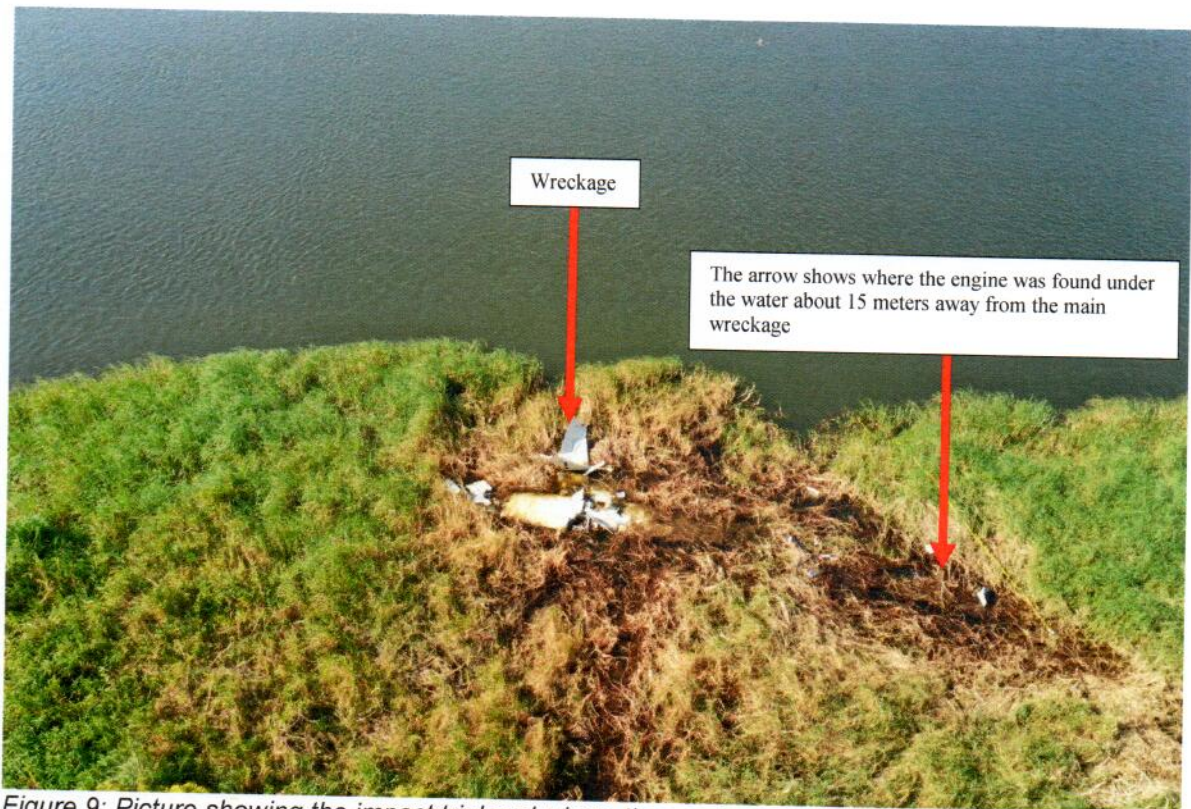
After take-off from runway 10, the aircraft made an early left turn, thereafter the left wing clipped a tree next to the river and crashed a few seconds later into the Zambezi River. The right-wing tip fuel tank was found at the beginning at the first point of impact. The engine was found under water in the impact trail, about 15 meters away from the main wreckage. The main wreckage was found around 40 meters away from the impact point facing into a southerly direction. The nose section was totally destroyed and the instrument panel was just attached to the fuselage by cables. The main aircraft fuselage was destroyed; the tail section bend towards the right side of the aircraft.

Figure 9: Picture showing the impact trail and where the engine was found (Drone image).

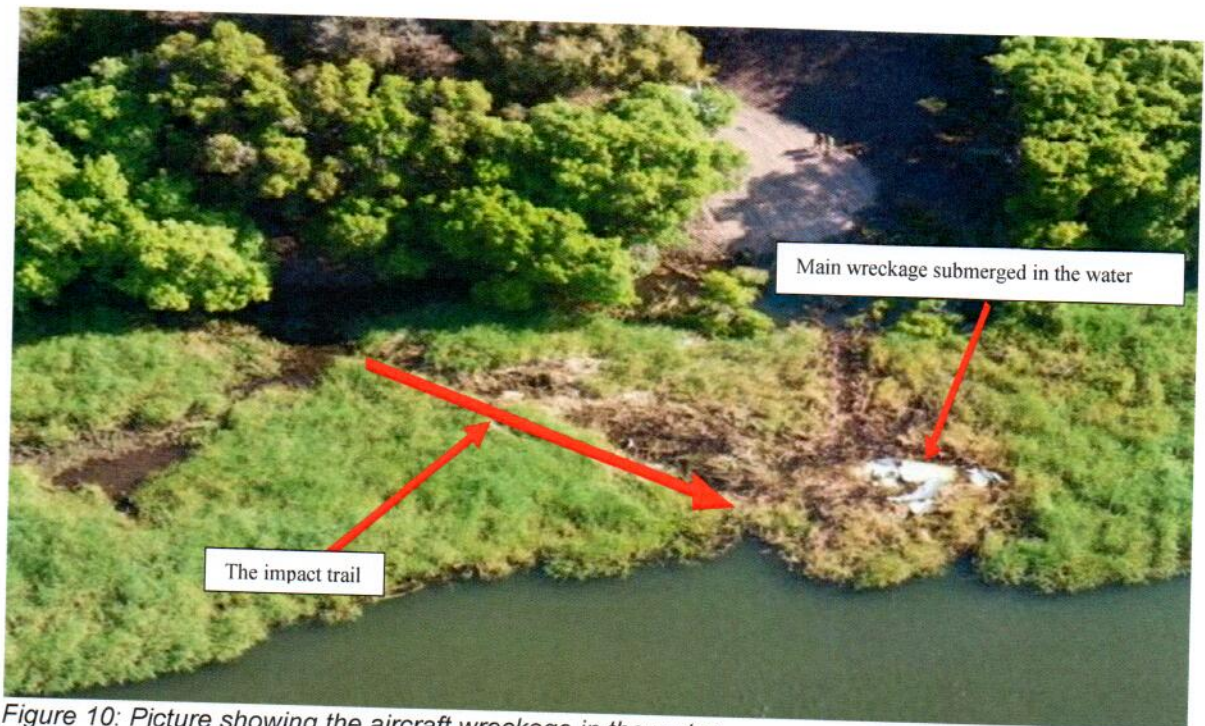
Figure 10: Picture showing the aircraft wreckage in the water.

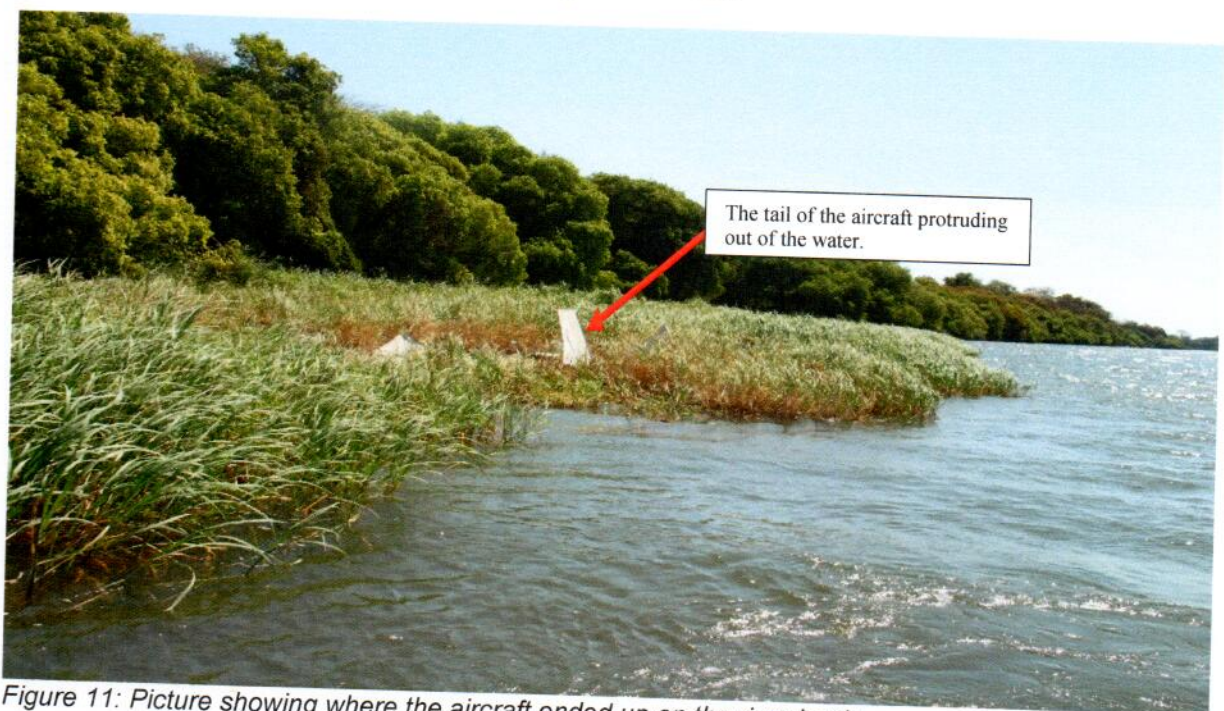
Figure 11: Picture showing where the aircraft ended up on the river bank.

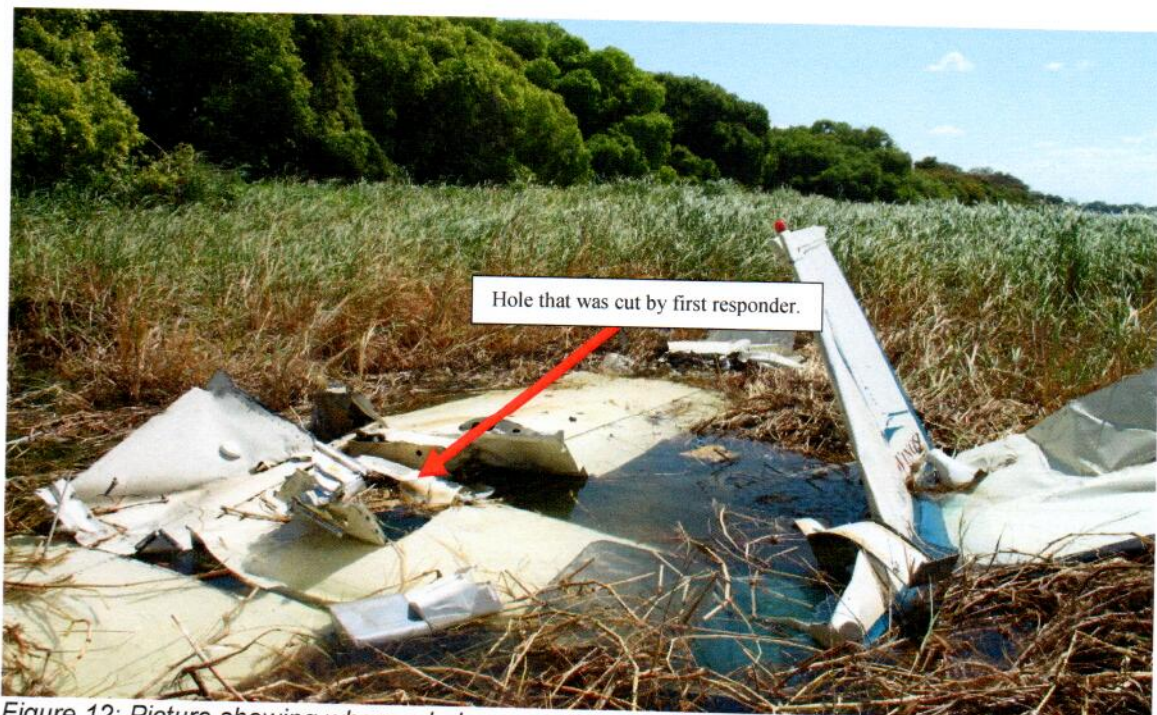
Figure 12: Picture showing where a hole was cut on top of the aircraft between the wings to gain access to the cabin.

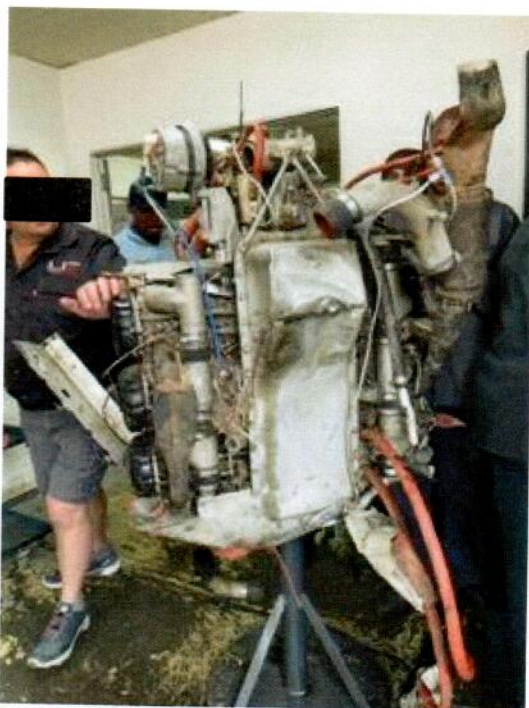
The engine was relatively intact with all major components attached. When the engine was turned it showed the presence of pressure in all cylinders. The crankcase was opened and the crankshaft was rotating satisfactory.

Figure 13: Engine being turned.

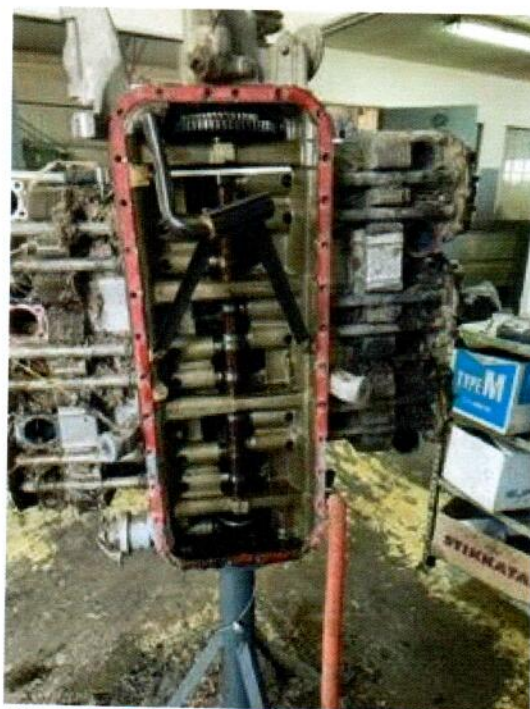
The oil sump was removed and oil was found in the sump, no metal pieces were found.

Figure 14: Engine, after oil sump was removed.

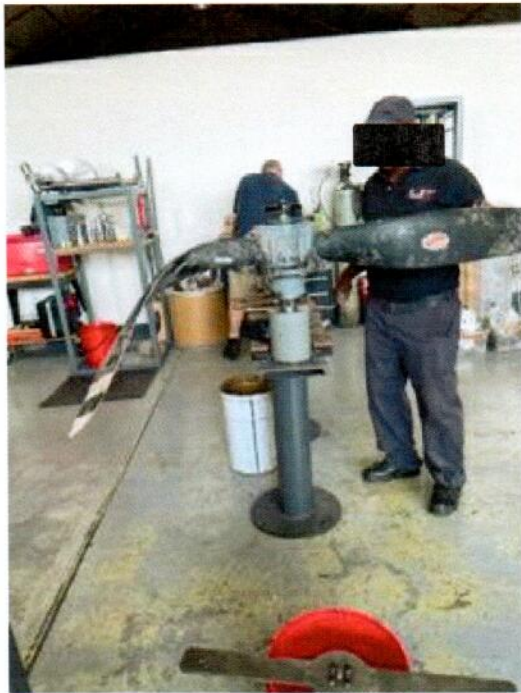
All propeller blades remained attached to the main hub as it was installed. The hub showed evidence of being lubricated and all bearings were intact and showed no sign of any defects. The blades were removed from the hub and examined. Minimal rotational damage was observed on the blades. Varying degrees of bending at or near the root end of the blades were observed, however there was more warping on the No 2 blade consistent with it being the first to strike at impact.

Figure 15: Propeller still attached to the hub.

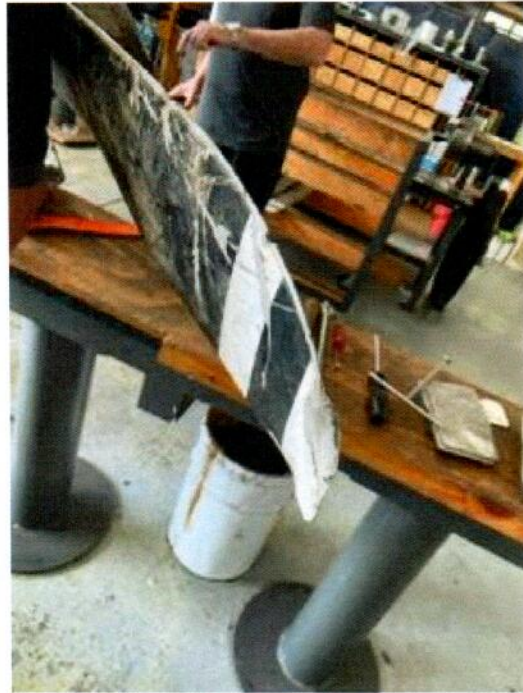
Figure 16: No. 2 blade with more warping.

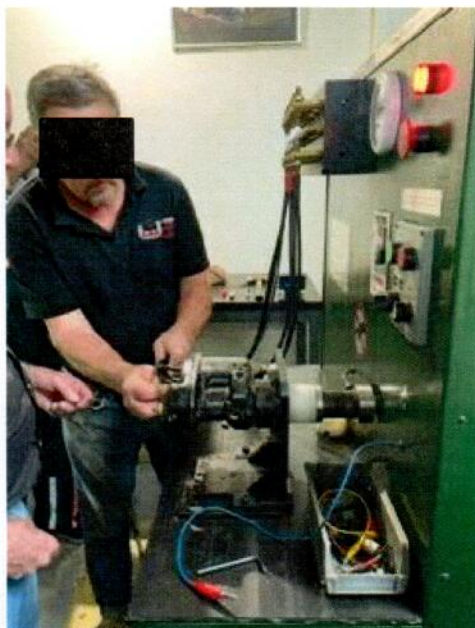
The magnetos were removed and bench tested for functionality. At first the results were inconclusive, this was found to be due the water in the enclosure. The units were dried and tested again with the result being satisfactory.

Figure 17: Magnetos being bench tested.

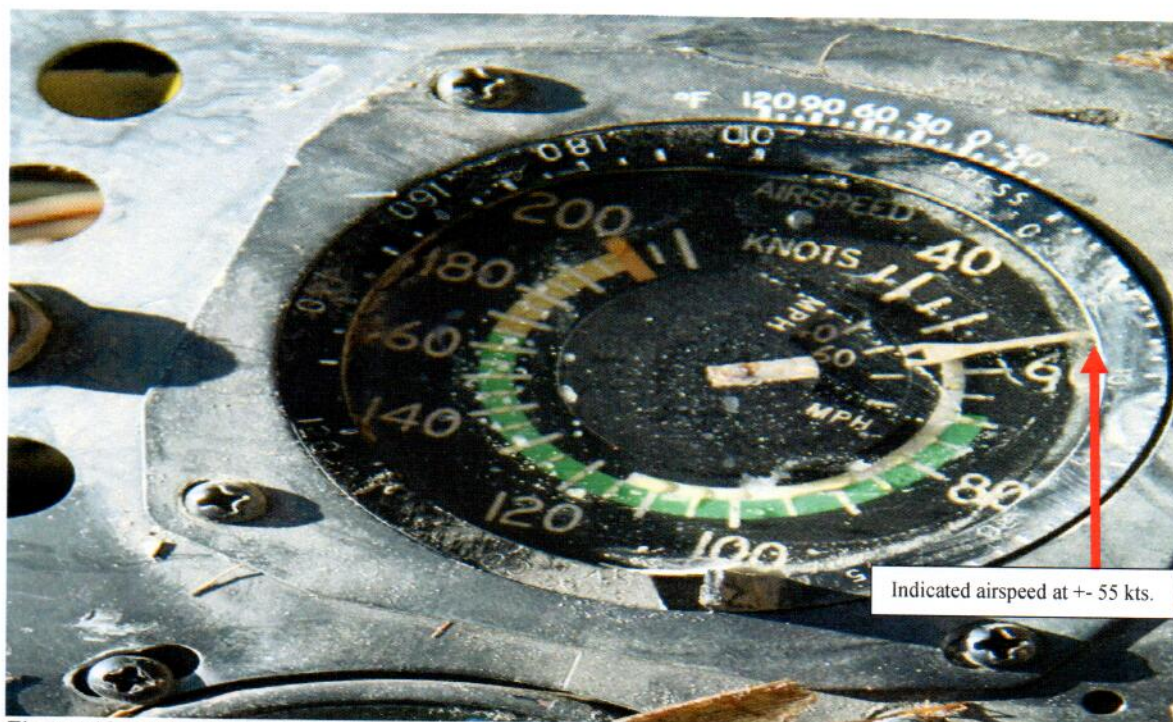
1.18.1. During the wreckage investigation it was found that the aircraft air speed indicator showed that the aircraft Indicated Airspeed was 55 kts at impact.

Figure 18: In the Picture the red arrow is pointing to the aircraft speed during the crash on the Airspeed indicator.

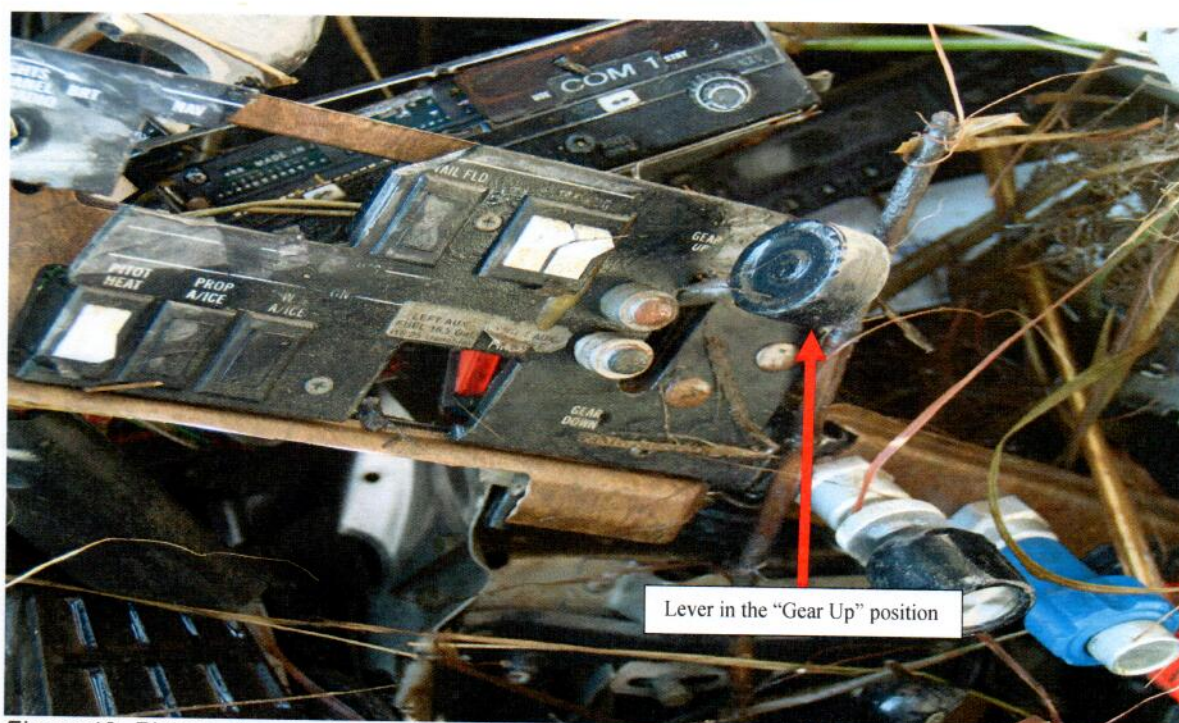
- 1.18.2. During the wreckage investigation the undercarriage lever was found selected in the up position and the undercarriage were found still in the retracted position. The undercarriage only dropped during the recovery and lifting of the wreckage out of the water, this was because of no hydraulic pressure to keep it in the retracted position.

Figure 19: Picture showing the undercarriage lever in the selected up position

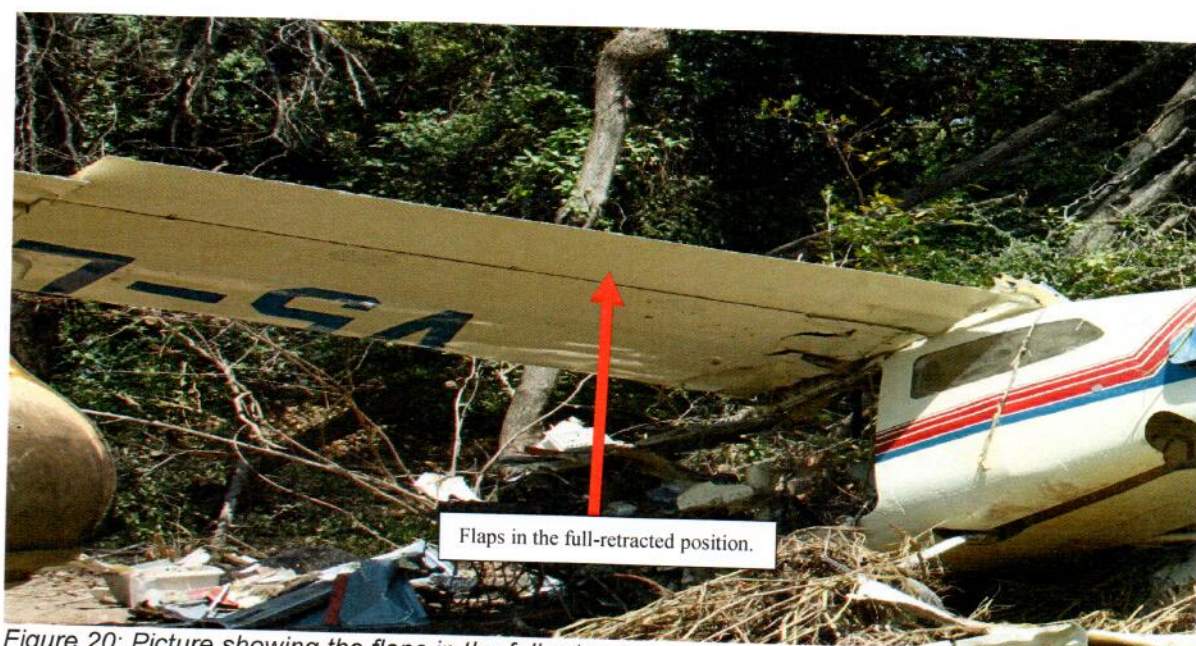
1.18.3. The position of the flaps was found fully retracted.

Figure 20: Picture showing the flaps in the full-retracted position.

3.3.3 Aircraft retracting flaps below the recommended flaps retraction speed.
