**DIRECTORATE OF AIRCRAFT ACCIDENT
INVESTIGATION**

CIVIL AIRCRAFT ACCIDENT REPORT

ACCID/012916/02-02

OPERATION	: License Renewal Flight
AIRCRAFT	: V5-MJW
LOCATION	: Hosea Kutako Airport (313m NNE Of the runway threshold).
DATE	: 29 JAN 2016

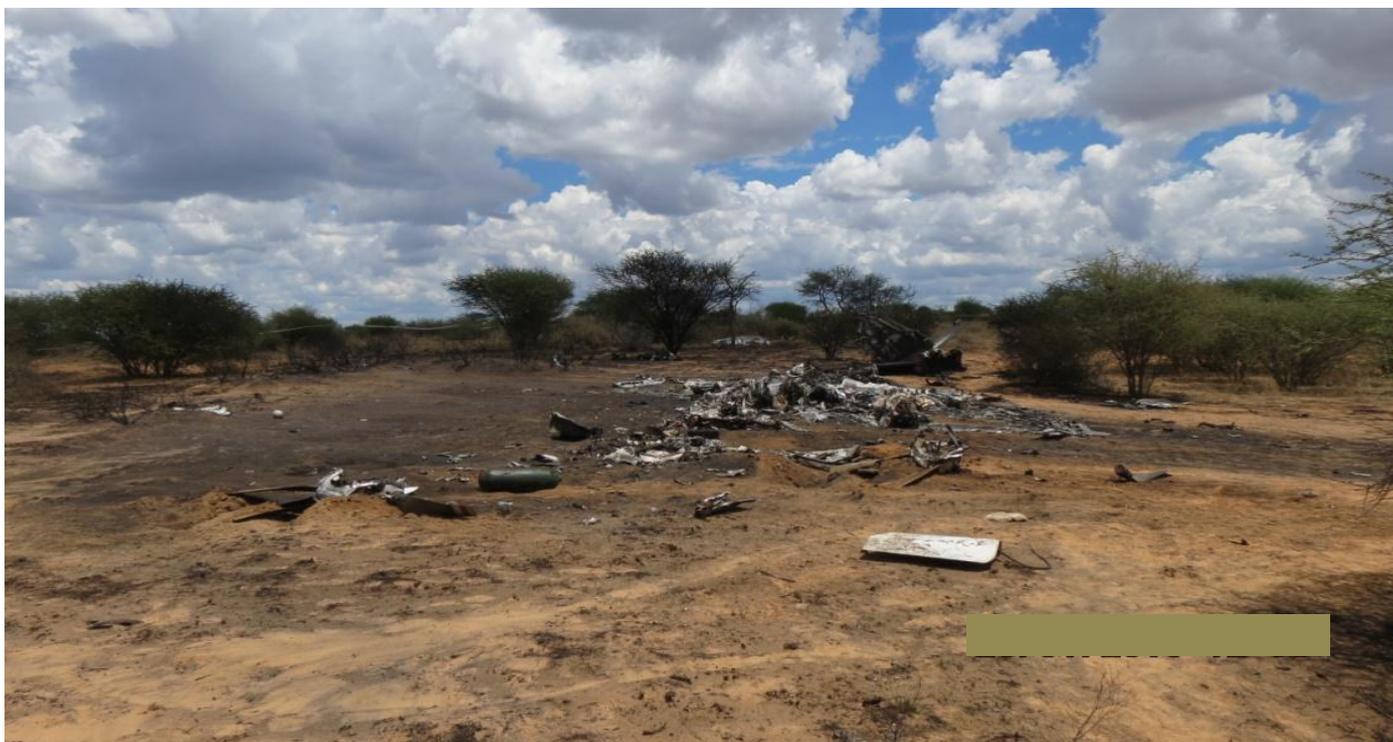
- 1.3.1 The aircraft was destroyed on impact and consumed by post impact fire.

Figure 2. Photo showing the destroyed aircraft and ensuing post impact fire.

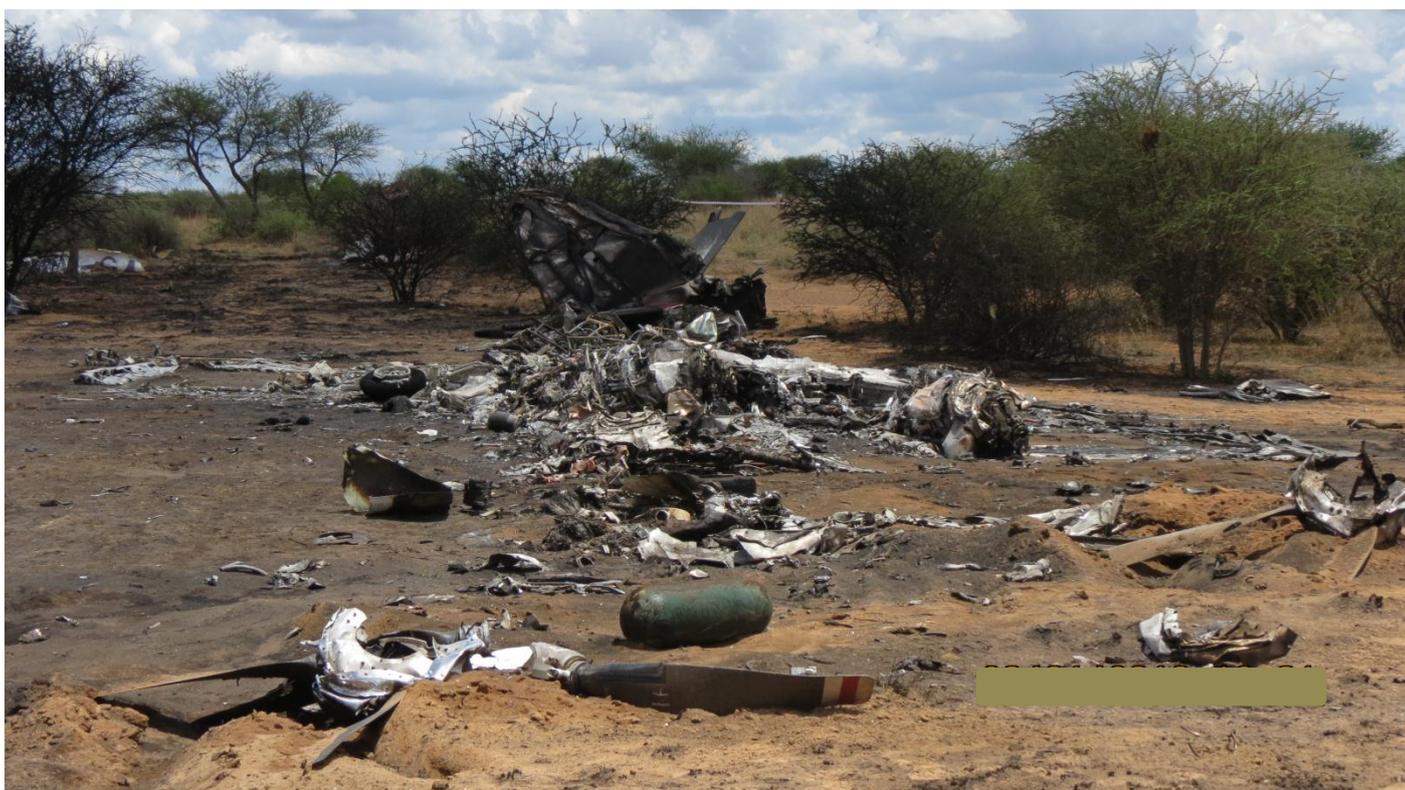
The propellers were found broken off at the point of impact and displayed little signs of rotational forces on the ground scars.

Figure 3. Photo showing the point of first impact and the rest of the aircraft.

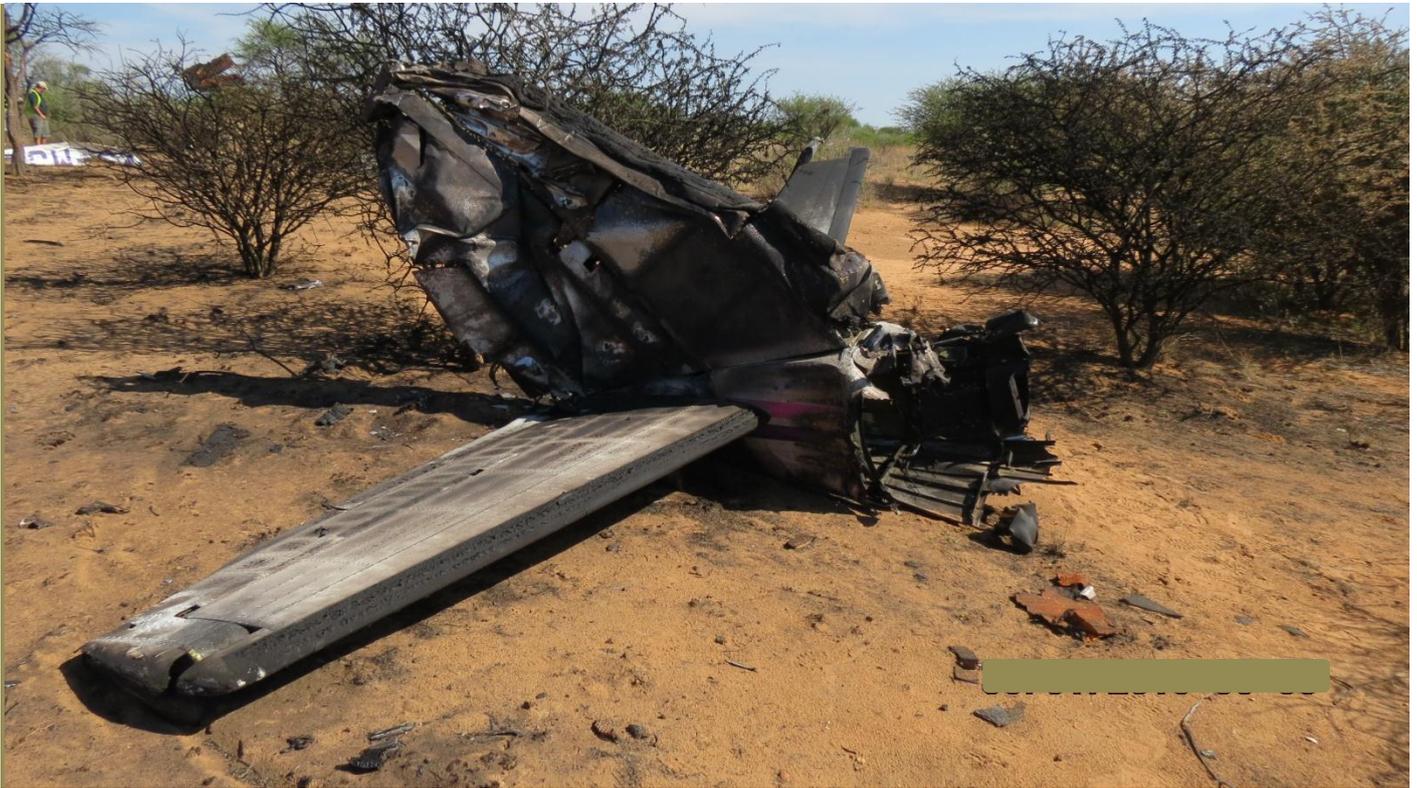
Figure 4. Photo showing the broken off empennage

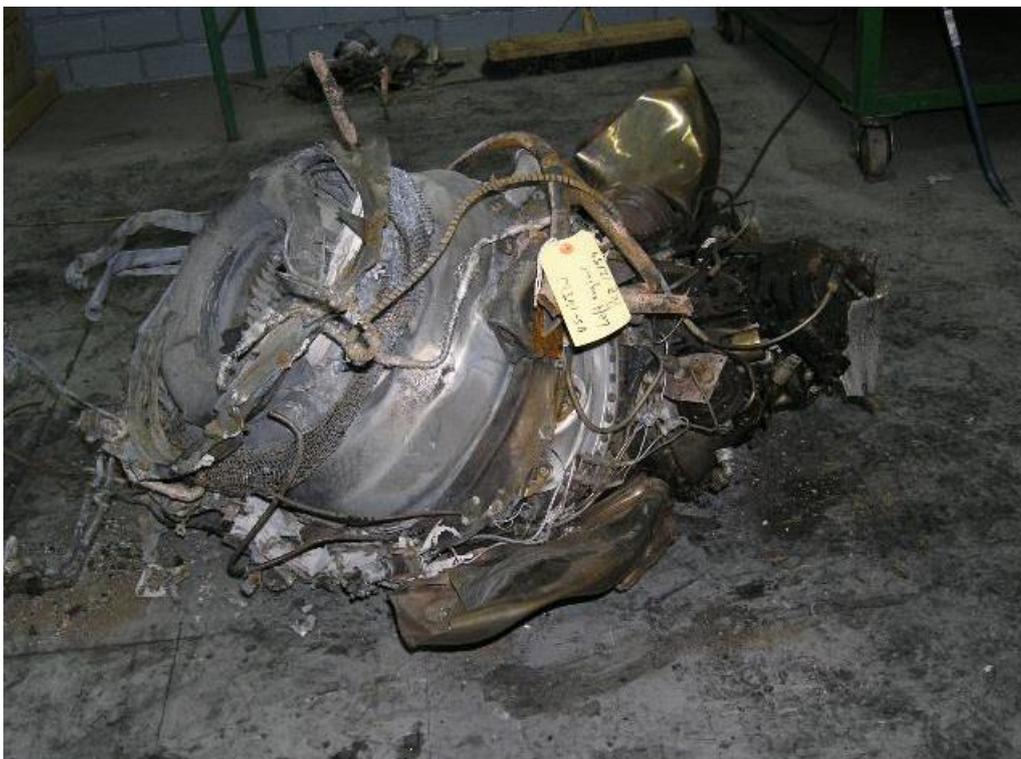
Both engines were received separated from the engine nacelle. The engines displayed severe impact and fire damage. The airframe propeller hubs were impact fractured from the propeller shaft.

Figure 5. Engine right hand view.

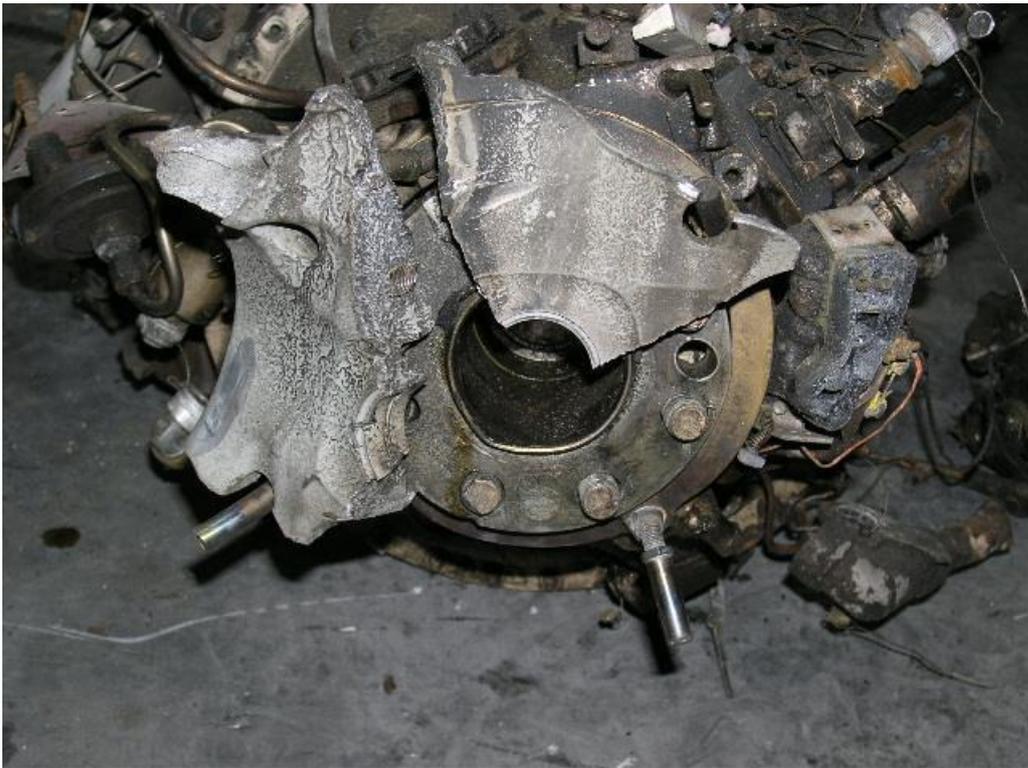
Figure 7 Propeller shaft and hub.

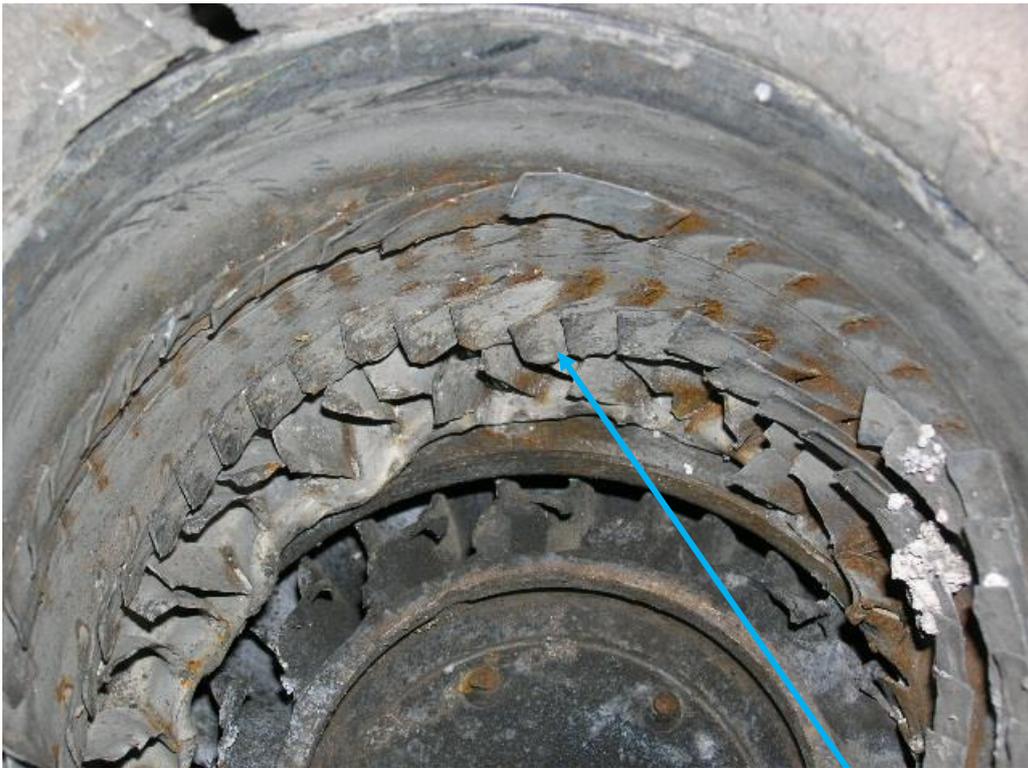
Figure 11 Compressor stator vanes and shrouds, and centrifugal impeller, lower circumference

All of the stator airfoils were deformed sharply with the direction of compressor rotation, and displayed strong circumferential rubbing. The shroud face displayed circumferential rubbing due to contact with their adjacent blade airfoil.

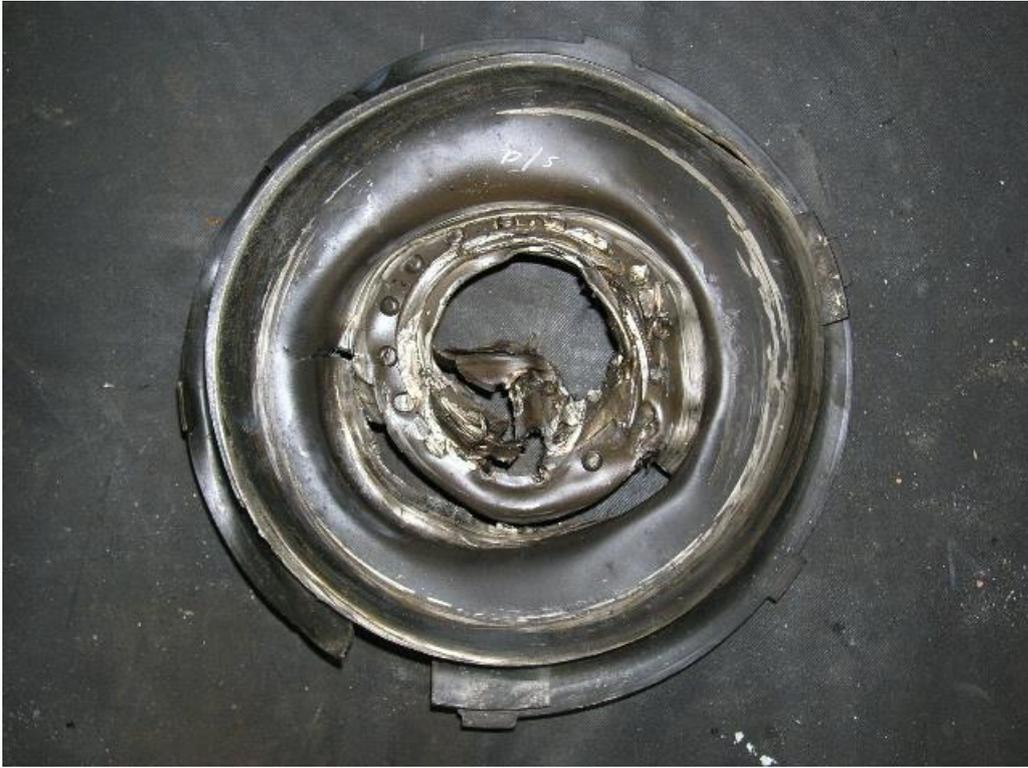
Figure 11 Inter-stage baffle downstream side.

The disc face displayed severe circumferential rubbing and machining due to contact with power turbine guide vane ring. The disc hub showed heavy circumferential machining due to contact with the compressor turbine disc, through the inter-stage baffle.
