**MINISTRY OF WORKS AND TRANSPORT  
DIRECTORATE OF AIRCRAFT ACCIDENT INVESTIGATIONS**

**RE: AIRCRAFT ACCIDENT REPORT**

## DIRECTORATE OF AIRCRAFT ACCIDENT INVESTIGATION ACCIDENT REPORT – EXECUTIVE SUMMARY

Name of Owner/Operator	: BV Investments 622 CC.
Manufacturer	: Lockwood Aircraft
Model	: Air-cam1999
Nationality	: Namibia
Registration Marks	: V5 - PVS
Place	: Etosha National Park
Date	: 08 <sup>th</sup> March 2014

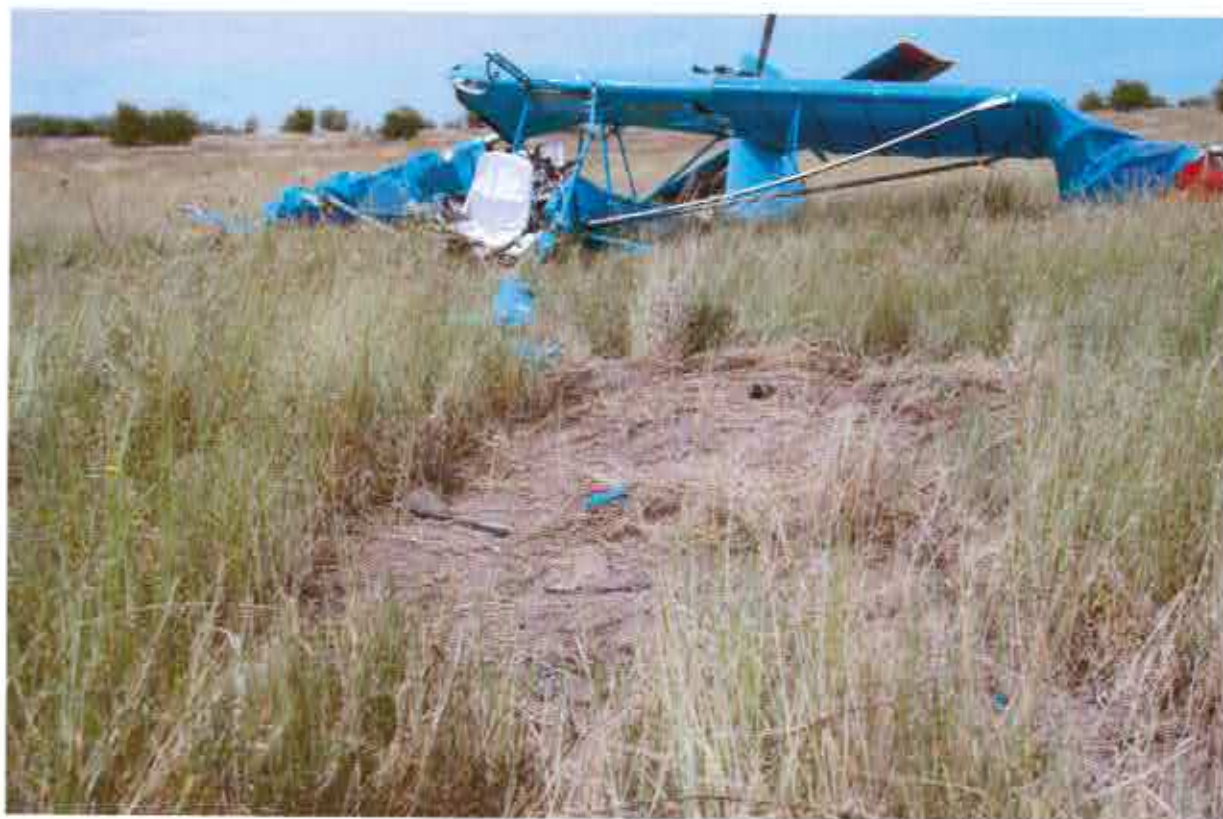
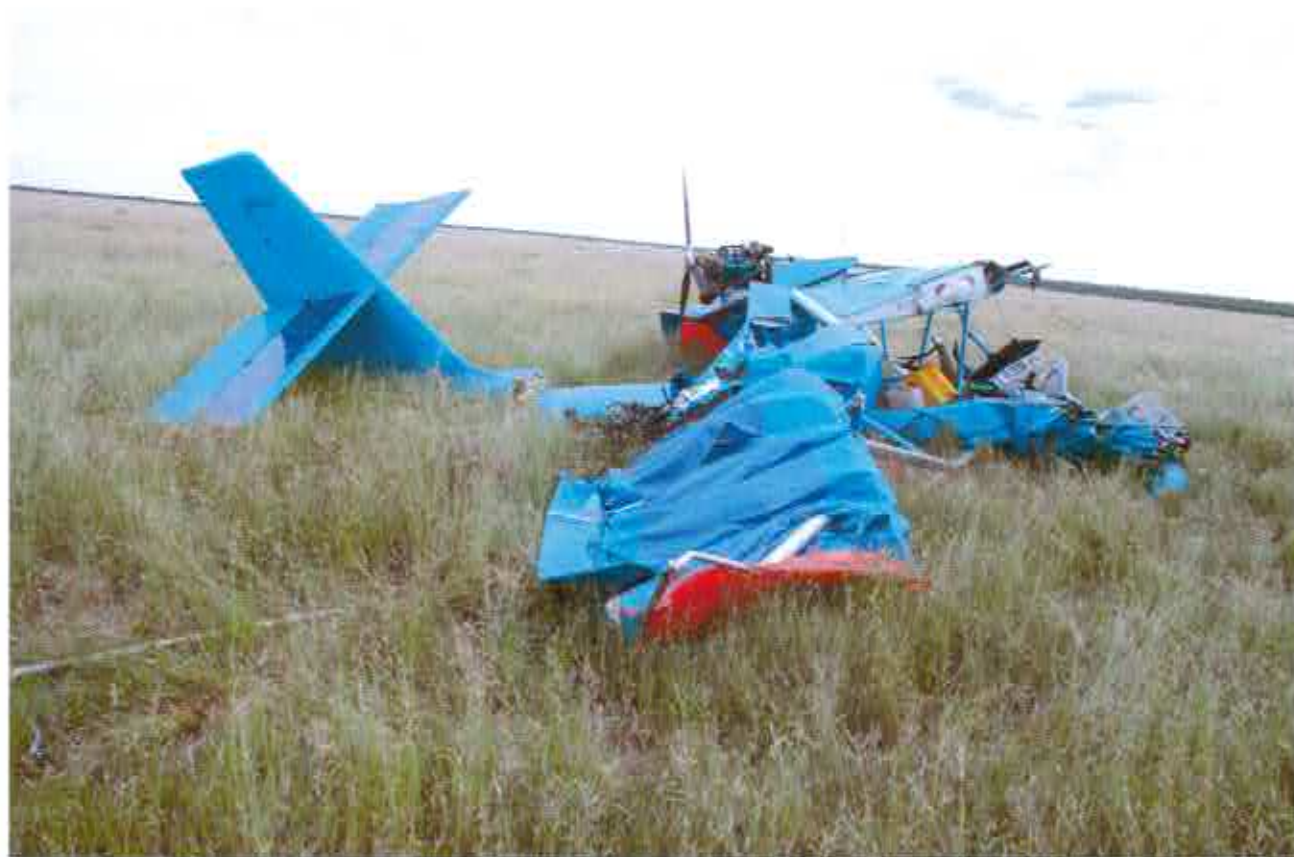
- 1.3.1 The aircraft was destroyed by impact forces

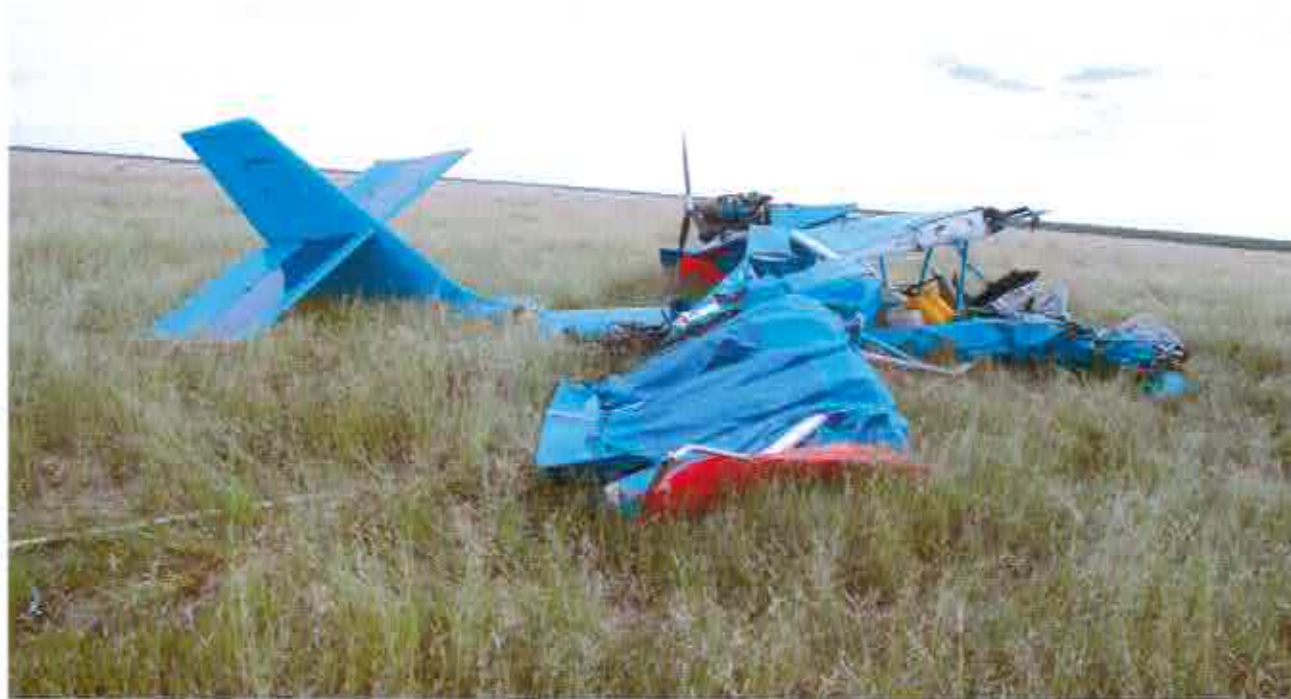
- 1.12.1 The aircraft was flying in a steep bank of about  $45^\circ$  and impacted the ground with the right wing first followed by the forward section. From the last impact the aircraft accelerated 6.3 metres forward, turn  $180^\circ$  to the direction of flight and came to rest.

- 1.12.2 The right wing was destroyed and found detached from the empennage.
- 1.12.3 The forward section was destroyed by the impact, the right main under carriage was damage and the wheel was found around 40 metres from the wreckage.

- 1.12.4 Because of the wobbling effect the tail section was found broken upward.
- 1.12.5 The three propellers on the right engine were found broken off and one piece of the propeller was found around 70 metres in the direction of flight from the wreckage.

- 1.12.6 Most of the instruments got damaged but the two engine RPM gauges and the position of the throttle indicates that the engine was at full power with both gauges indicating about 5800 Revolution per minute (RPM).

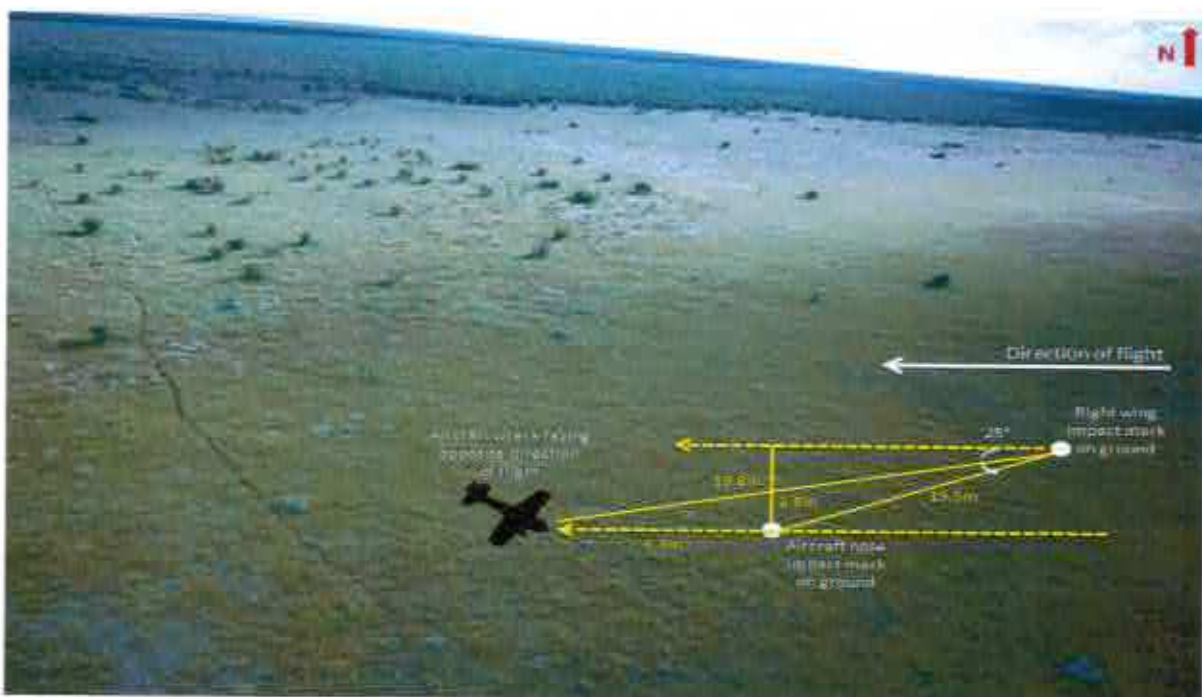
- 1.12.3 Right wing impact to nose impact point =13.5 metres
- 1.12.4 Right wing impact to where the aircraft fuselage came to rest =19.8 metres
- 1.12.5 The width from the Right wing impact point to the fuselage impact point =2.5 metres
- 1.12.6 Fuselage impact point to where the aircraft came to rest 6.3 metres
- 1.12.7 Right wing impact point angle to nose impact point 25°

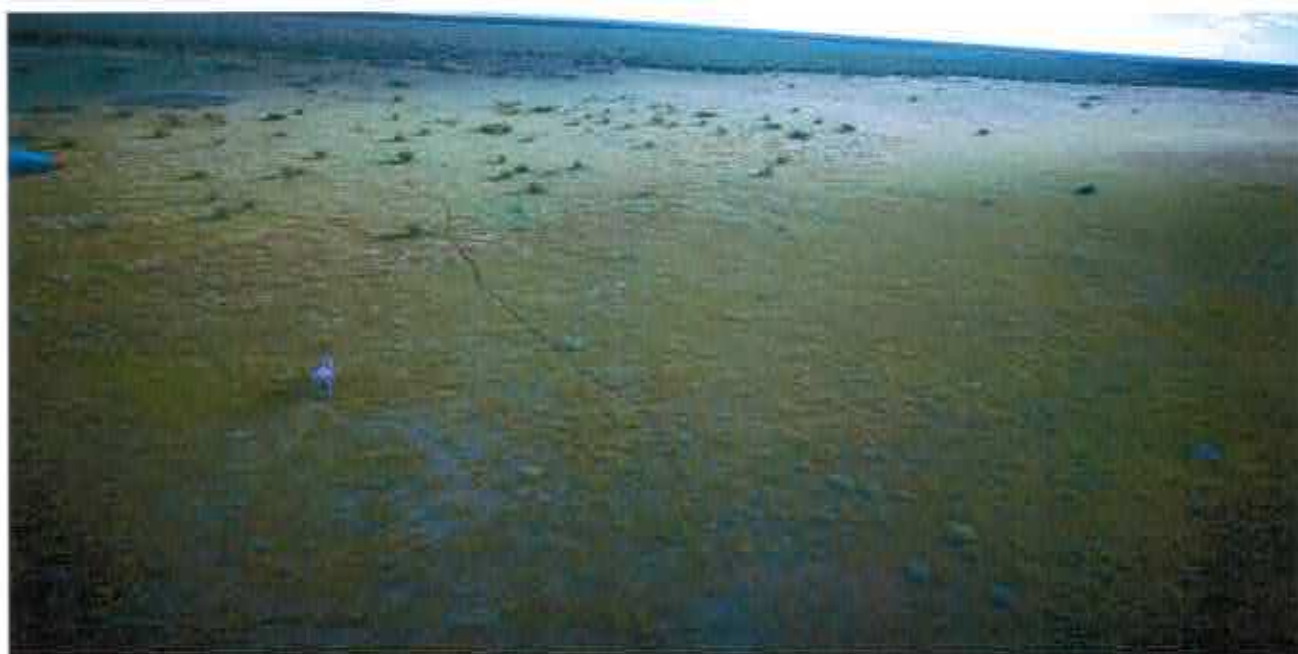
1<sup>st</sup> PICTURE

- 1.18.5 Picture one up to fourth indicate how low the pilot was flying and some indicate the time taken putting into consideration the position of the aircraft from one picture to the next. It was clear that the pilot made steep turns to align the elephant with the storm in the background.
