Accident Reference: ACCID/121720/01-5

Aircraft Accident Investigation Final Report

V5-ULT. EROS AIRPORT, WINDHOEK

Gyrocopter Collision with Terrain
Private Flight
Calidus. Auto- Gyrocopter,
V5-ULT. Eros airport, Windhoek
17th December, 2020

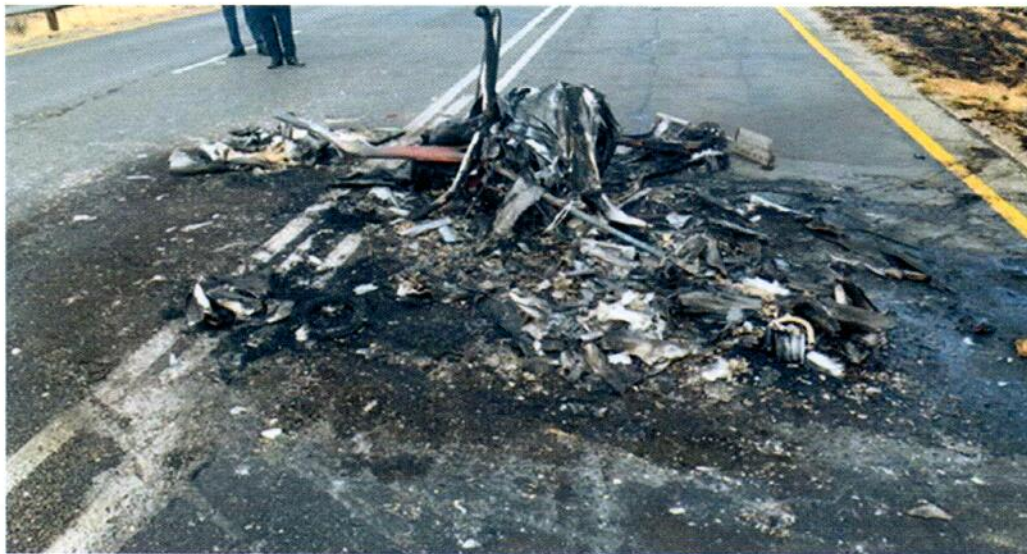
1.3.1 The aircraft was destroyed

Figure 1: Gyrocopter destroyed then consumed by post impact fire.

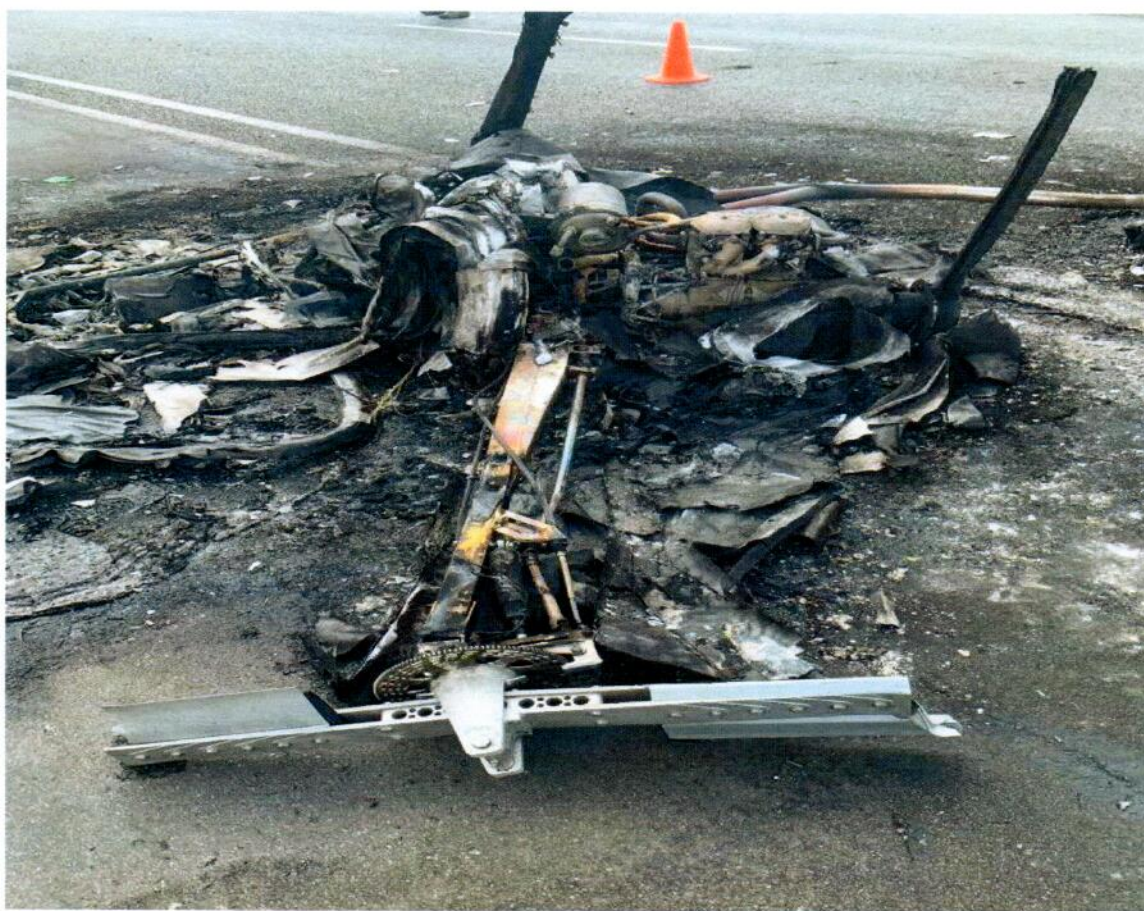
The gyrocopter was flying very low along the road leading to Hosea kutako airport. He then hit the powerlines which are about 35m/114 feet. This stopped the gyrocopter which fell on the road and was later engulfed with fire.

Figure 2: the wreckage laying across the road after hitting power lines.
