**Accident Reference: ACCID 013022/01-01**

## **Aircraft Accident Investigation Final Report**

**JABIRU 2 V5-UZI**

**DESCRIPTION OF OCCURRENCE:** (LOC-G) Loss of control on ground.

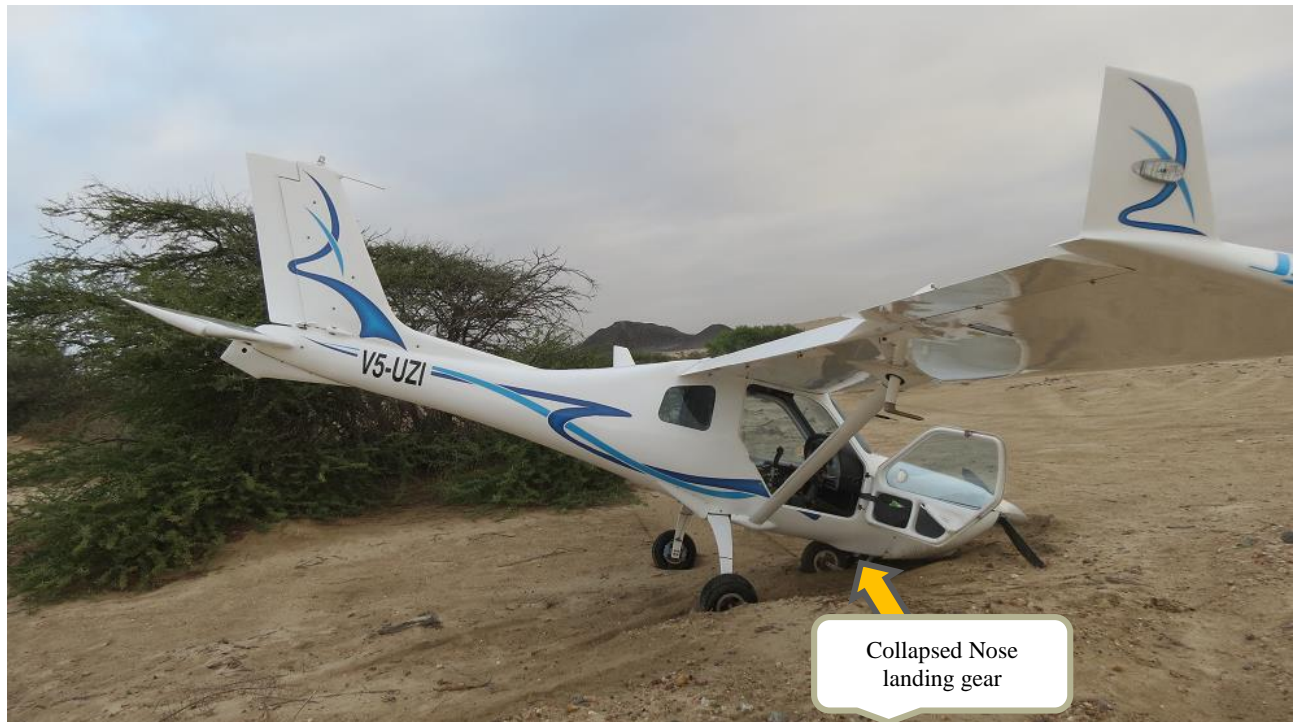
- 1.1.3 The soft wet sand caused the landing gear to collapse.
- 1.1.4 The aircraft was substantially damaged. The pilot sustained minor injuries, the passenger sustained fractures and was taken to the hospital for treatment.

#### 1.3.1 The aircraft sustained minor damage.

*Figure 1: The aircraft as it came to rest.*

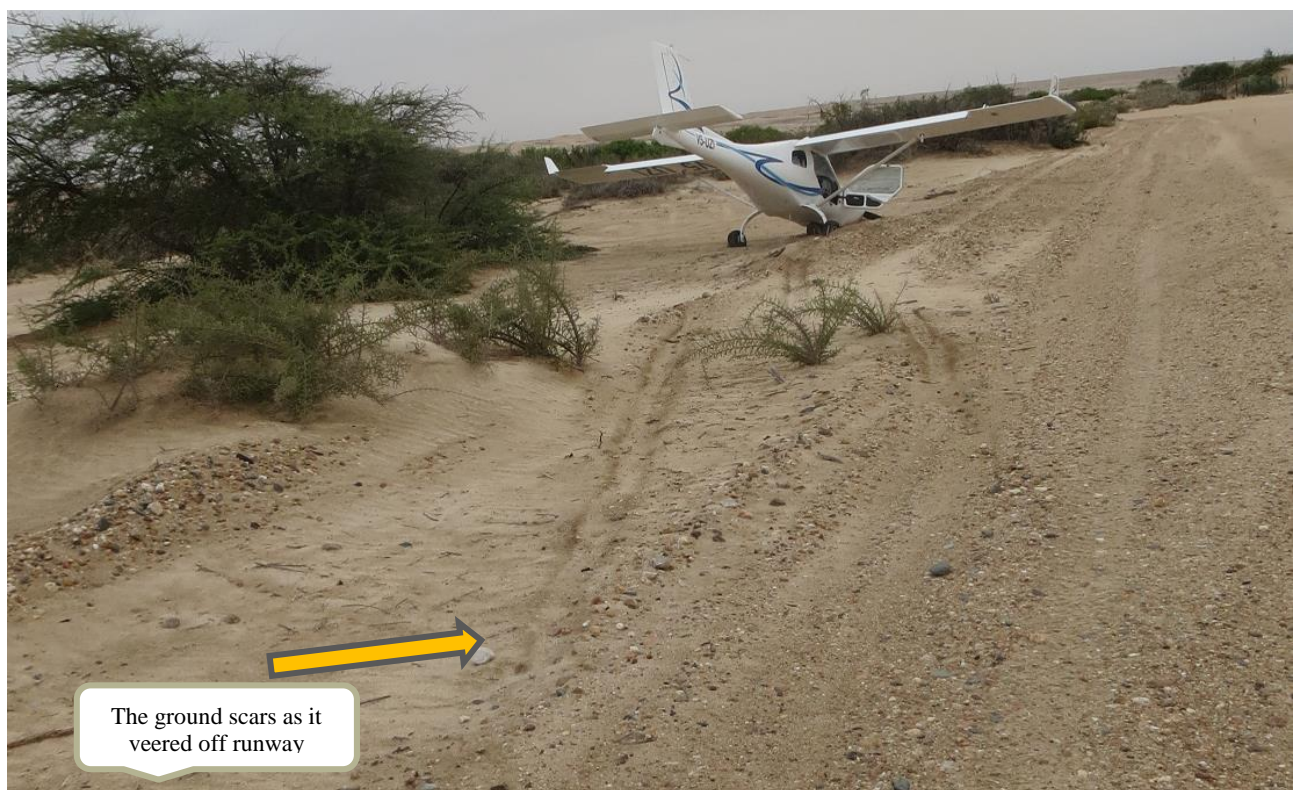
*Figure 2: The aircraft as it veered off the runway into wet sand.*

The aircraft encountered severe crosswind gust that pushed the experimental built light aircraft to the left, forcing it to lose directional control. The aircraft then veered off the runway into the soft desert sand which had received some rain the previous day. This caused the aircraft to stop abruptly collapsing the front gear.

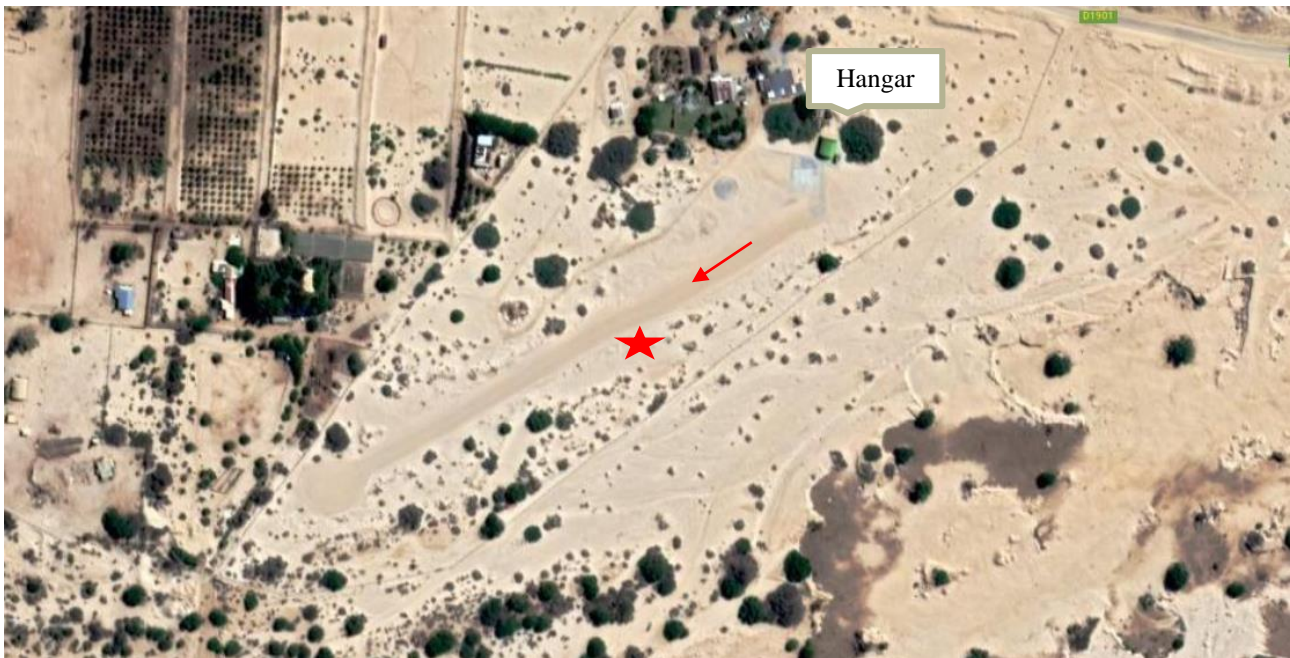
*Figure 5: Private aerodrome indicating direction and point of impact (Google earth).*
