Ministry of Works and Transport				INCID/04/2019/01-05	
	DIRECTORATE OF AIRCRAFT ACCIDENT INVESTIGATION INCIDENT REPORT – EXECUTIVE SUMMARY					
Aircraft Registration	V5-WAC	Date of Incident	20 th April 2019	Time of Incident	10:11 UTC	
Type of Aircraft	CESSNA 404	Type of Operation	Charter			
Pilot- In - command License Type	CPL	Age	23	License Valid	valid	
Pilot-In-command Flying Experience	Total Flying Hours	1500	Hours on Type	230		
Last point of departure	FYAR (Arandis airfield)					
Next point of intended landing	Mowe bay					
Location of the accident site with reference to easily defined geographical points (GPS readings if possible)						
S 22° 13' 14 & E 14° 14'39'						
Meteorological Information	Wind Direction: Northerly, Wind speed: 4-8 kt, Visibility: Good, Temperature: Unknown Cloud cover: OVC, Cloud base: CAVOK, Dew point: Unknown					
Number of people on board	1+8	No. of people injured	0	No. of people killed	0

AIRCRAFT INCIDENT REPORT

Name of Owner/Operator : Westair Aviation (Pty) Ltd
Manufacture : Cessna
Model : 404
Nationality : Namibian
Registration : V5 - WAC
Location : Arandis airfield
Date : 20th April 2019
Time : 10:11

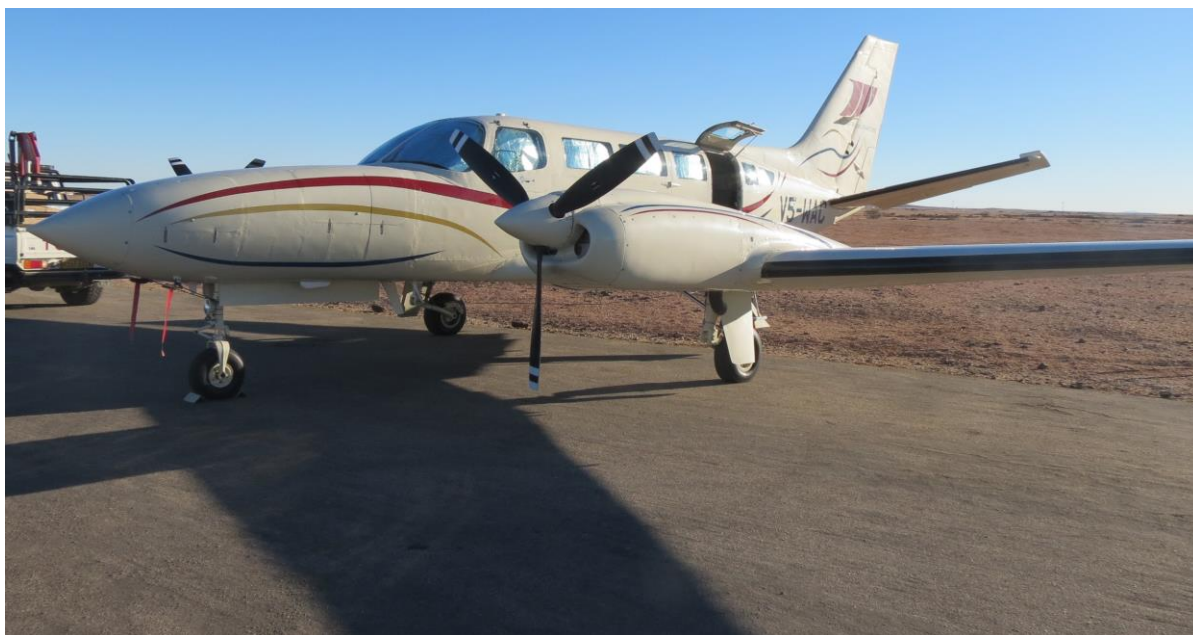
Figure 1: Aircraft after landing safely and parked at designated area. FYAR

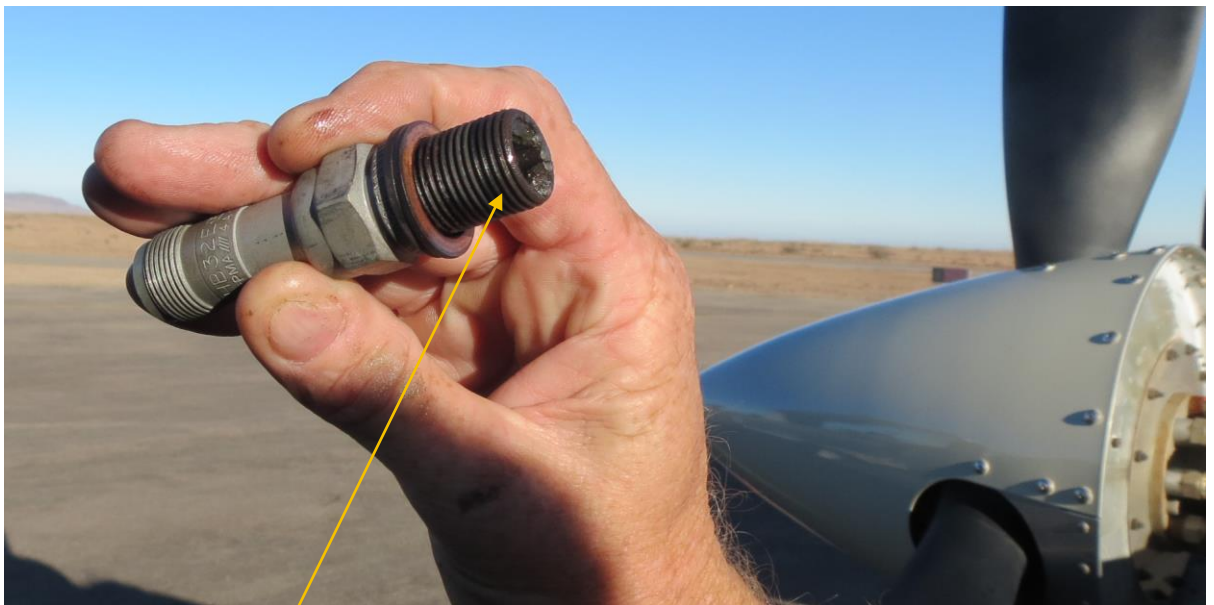
The aircraft landed safely with no visual damage. However initial field investigation showed evidence of metal deposits on the No.2 spark plug.

Figure 2. Metal deposits on the No.2 spark plug.

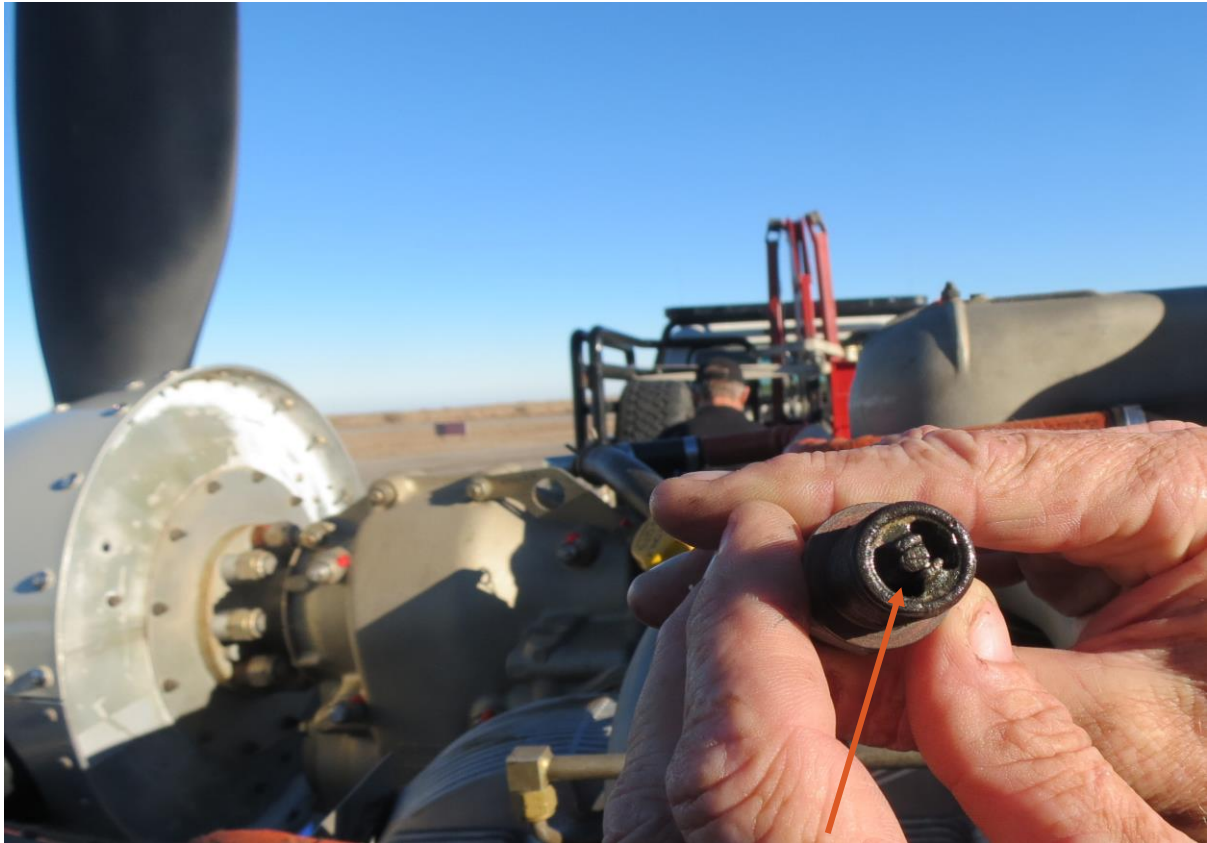
Figure 3. Grounded Spark Plug Electrodes on No.2 cylinder of the right engine.

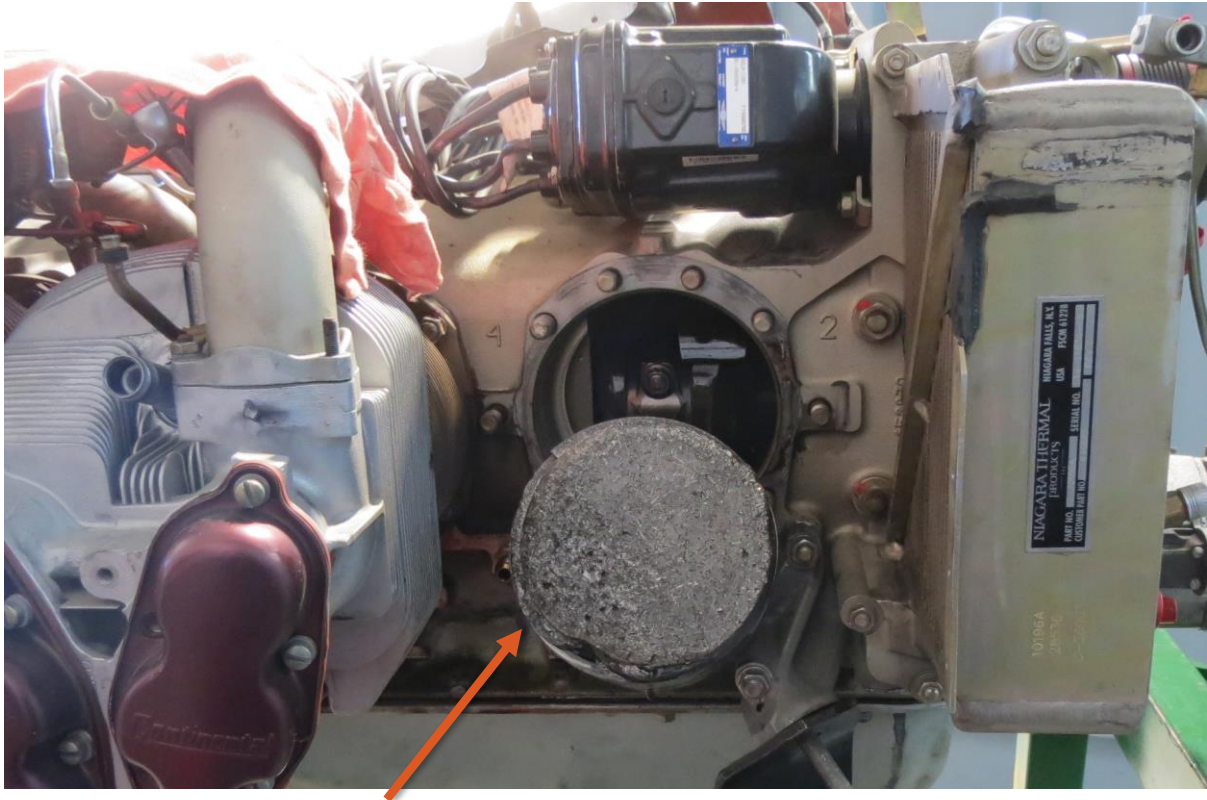
1.16.2. All cylinders were removed sequentially and pistons examined. The number two piston exhibited substantial wear and the upper piston ring was found badly damaged which resulted into a piston failure.

Figure 3. Piston no.2 exhibiting substantial wear.

- 3.3.1 Piston failure in No.2 Cylinder on the right engine due to undetermined factors.

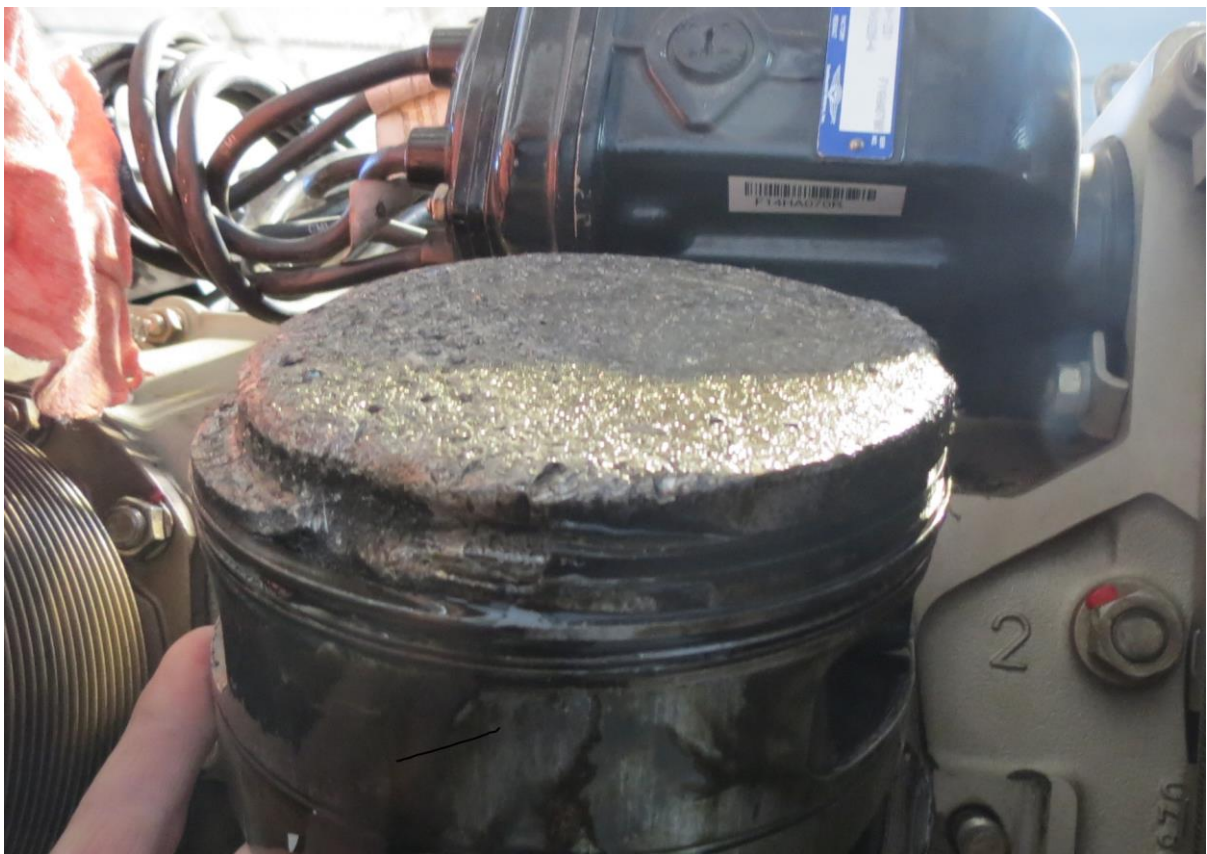
Figure 4. A close up view of the excessive heat damage on the piston head

1.18.1 Piston failure can be attributed to many factors, one of it being detonation. Detonation is the abrupt combustion or explosion of the fuel charge inside the cylinder¹
