CIVIL AIRCRAFT ACCIDENT REPORT

ACCID/050523/01-04

**AIRCRAFT
REGISTRATION : V5-WOT**

AIRCRAFT TYPE & REGISTRATION: C182 (V5-WOT)

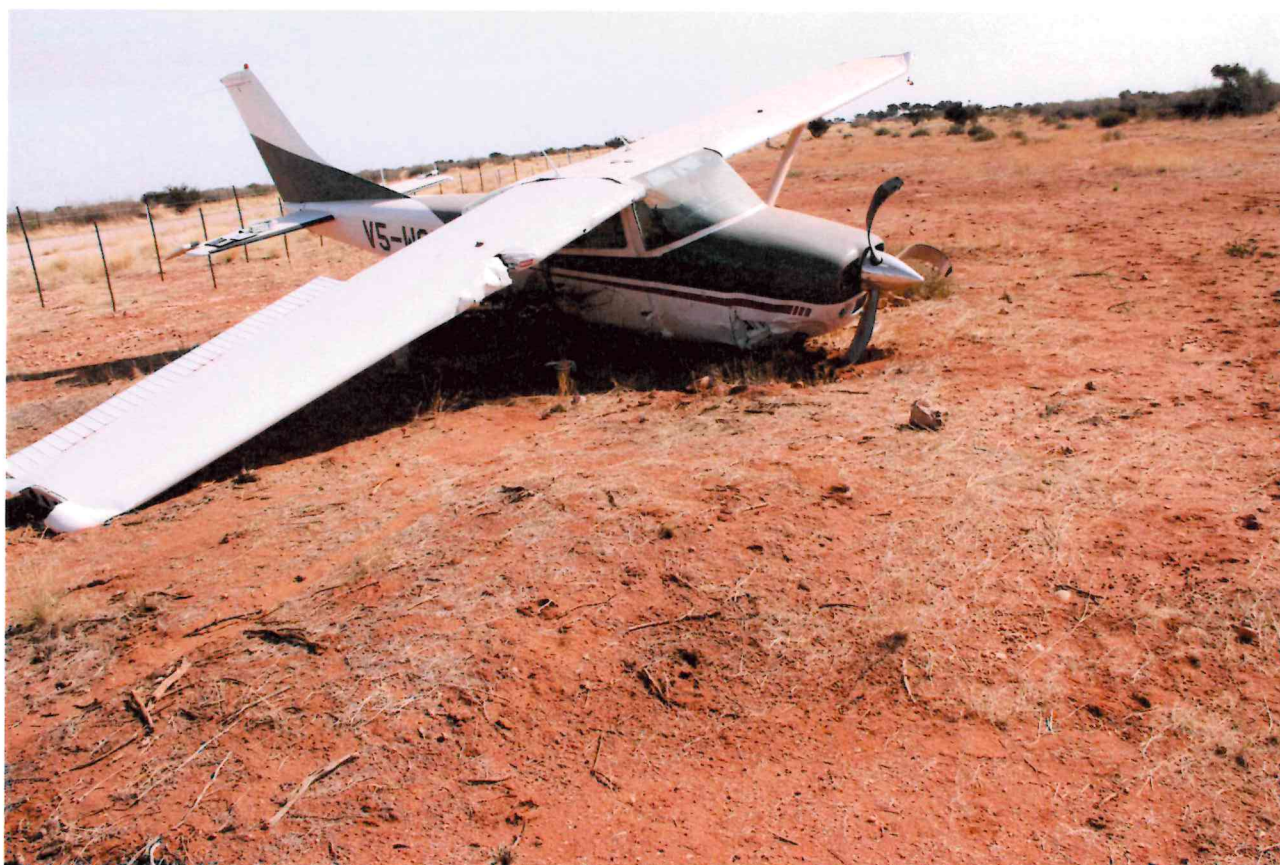
- 1.1.4 On final approach for runway 01 just before touched down the aircraft experienced severe windshear from the left (west) that lifted the aircraft from the runway over the fence where it crashed.
- 1.1.5 The aircraft first stroked a shepherd tree, uproot the tree, and dragged it for about 15 meters before struck another tree and came to rest facing 90 degrees from the direction of flight. The aircraft was substantially damaged but the pilot and the passenger did not sustained any injuries.

The aircraft was substantially damaged.

Figure 1: Damage to the lower fuselage, undercarriage, propeller and the wings.

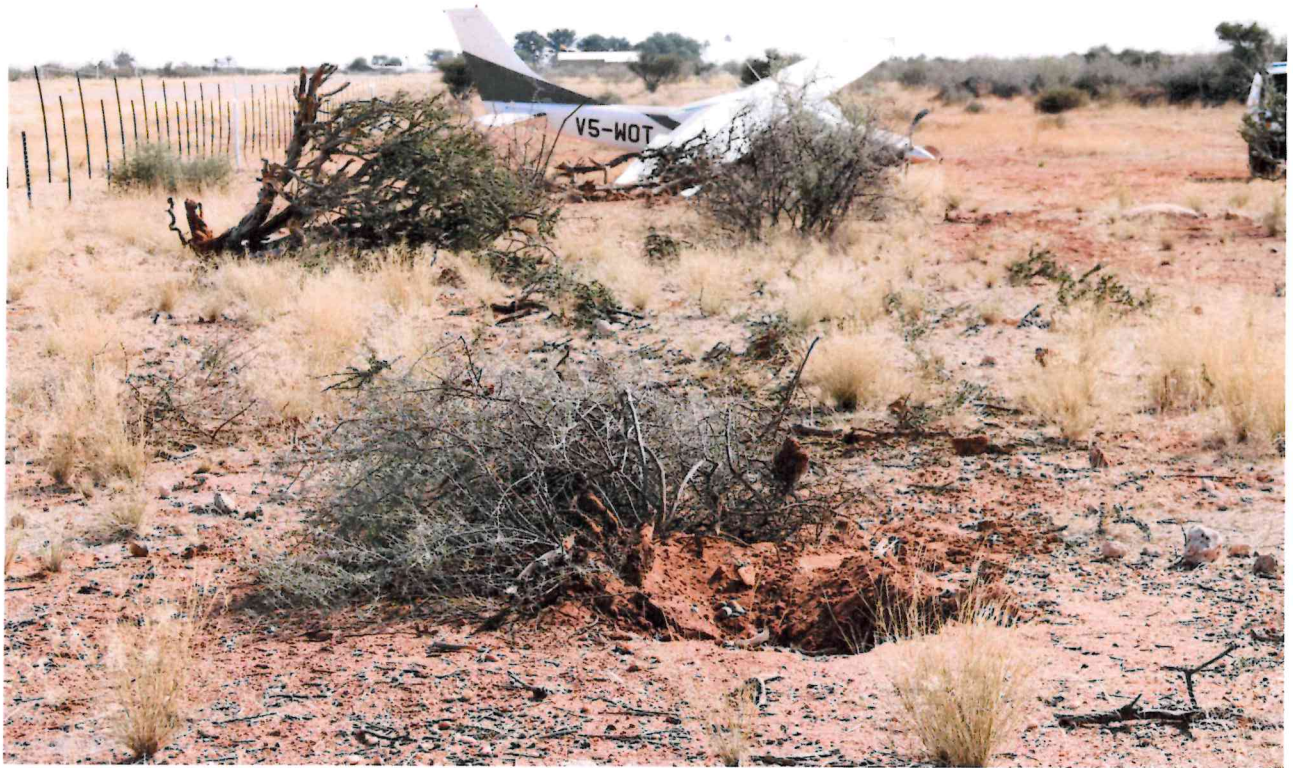
1.4.1 There was damaged to two shepperd trees.

Figure 2: Damage to the two shepperd tree..

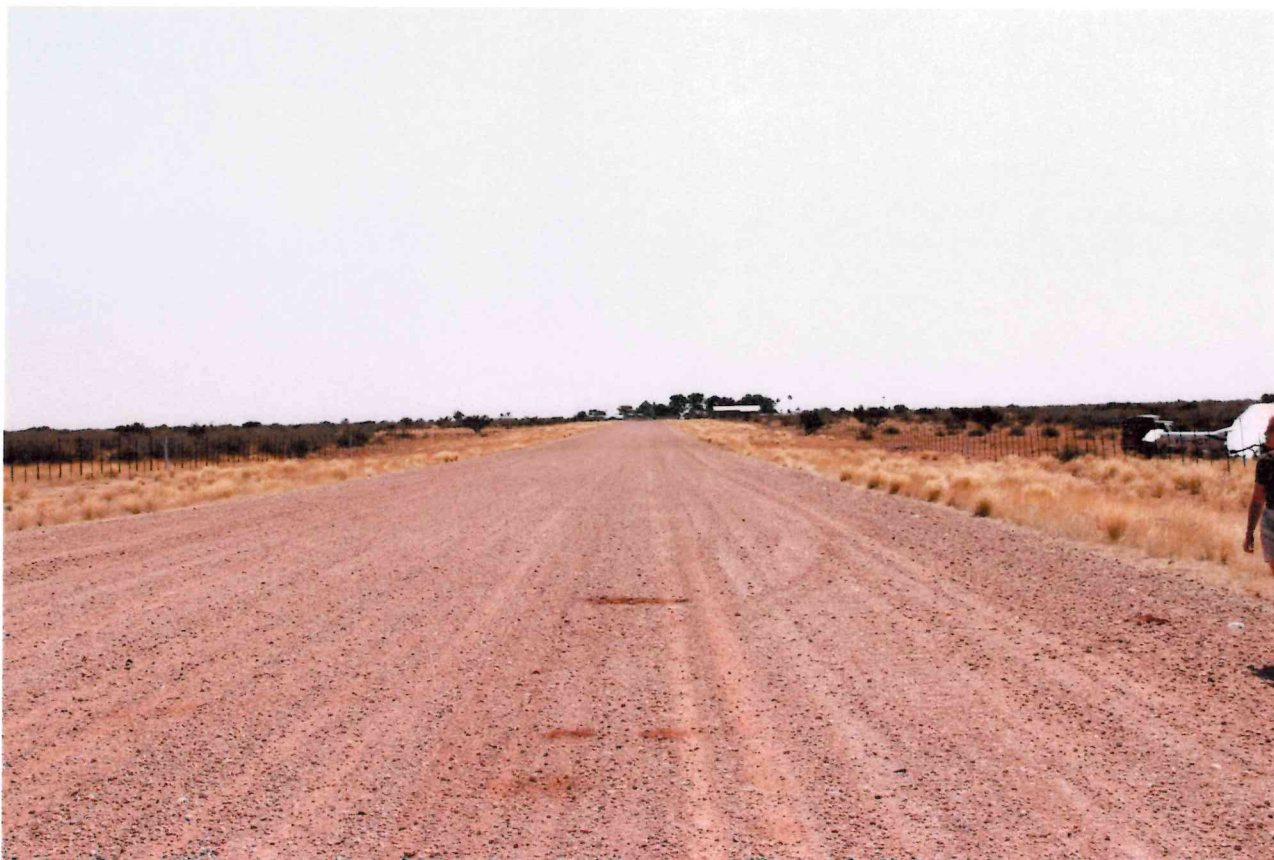
The aerodrome is at an elevation of 3897 ft above sea level. There is a gravel runway 01/19 measuring 1.6 km and 16 meters wide. There are two wind socks on the airstrip the main one is located midway of the runway and the other close to the hangar. The runway is fenced off with a two meter animal proof fence.

Figure 3 : Lapa lange airstrip.
