REPUBLIC OF NAMIBIA

Directorate of Aircraft Accident and Incident Investigations

Aircraft Accident Investigation Final Report

Robinson R44 Raven II: ZS-HLG

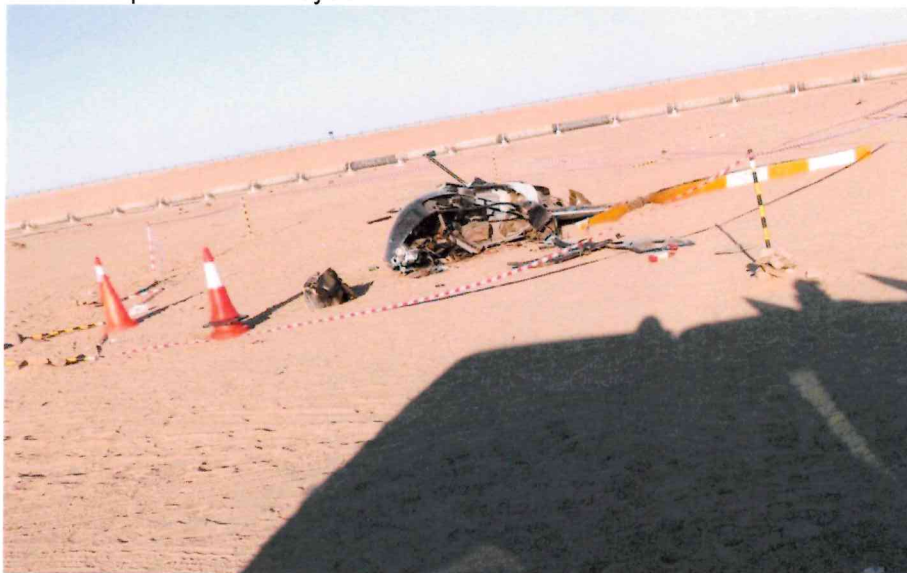
1.3.1 The helicopter was destroyed.

Figure 3: Picture showing the destroyed Helicopter as it came to rest.

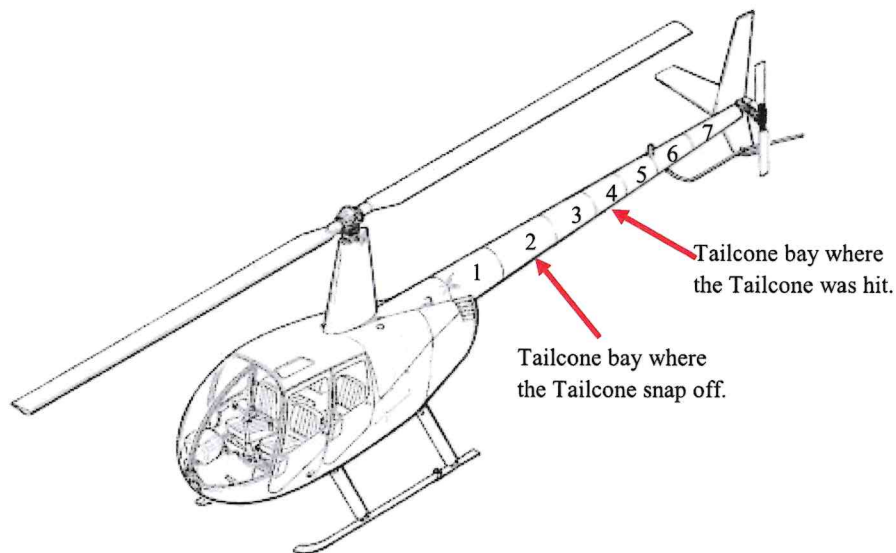
- 1.12.1. The Helicopter experienced an inflight break-up when one of the Main Rotor (MR) blades hit the tailcone causing it (tailcone) to detach from the main fuselage. The MR blade (red) hit the tailcone at the No. 4 tailcone bay, however the tailcone separated at the No. 2 bay. The left side of the number 1 and 2 tailcone bays were flattened inward.

Figure 8: Drawing shows where the tailcone was strike and where it detached from the helicopter.

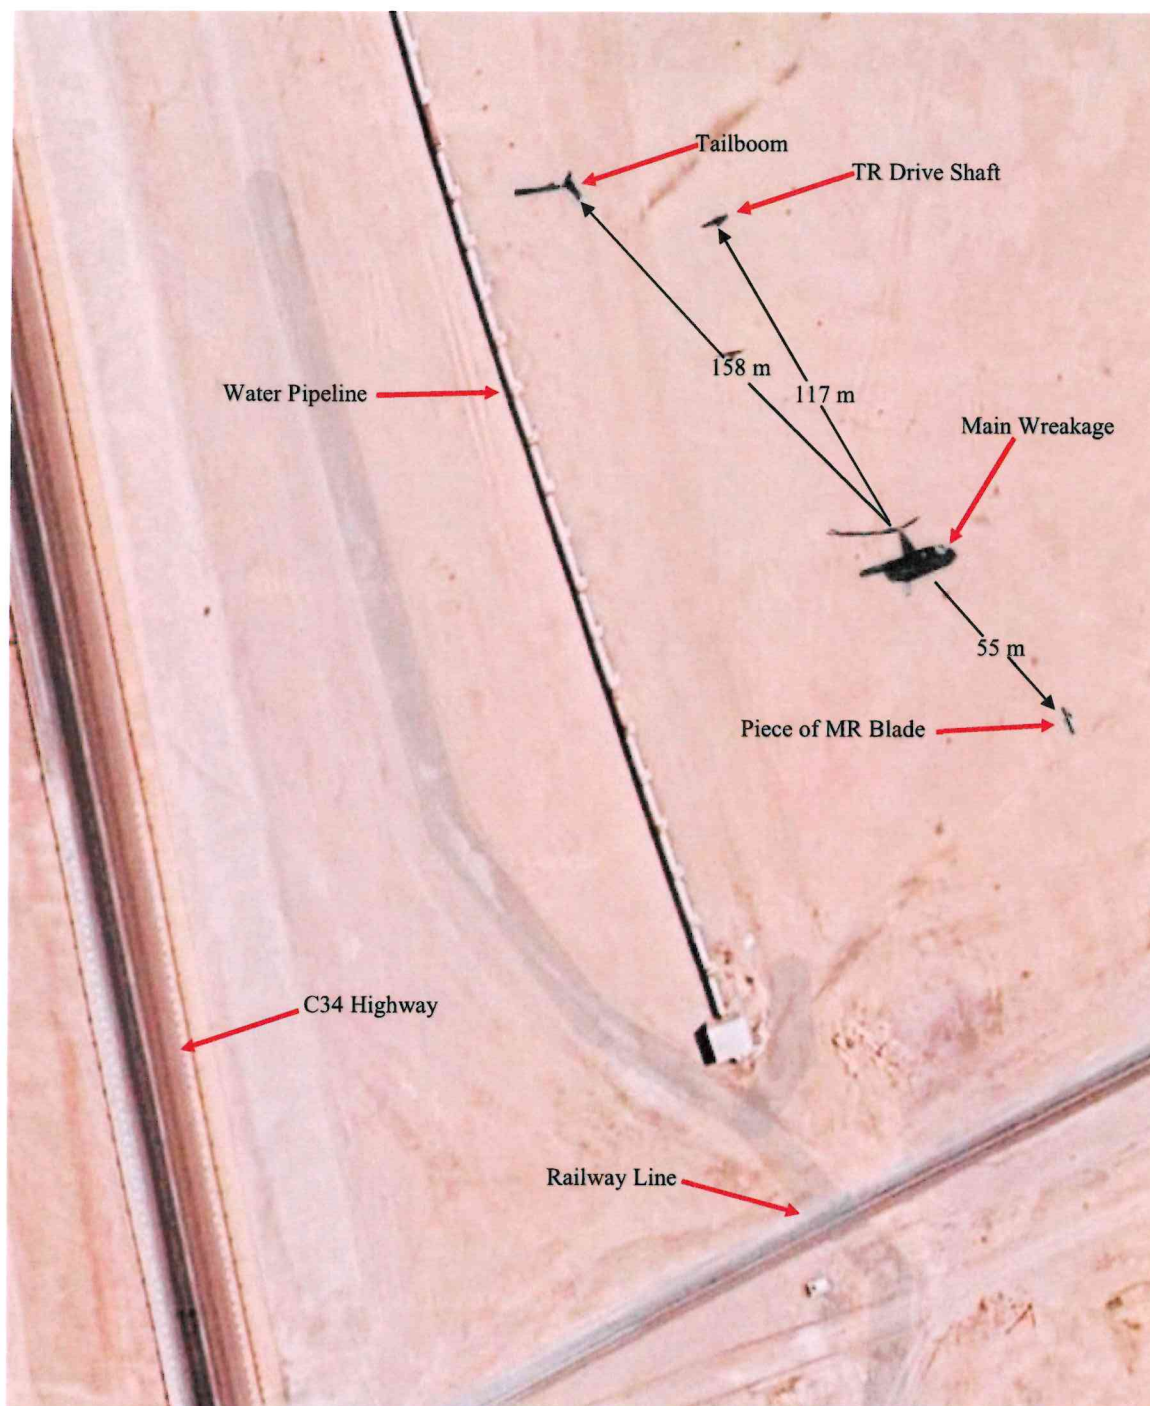
- 1.12.2. The helicopter came spiraling down to the ground and impacted the ground on the left side at a high velocity.
- 1.12.3. The tailcone was found 158 m from the main wreckage, the TR drive shaft was found 117m from the main wreckage. A 3,56 m section of the Red MR blade that hit the tail was found 55 m away from the main wreckage. Plexiglas sections were found throughout the debris field.
- 1.12.4. The instrument panel was found in front (nose section) of the helicopter.
- 1.12.5. Pieces of the landing skid were found close to the main wreckage, consistent with being still attached to the helicopter on impact.
- 1.12.6. When the helicopter hit the ground, the impact was so severe that the main cabin was compressed. The helicopter was destroyed.

Figure 9: Picture shows how the Wreckage was distributed (Illustration).

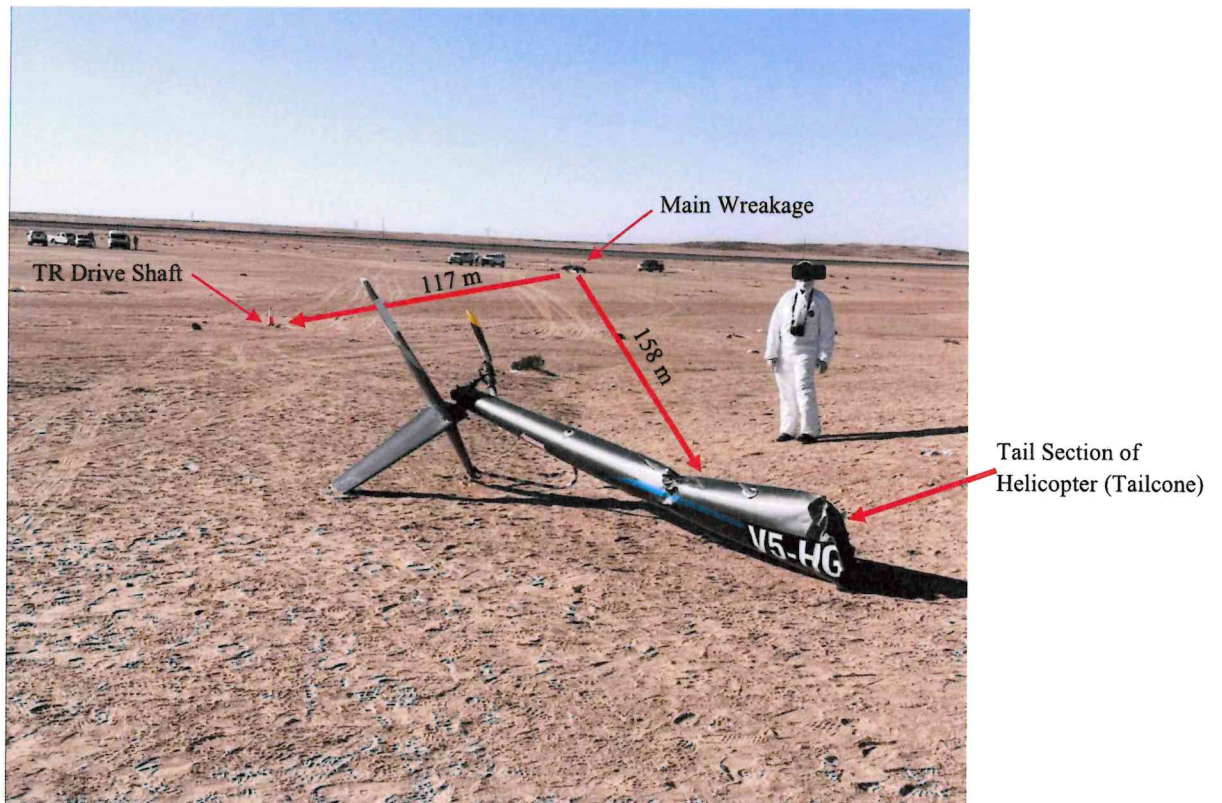
Figure 10: Picture showing how far the tailcone landed away from the main wreckage.

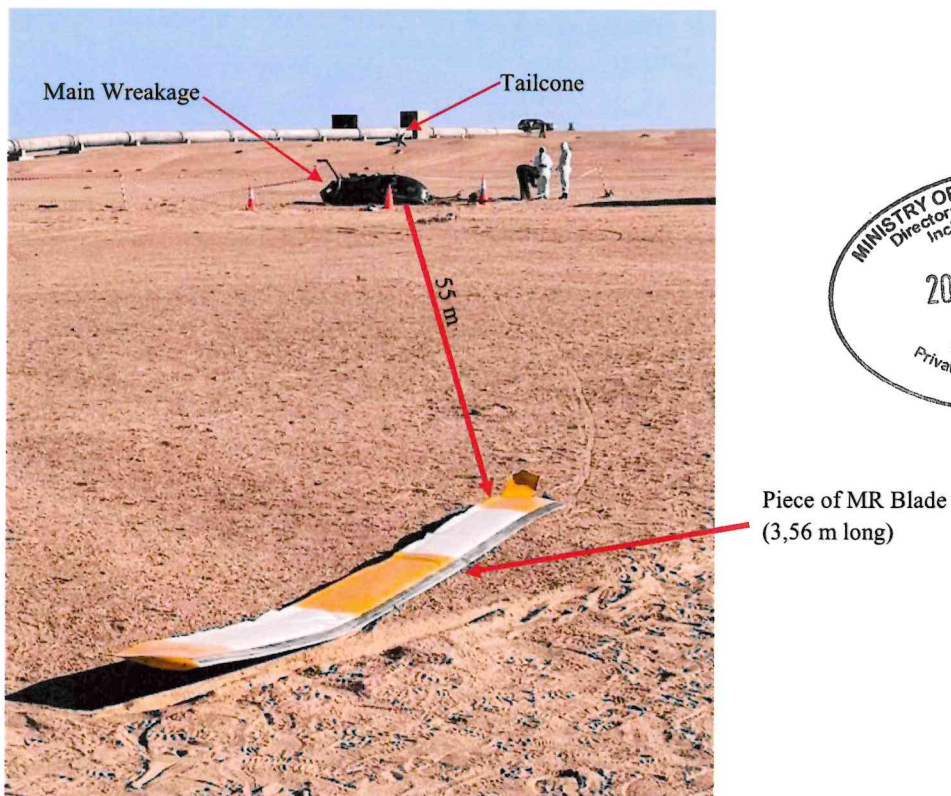
Figure 11: Picture showing how far the piece of the Red Main Rotor Blade landed away from the main wreckage.

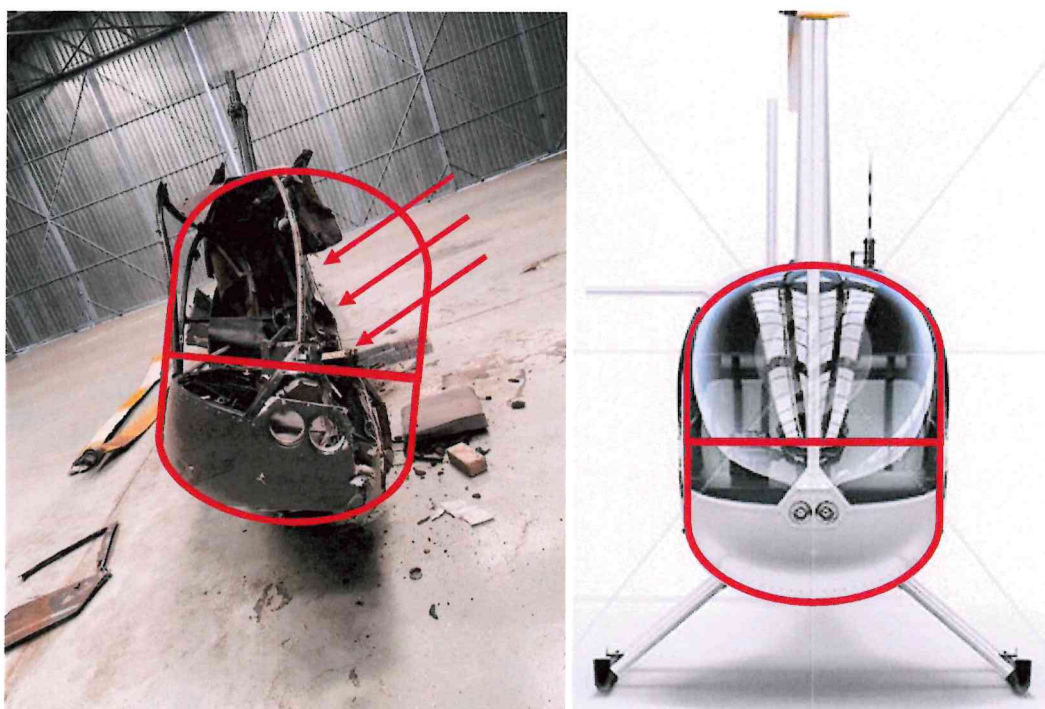
Figure 12 & 13: Picture showing how the main cabin is compressed, red indicates the actual size of the helicopter.

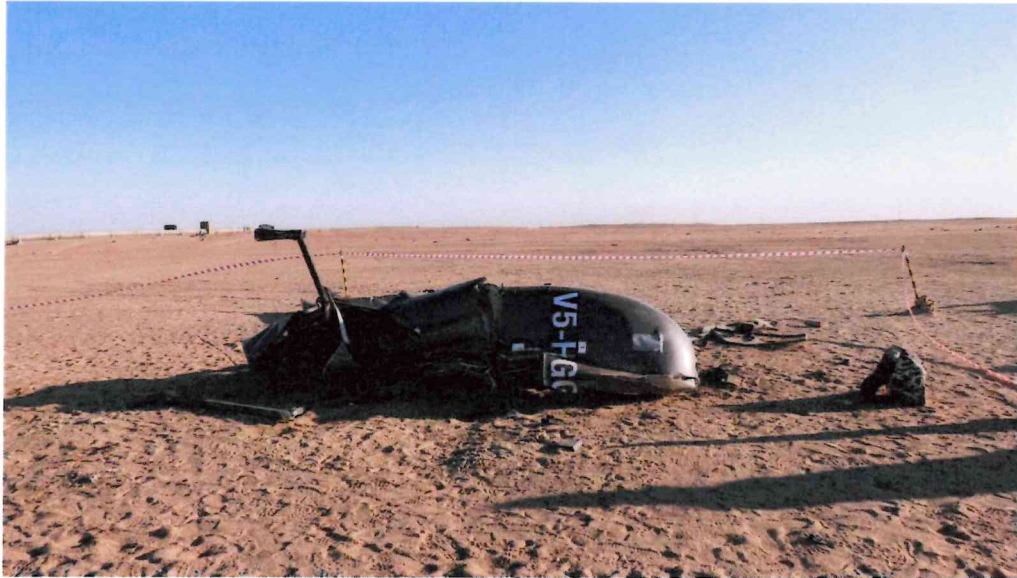
Figure 14: Picture showing how the main cabin is compressed.

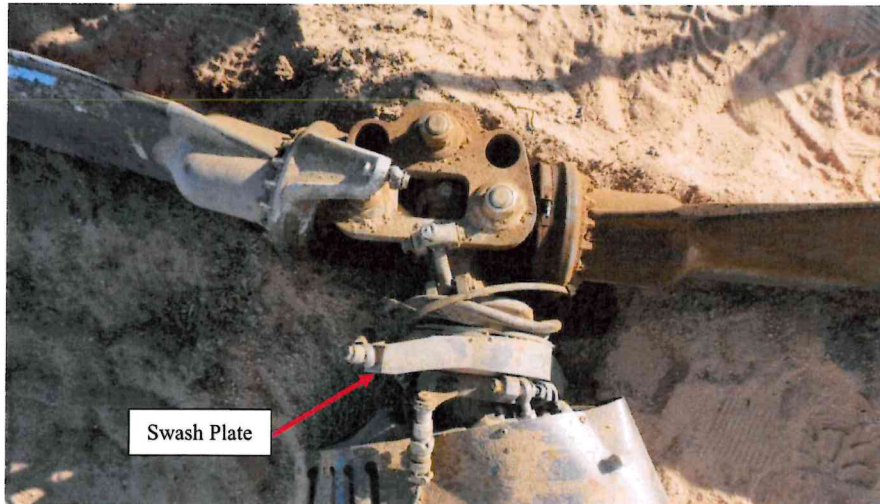
1.16.1.3. Swashplate: On site investigation found that the rotating swashplate was rotated 180° from its normal position. The rod end on the Fork Assembly was also fractured. The swashplate was removed, inspected and was found to be lubricated. The presence of grease was found in the in-closure. The bearings were not ceased as the swashplate could easily be rotated by hand and no rough or dry bearings was found.

Figure 15: Picture showing the swashplate rotated 180° from its normal position.

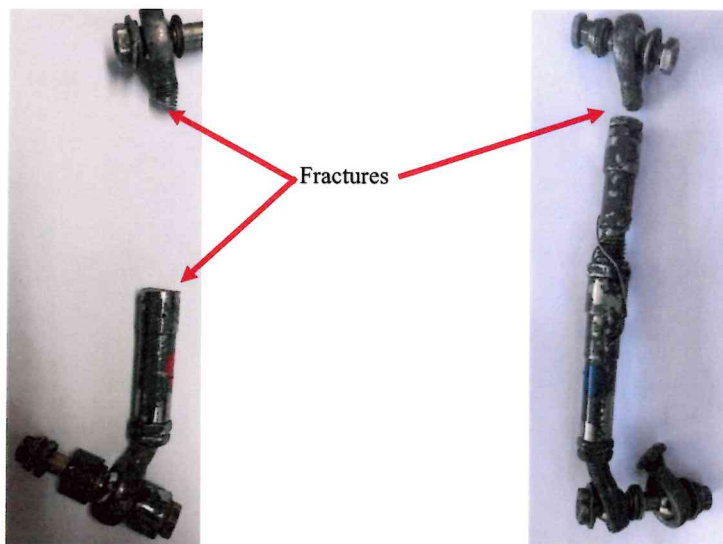
- 1.16.1.4. Pitch Links (Part Number: C258-1). The one Pitch Link (blue) was fractured at the upper rod end and was relatively straight, while the other Pitch Link (red) was fractured at the upper rod end and in the middle of the Link. The missing piece of the red Pitch Link could not be found.

Figure 17 and 18: Pictures showing the two pitch links that was on the helicopter (Red left and blue right)

- 2.2.2. Data gathered during the investigation concluded that both Pitch Links failed due to overstress, however it is likely that the red pitch link failed first after the MR blade (red) clipped the windshield, causing the MR blade (red) to lift suddenly then tilt to the side and dive. The sudden dive of the Red MR blade caused the top side of the blade to make contact with the tailcone. After the MR Blade struck the tailcone, it (the tailcone) detached from the helicopter. The helicopter then spun out of control and fell to the ground.

1.18.1. During the 12-year inspection the Robinson Helicopter Company Manual states that the C258-1 Pitch Link Assembly should be replaced with the new C258-5 Pitch Link Assembly. See Appendix A for the full page of the Manual.

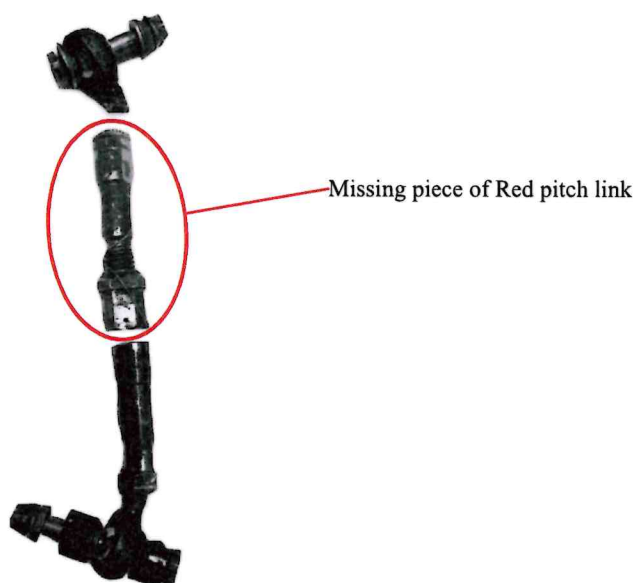
Figure 19: Picture shows how the missing piece of Red pitch link look like (Illustration).

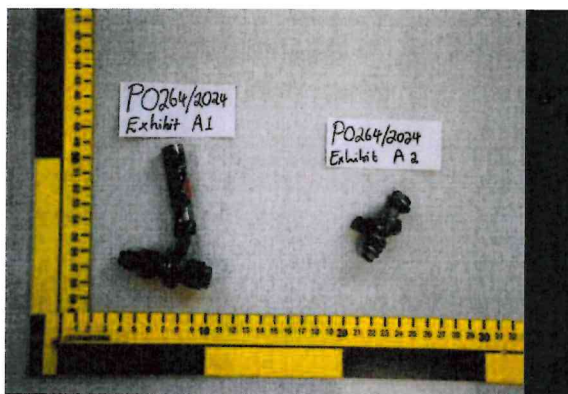
- No significant corrosion/ rusting was observed on both Pitch Link Assemblies (Exhibits A1, A2, B1 and B2).

Figure 20: Picture shows the Red Pitch Link, Exhibits A1 and A2.

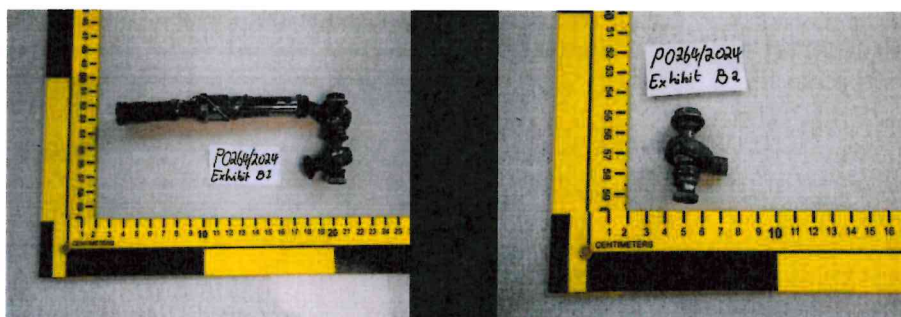
Figure 21 and 22: Picture shows the Blue Pitch Link, Exhibits B1 and B2.

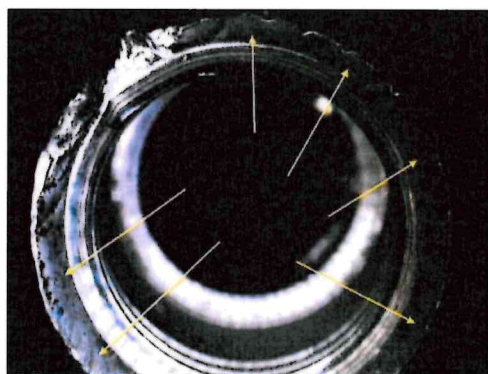
- Chemical analysis on the surface and inner circumference indicated that ratio (by weight) of Iron to Oxygen was very high in favour of Iron (the ratio of Oxygen to Iron in typical corrosion is 1.5 to 1 in favour of Oxygen. In heavy corrosion Oxygen to Iron ratio is 1.7 to 1, in favour of Oxygen). This is an indication that corrosion/rust was very minimal on all exhibits.
- In consideration of the above, it was possible to infer that:
 - Strong evidence indicated that Exhibits A1, A2, B1 and B2 failed due to sudden overstress (relatively straight shear lip patterns, relatively flat, smooth pattern, with no significant striation on the inner circumference).

Figure 23: Picture shows smooth pattern with no significant striation on the inner circumference of Exhibit A1 (Red Pitch Link)

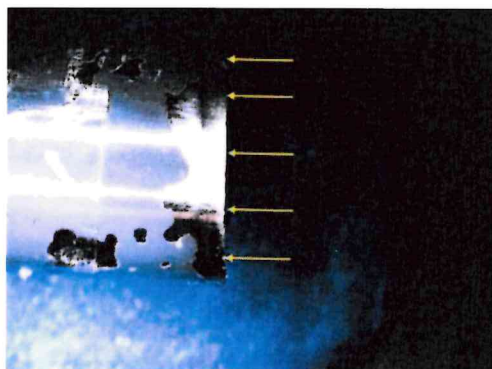
Figure 24: Picture shows straight shear lip pattern on Exhibit A1 (Red Pitch Link)

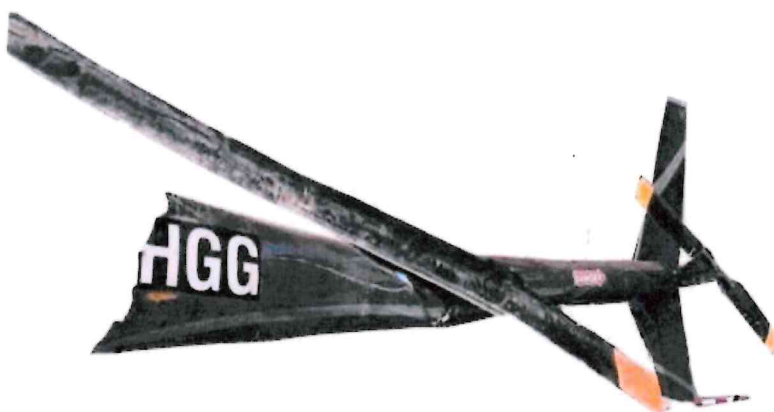
Figure 27: Image shows how the MR blade made contact with tailboom (Illustration).

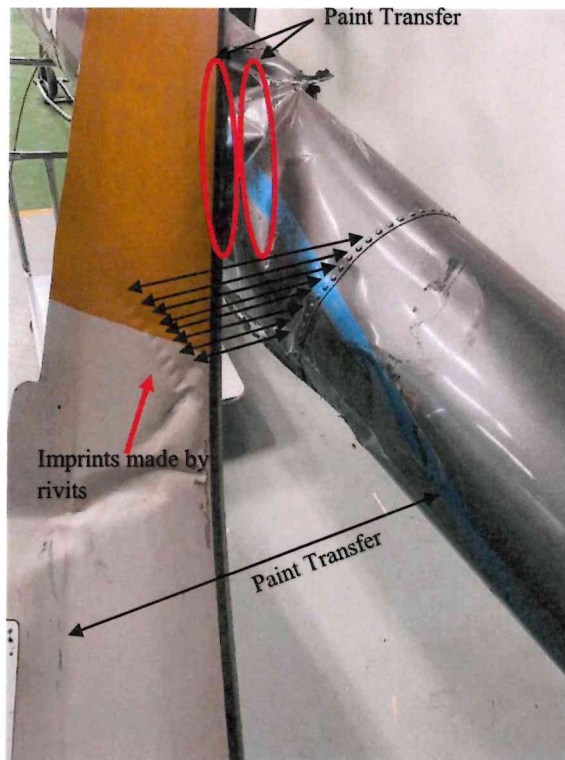
Figure 28: Image shows transfer marks. Top part of main rotor blade and tailboom

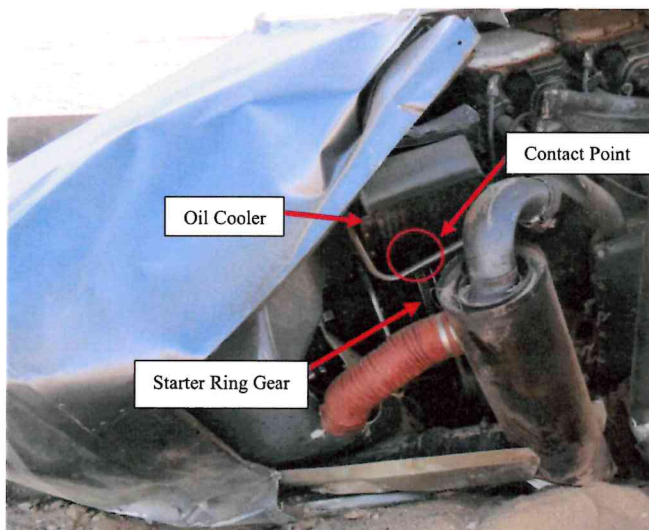
- 2.2.3. When the helicopter impacted the ground, the engine was not working. This was evident from the teeth imprints made by the starter ring gear on the oil cooler on impact. If the engine was working, grinding marks would have been visible instead. The engine likely stalled when the pilot entered the auto-rotation by rolling the throttle to idle (possibly “chopping” the throttle) resulting in stoppage of the engine

Figure 29: Picture shows the contact point of the Oil Cooler and Starter Ring Gear.

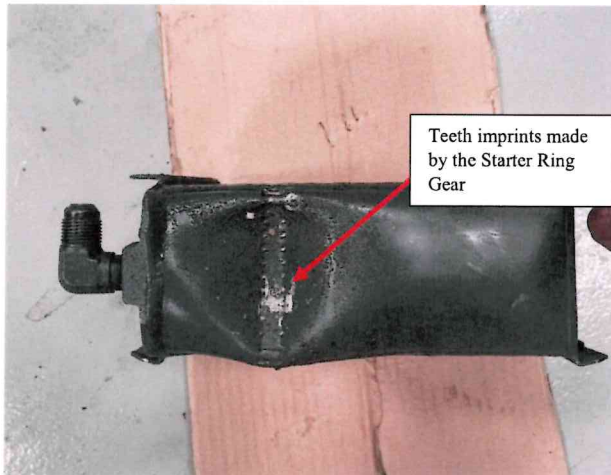
Figure 30: Picture shows the teeth imprints made by the Starter Ring Gear on the Oil Cooler.
