Accident Reference: ACCID/110322/02-06

Aircraft Accident Investigation Final Report

CIRRUS SR22 ZS-PVW

Runway Excursion at Okahirongo river lodge Airstrip RWY 01

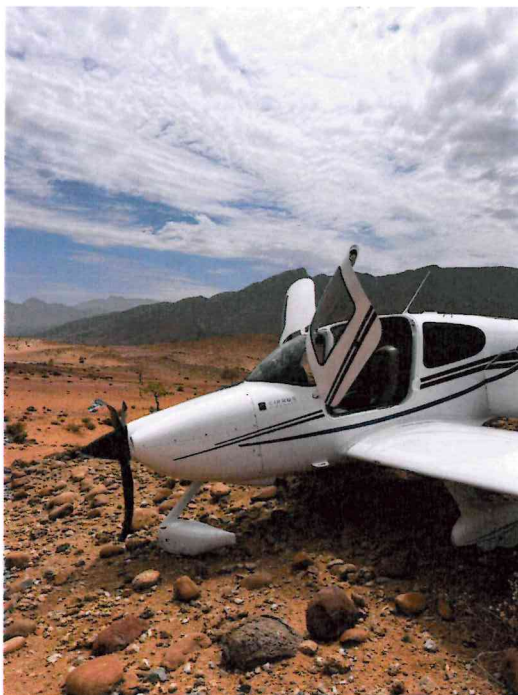
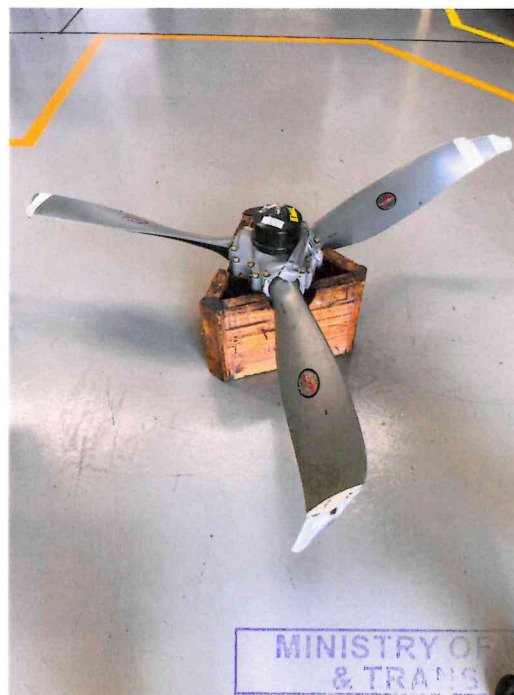
- 1.1.5 After overrunning the runway, the aircraft rolled down a steep embankment beyond the Northern threshold and came to a full stop approximately 10 meters from the Runway end (Threshold 19). The propeller stroked the ground and rocks when the aircraft went off the Runway.

- 1.3.1 The Aircraft sustained slight damage, however the propeller, nose gear strut (small crack) and the wheel fairings were damaged during the accident.

Figure 2 and 3: Pictures shows how the propeller was damaged.

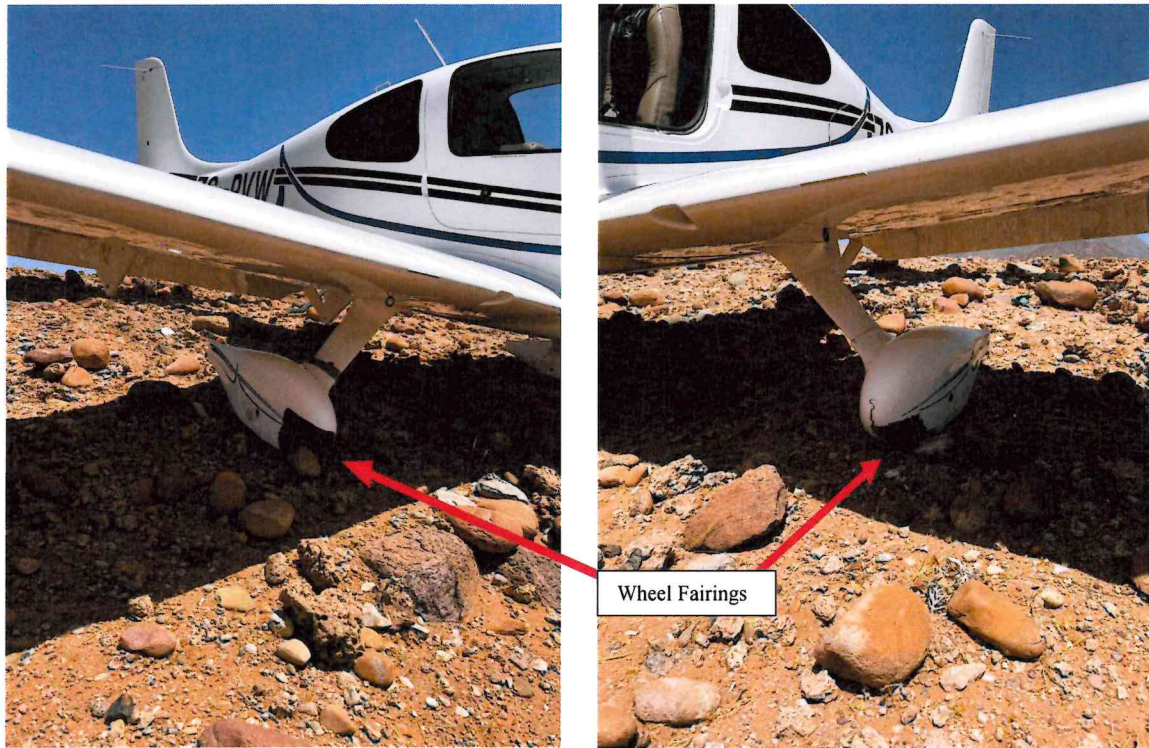
Figure 4 and 5: Pictures shows the damaged wheel fairings.

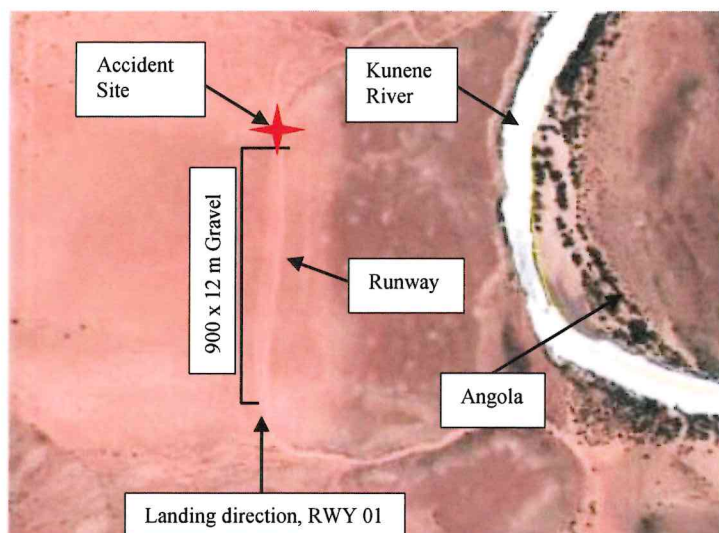
Figure 6: Okahirongo River Lodge Airstrip (Source: Google Earth)

RWY has moderate sized rocks. Keep pressure off nose wheel.
Beware of high terrain on the east and west of RWY. Downslope towards the south.
Animals and humans moving freely.
Make sure aircraft is locked.

Accessible by C210 (weight restricted) and C208
Airfield is not clearly visible from the air.
RWY clearly marked with tyres and rocks, however due to narrow RWY, these can be hazardous. Slight bumps and ditches
Concrete Run-up pad, good condition
RWY slope up from South. Land from South (RWY 01).
RWY lose gravel, bumpy. NO cellphone reception.

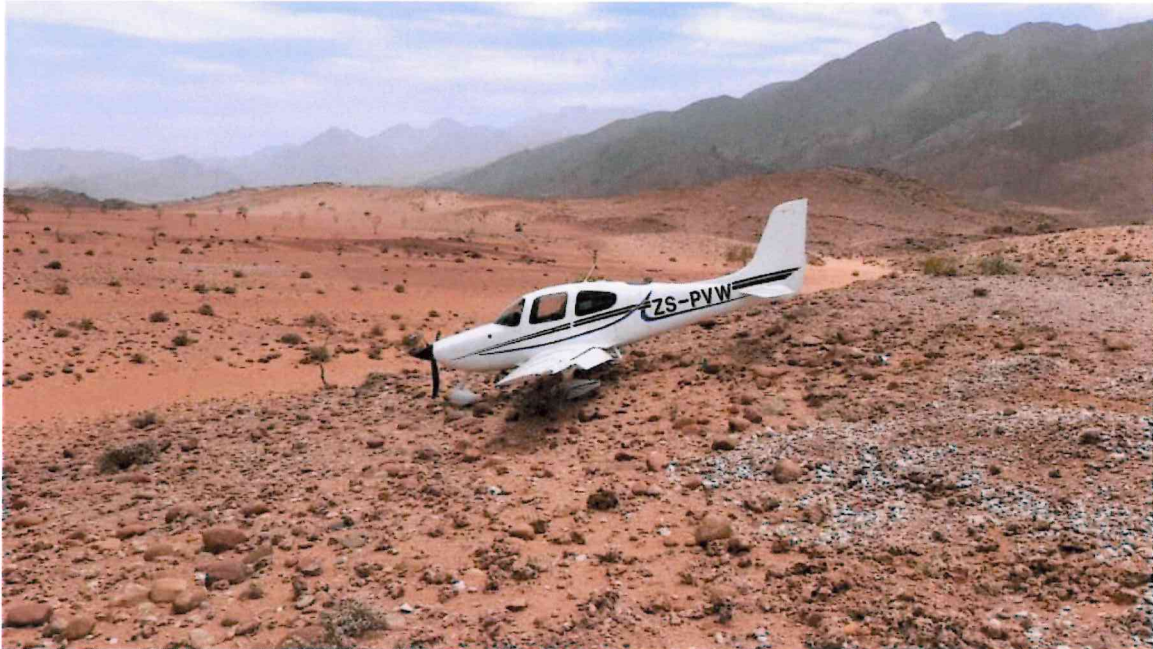
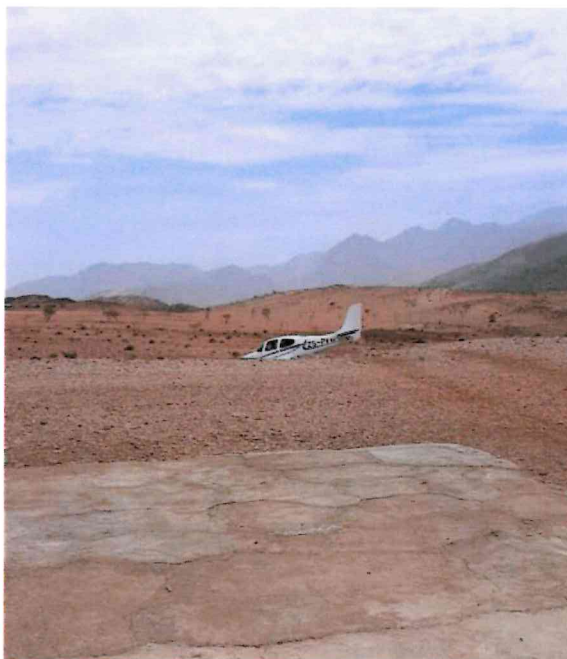
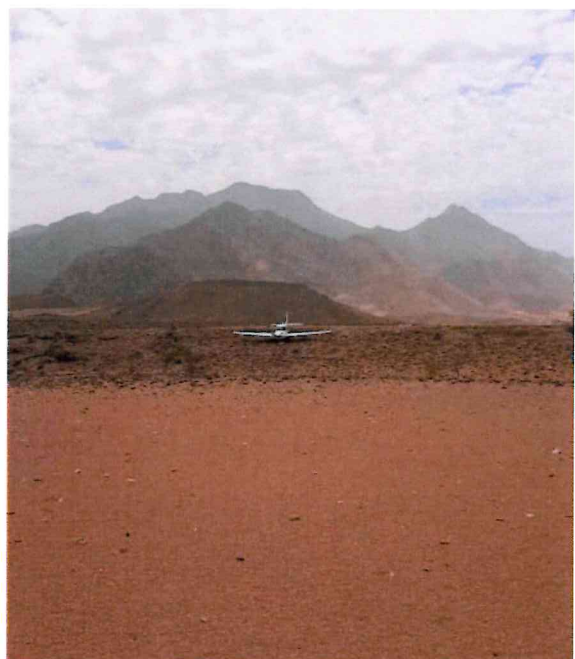
The aircraft remained intact. After overrunning the RWY, the aircraft came to a full stop approximately 10 meters from the end of the runway.

Figure 7, 8 and 9: Pictures showing where the aircraft came to a full stop.
