## **REPUBLIC OF NAMIBIA**

### **CIVIL AIRCRAFT INCIDENT REPORT**

INCID/111013/01-02

<b>OPERATION</b>	: Scheduled International Flight
<b>AIRCRAFT</b>	: ZS-SXY
<b>LOCATION</b>	: Hosea Kutako International Aerodrome
<b>DATE</b>	: 11 <sup>th</sup> October 2013

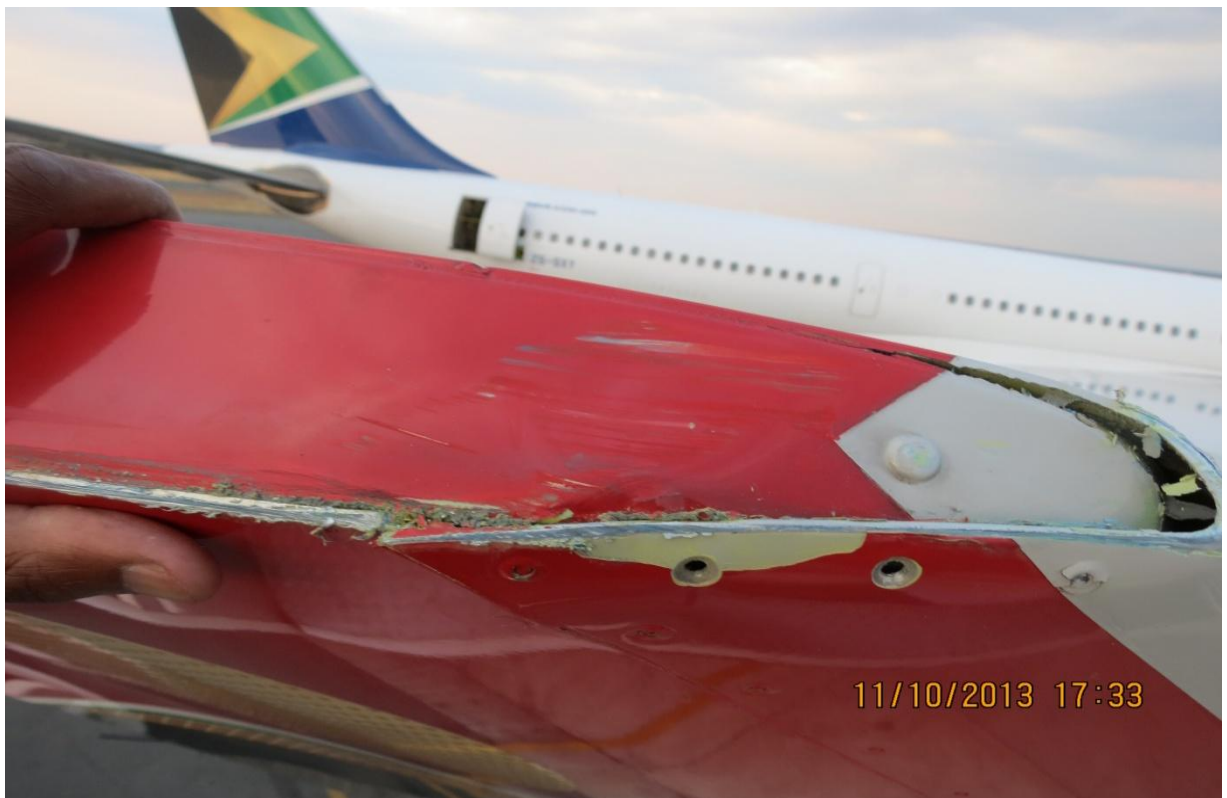
- 1.1.5 There were no injuries to the crew, passengers or anyone else on the ground, however both aircraft sustained slight damages on the wingtips (see attached figure 1& 2) ZS-SXY underwent temporary repairs and was safely dispatched, while V5-ANO was dispatched in accordance with Airbus's Configuration Distribution List (CDL-57-02) where the winglet was removed for subsequent repairs.

- 1.3.1 ZS-SXY A332 sustained slight damage on the right winglet.

Figure 1: Right winglet damage

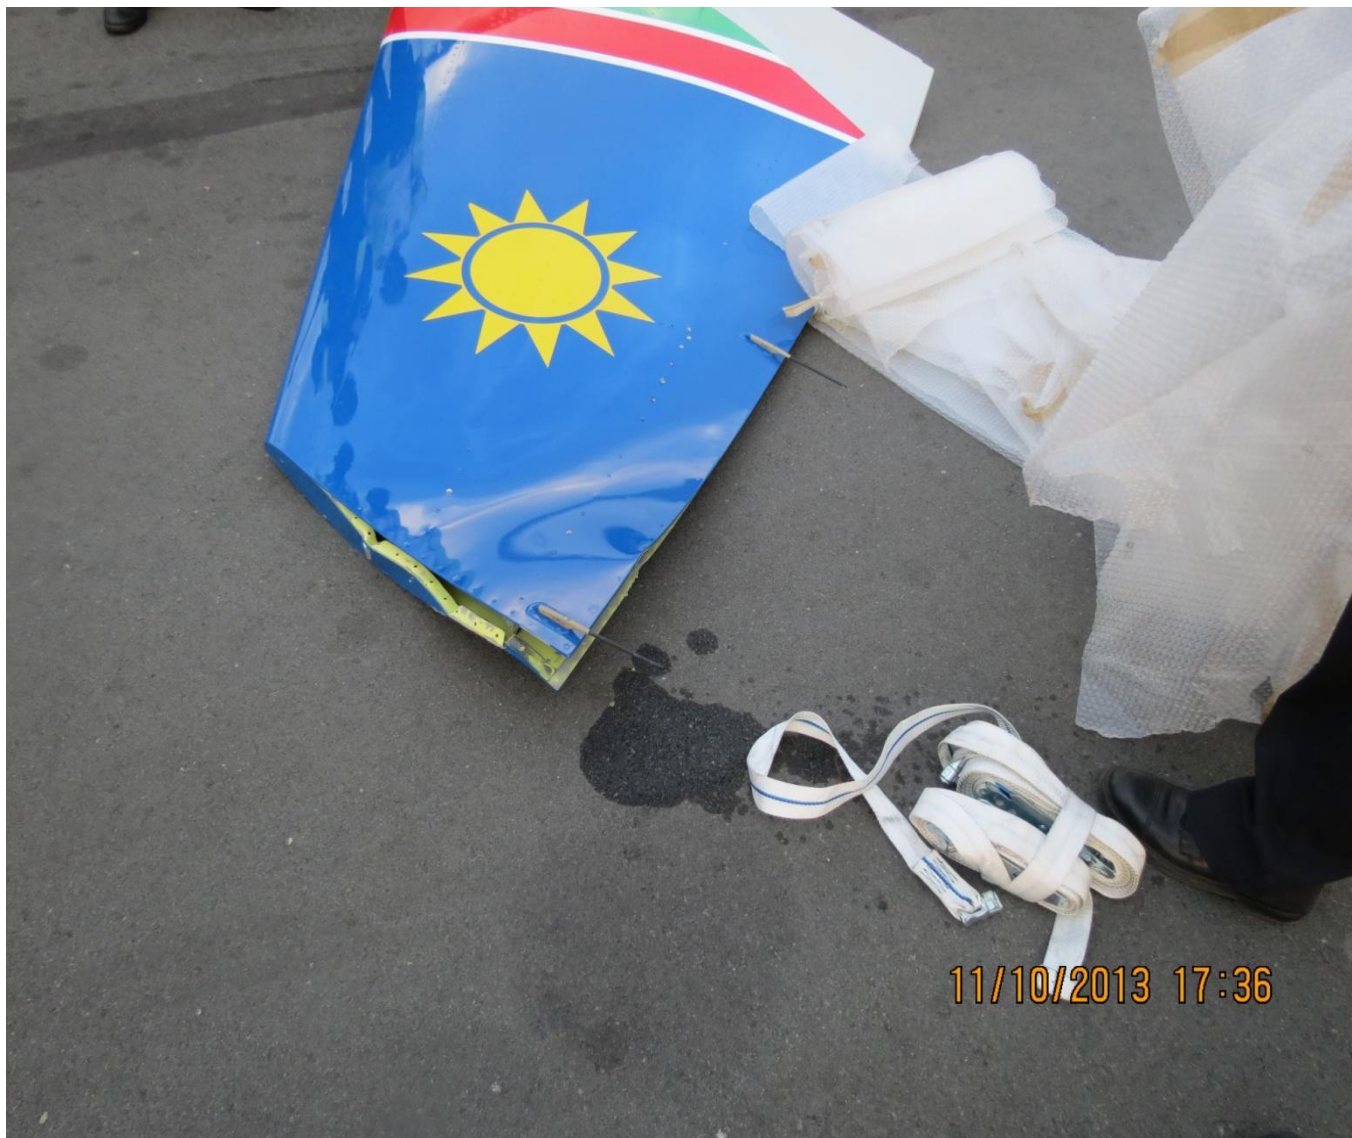
- 1.4.1 V5-ANO, Airbus A330 aircraft sustained slight damages on its left winglet which had to be detached in accordance with CDL guidelines by V5-ANO and Airbus engineers.

Figure 2: V5-ANO A330 winglet removed.

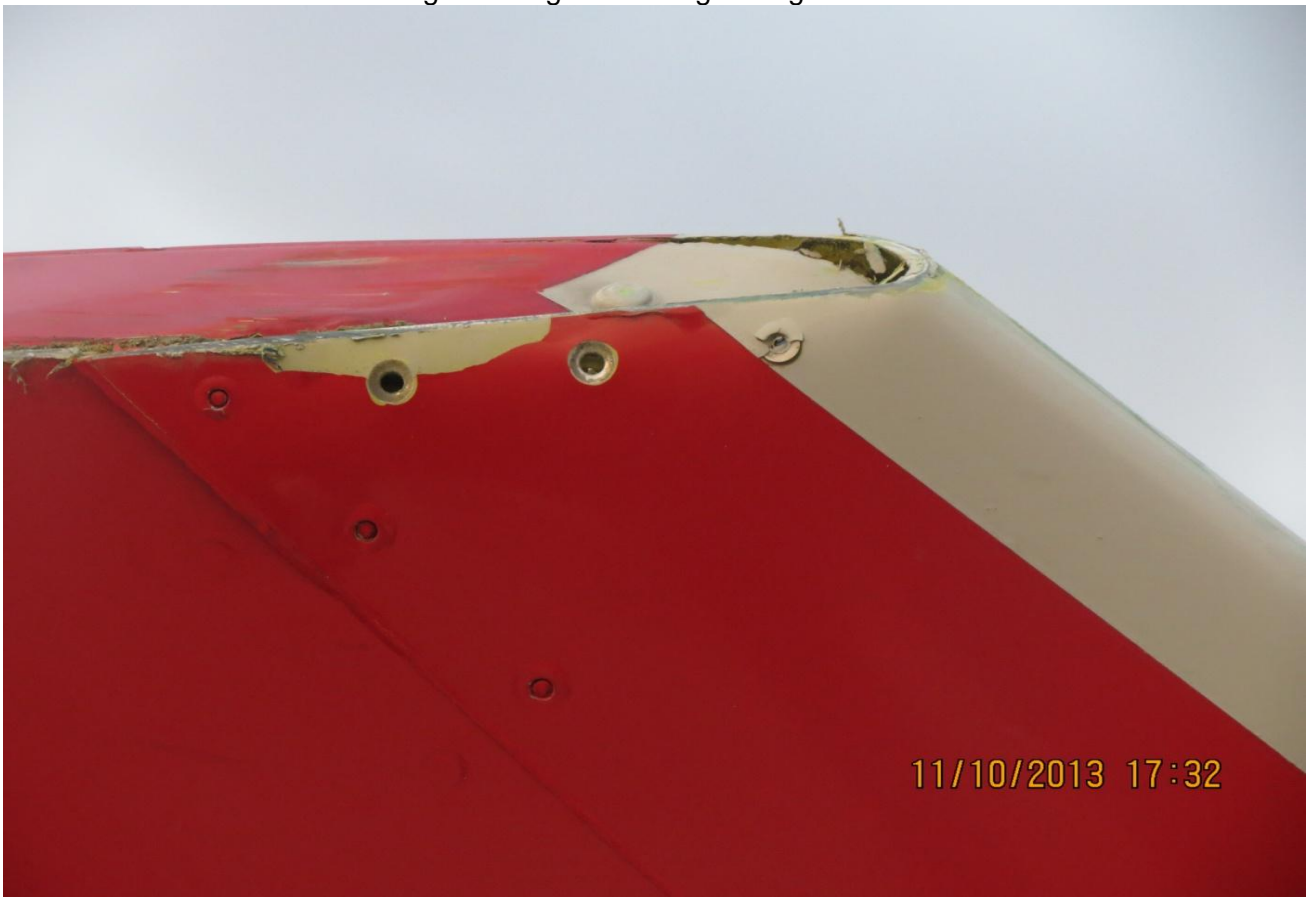
1.12.1 The aircraft sustained slight damages on its right winglet.

Figure 5. Close-up view of the right winglet damage.

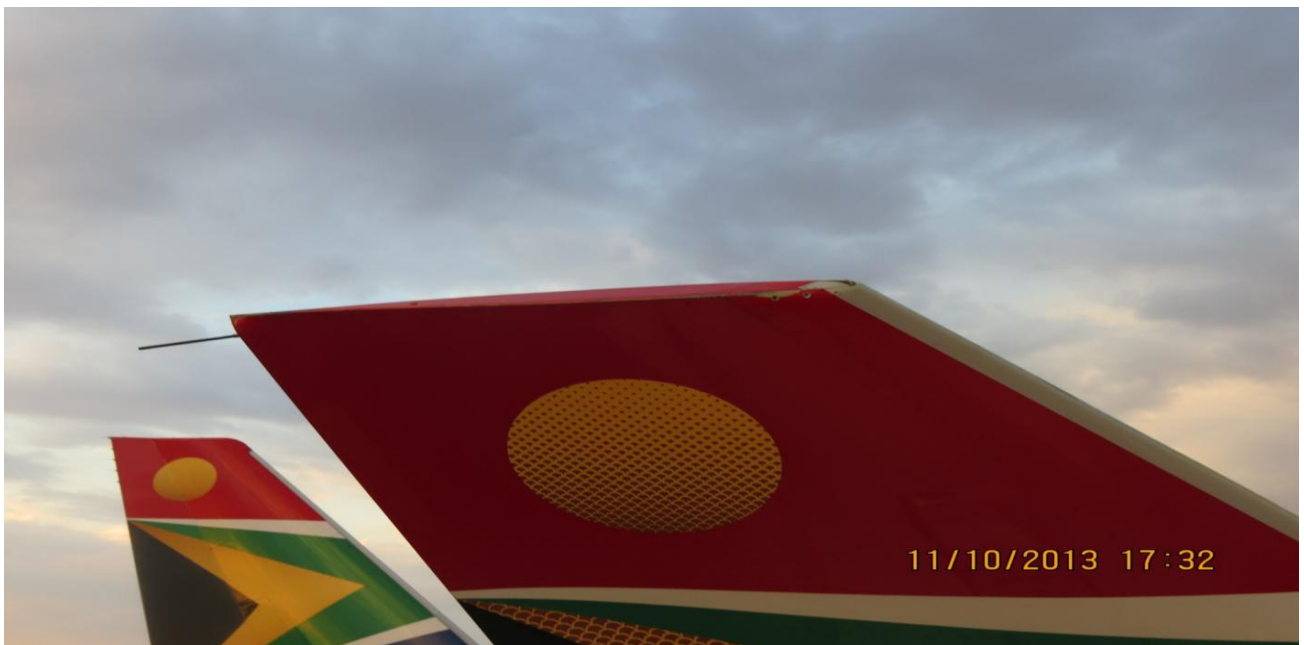
Figure 6. Winglet damage.

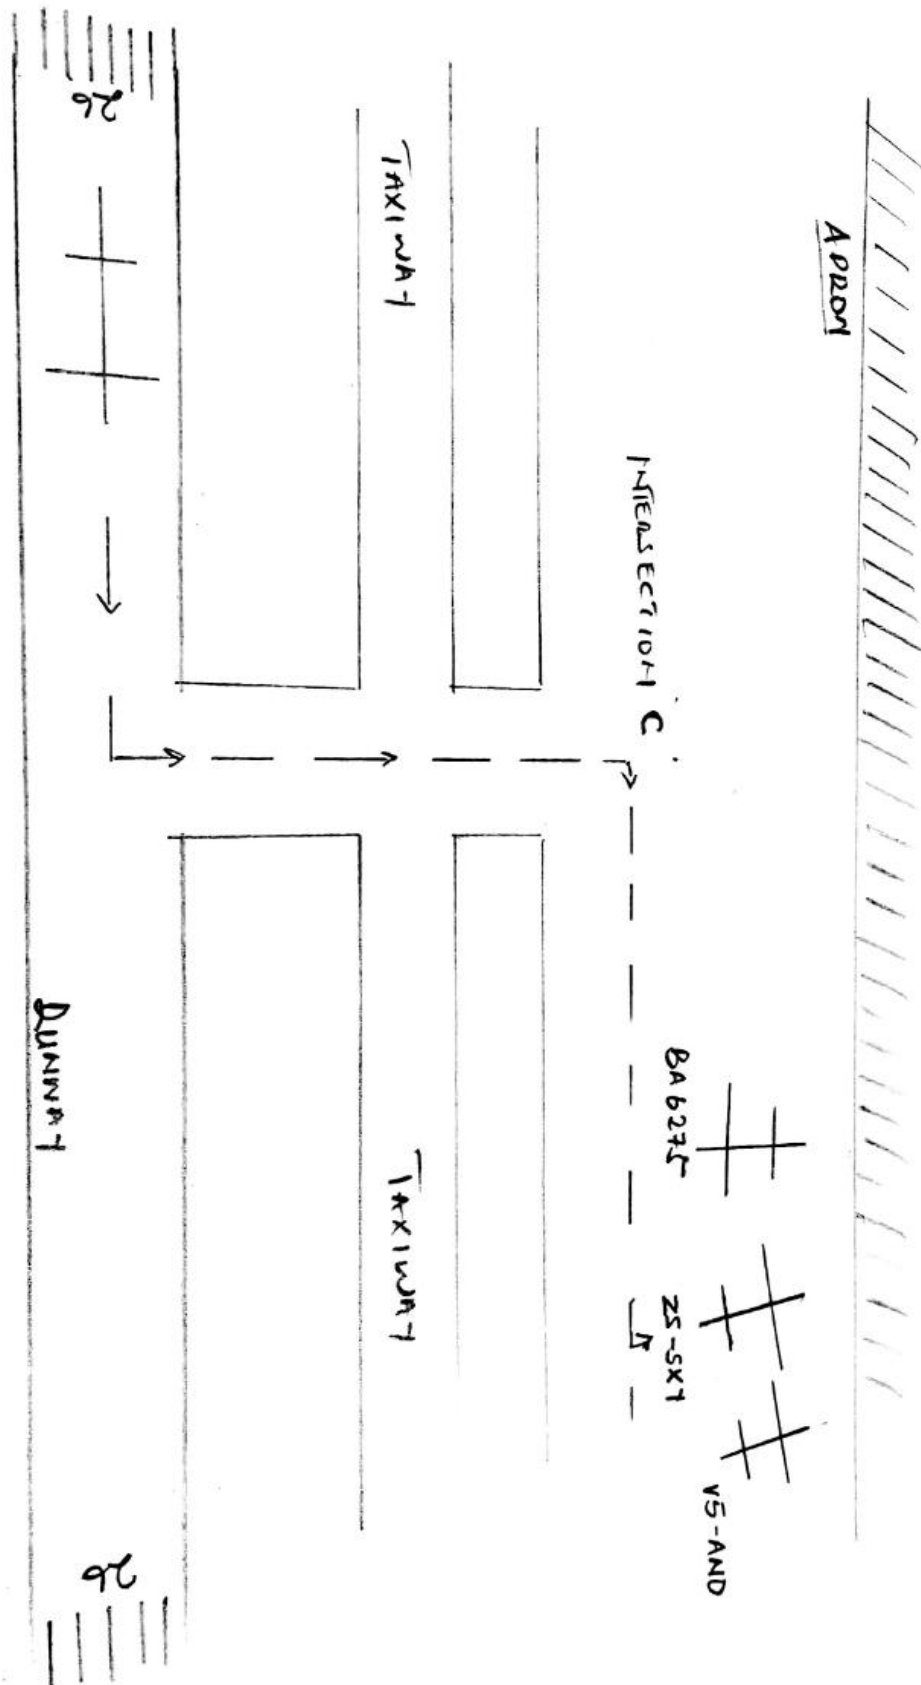
Sketch of the sequence of the occurrence

Appendix 2 shows a sketch of aircrafts at the apron relative to the intersection C and runway 26.
