Ministry of Works and Transport				ACCID/080719/02-13	
DIRECTORATE OF AIRCRAFT ACCIDENT AND INCIDENT INVESTIGATIONS ACCIDENT REPORT – EXECUTIVE SUMMARY							
Aircraft Registration		ZT-RBD	Date of Accident		07 August 2019	Time of Accident 08:42 UTC	
Type of Aircraft		ROBINSON R44 HELICOPTER RAVEN II		Type of Operation		Game counting Operation	
Pilot-In-Command License Type		CPL - Helicopter	Age	29	License Valid		Yes
Pilot-In-Command Flying Experience		Total Flying Hours	1543.2		Hours on Type		719.5
Last point of departure		Wabi Game Lodge Private Airfield					
Next point of intended landing		Wabi Game Lodge Private Airfield					
Location of the incident site with reference to easily defined geographical points (GPS readings if possible)							
GPS position: 20° 20' 56.33" South 017° 28' 29.00" East							
Meteorological Information		Surface Wind: Light and Variable, Visibility: CAVOK, Temperature: 25°C,

AIRCRAFT INCIDENT REPORT

Name of Owner	: Bushveld Game Capture CC
Operator	: Super Game Dealers CC
Manufacturer	: Robinson Helicopter Company
Type	: R44Raven II
Model	: 2016
Nationality	: South African
Registration Marks	: ZT-RBD
Place	: Wabi Game Lodge, 45 km east of Otjiwarongo

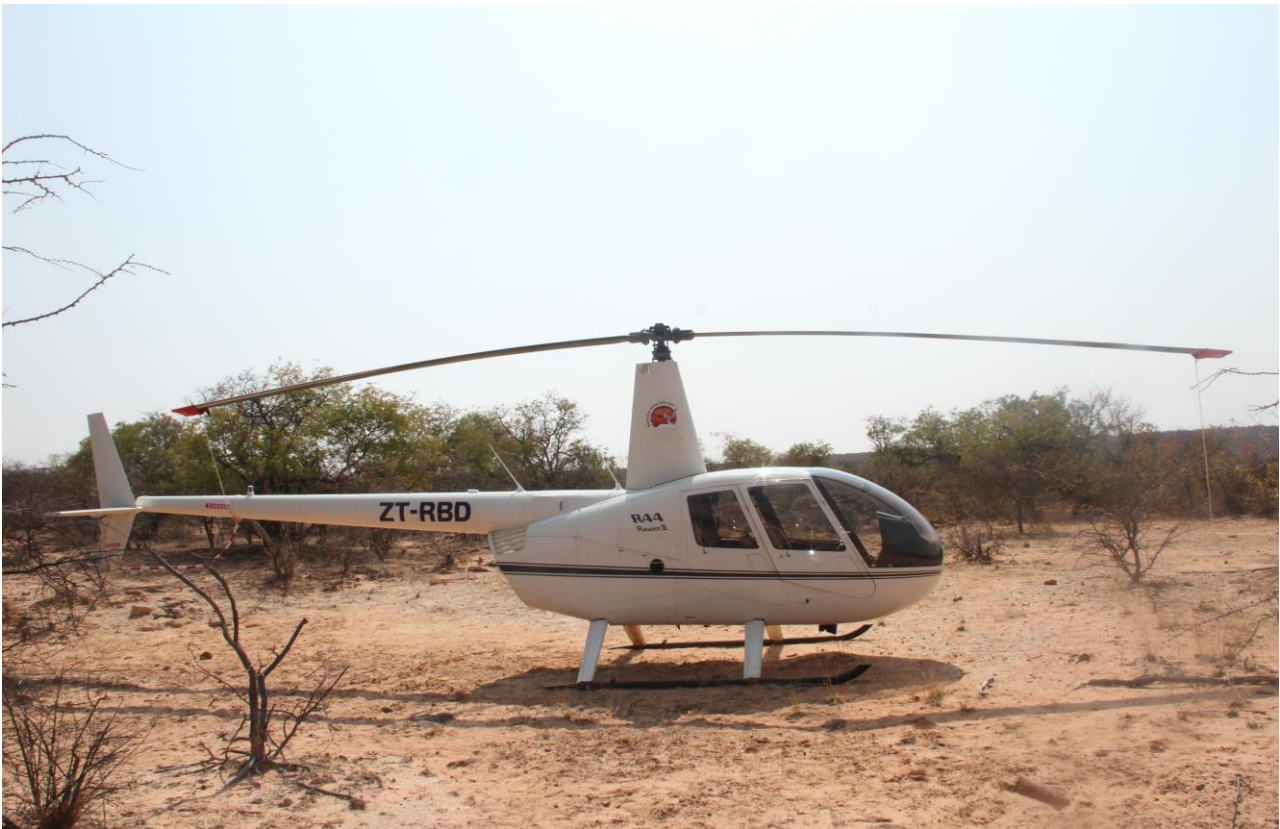
1.12.1 Following a low rotor RMP condition in flight, the pilot had opted to perform a forced landing while flying over bush type of terrain. Prior to ground contact, the tail rotor blades made contact with some vegetation (dry thorn bush) and fractured. Due to a loss in tail rotor effectiveness, the helicopter yawed slightly to the right before coming to rest as displayed in Figure 1.

Figure 1. The helicopter as it came to rest.

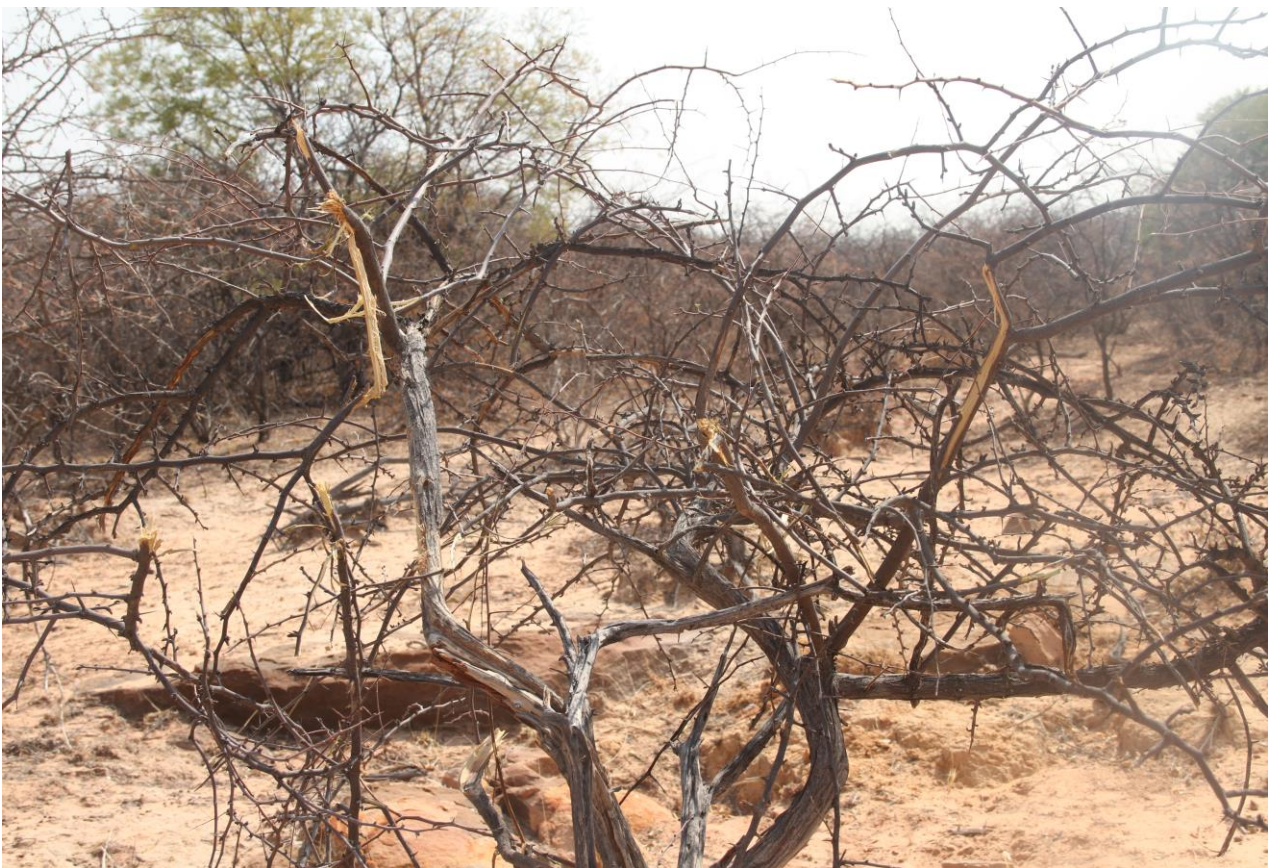
Figure 2. Several fractured branches of the thorn bush indicate contact with the tail rotor blades.

2.4 During a forced landing, the tail rotor made contact with vegetation (a thorn bush), which caused the entire tail rotor assembly to separate from the tail boom structure and caused the helicopter to start yawing to the right it touched down hard and bounced once before coming to rest in an upright position.

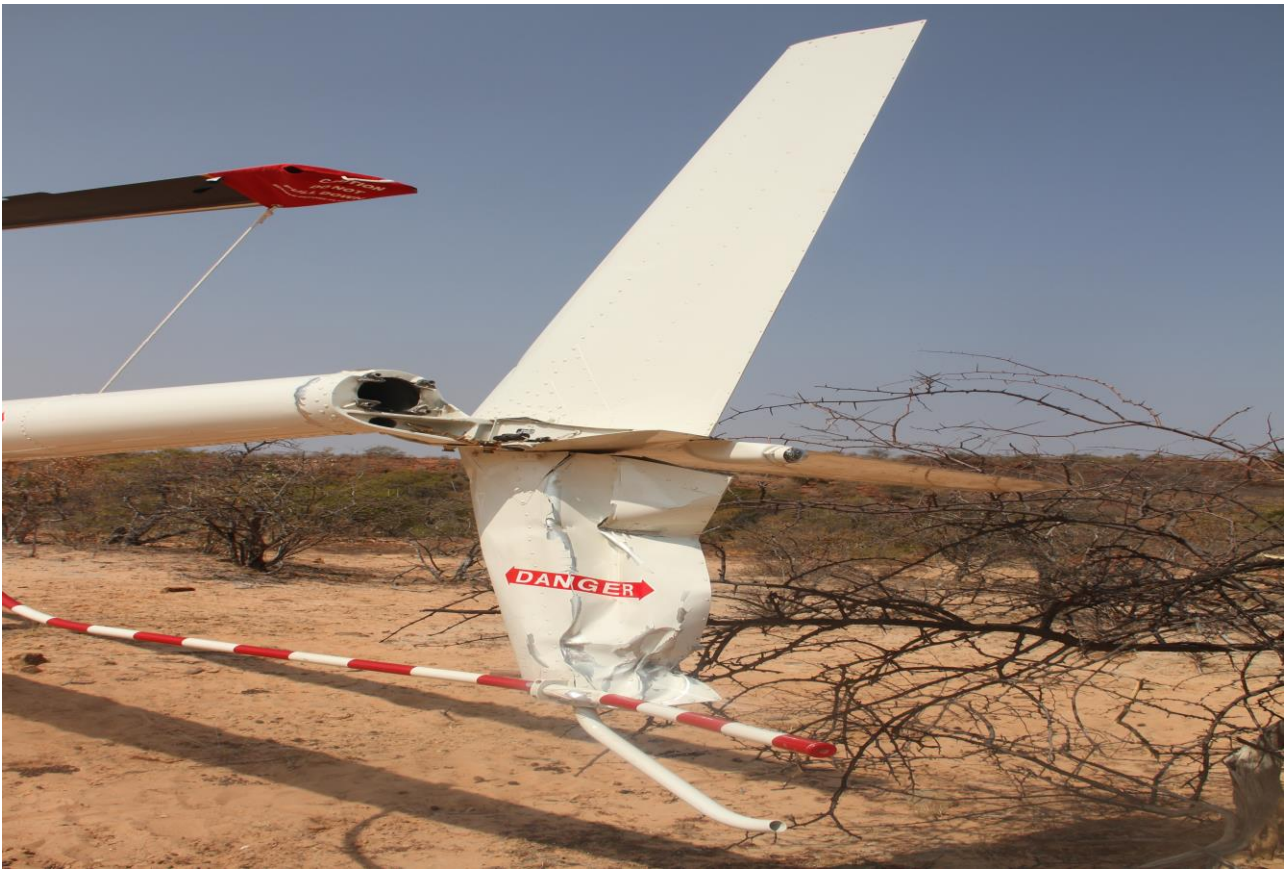
Figure 3. Closer view of the aft tail boom structure with the tail rotor assembly absent.

2.7 The helicopter sustained substantial damage as the entire tail rotor assembly broke off following a tail rotor strike. The aft tail boom structure as well as the lower vertical stabilizer was also deformed following the tail rotor assembly separation which required a major repair.

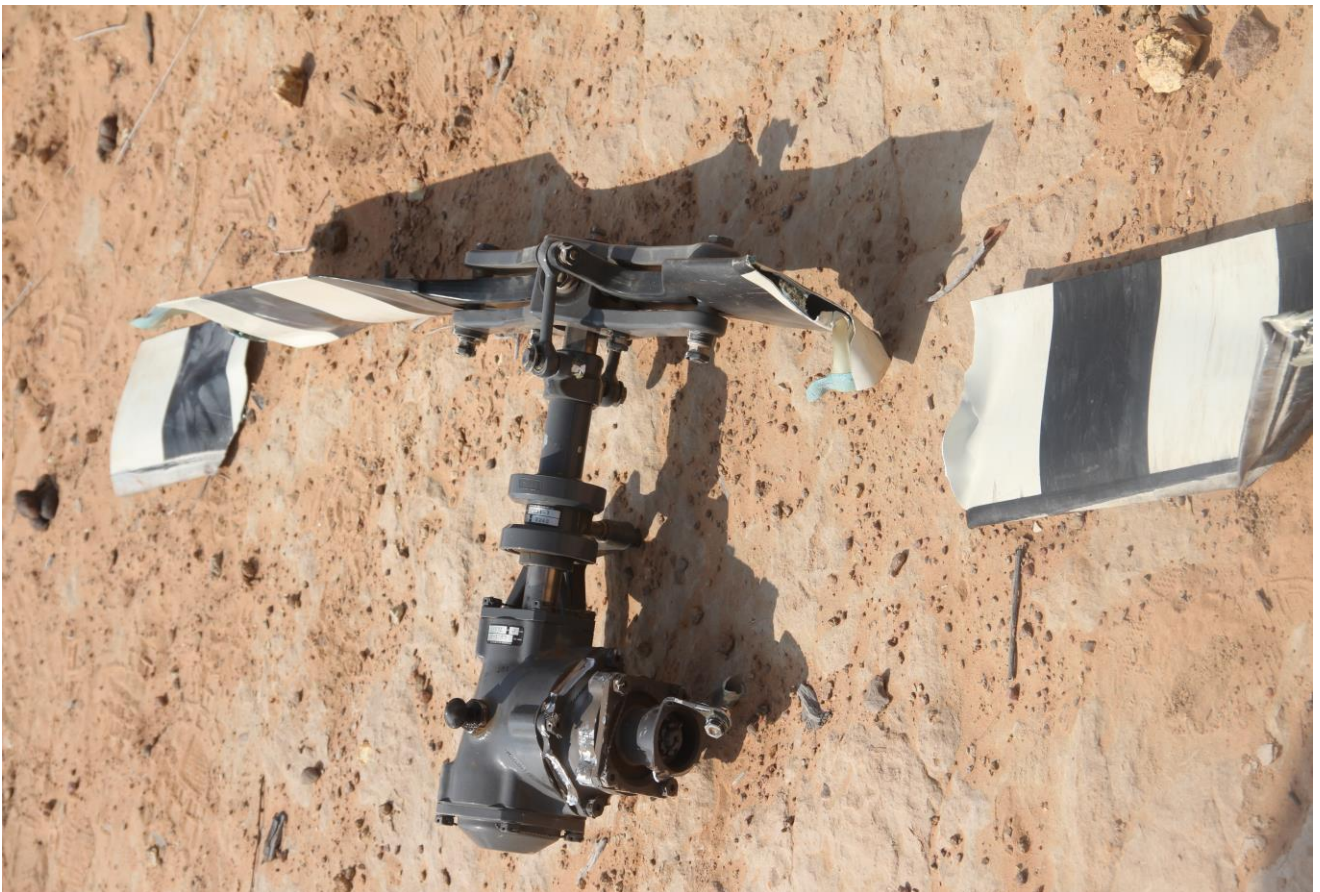
- 1.3.1 The entire tail rotor assembly broke off from the tail boom structure, which resulted in substantial damage.

Figure 4. The tail rotor assembly that broke off with both rotor blades being fractured.

- 3.1.9 The helicopter impacted the ground hard after striking vegetation (thorn bush) with the tail rotor, causing the tail rotor assembly to break off.
