Accident Reference: ACCID/06292023/01-05/

### Aircraft Accident Investigation Final Report

SAVANNAH MXP-70 V5-UZA

**DESCRIPTION OF OCCURRENCE:** (LOC-G) Loss of control on ground.

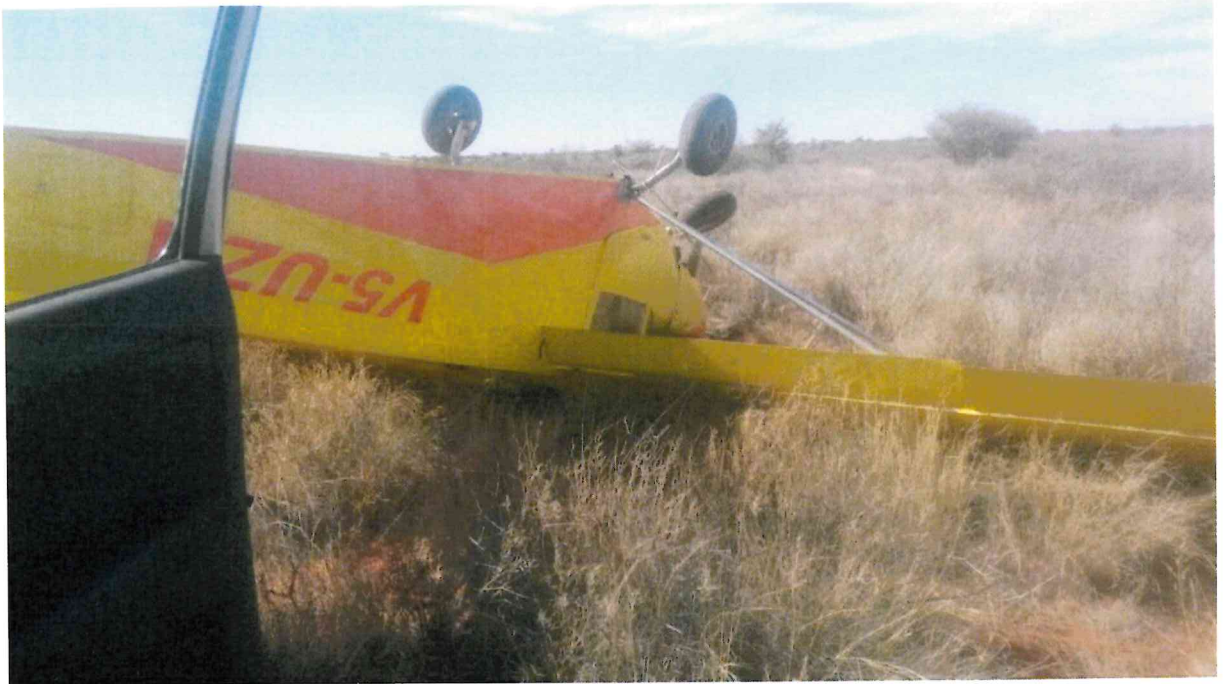
1.3.1 The aircraft was destroyed.

Figure 1: Aircraft at the accident site.

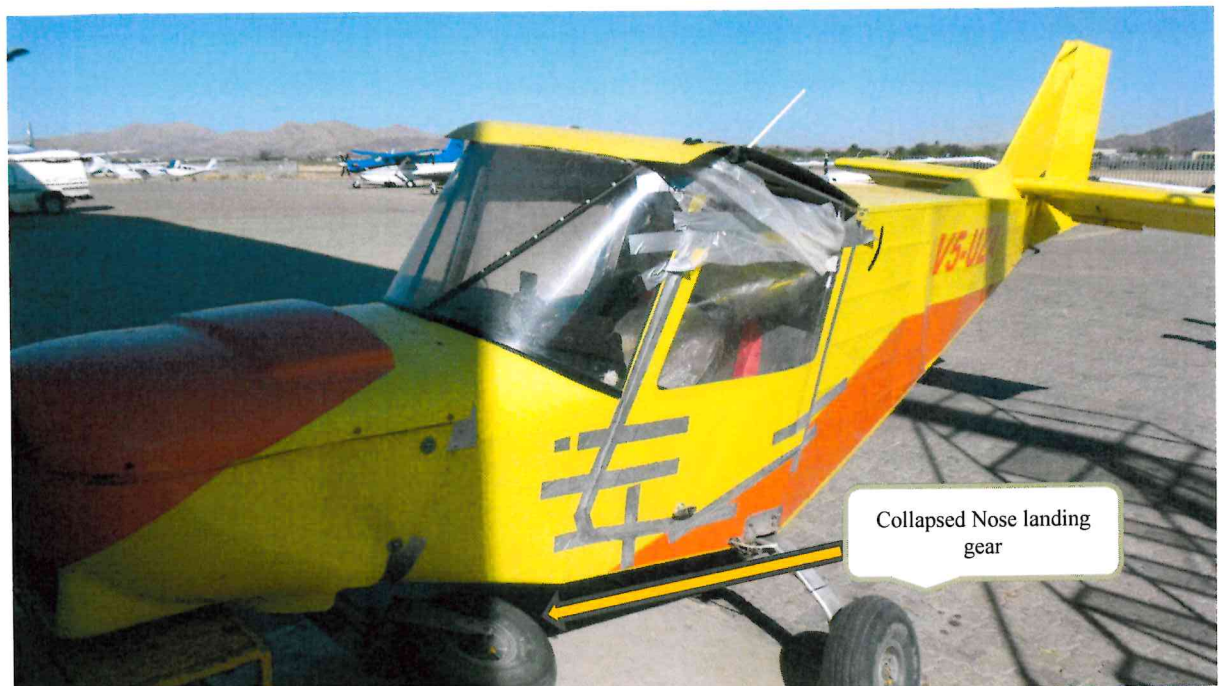
Figure 2: Photo depicting the aircraft's nose wheel strut collapsed...

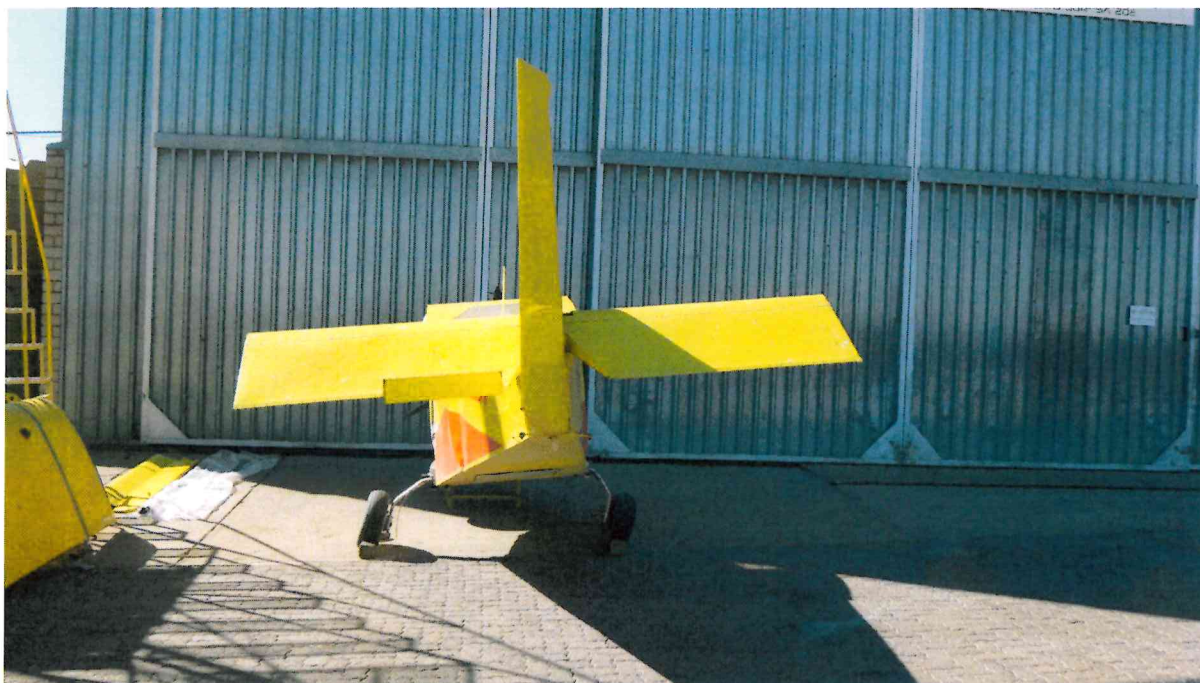
Figure 3: Photo depicting structural damage
