## Directorate of Aircraft Accident and Incident Investigations

### Aircraft Accident Investigation Final Report

AIRCRAFT TYPE & REGISTRATION: C182 (ZS-ERO)

DESCRIPTION OF OCCURRENCE: Runway excursion and subsequent ground collision with object.

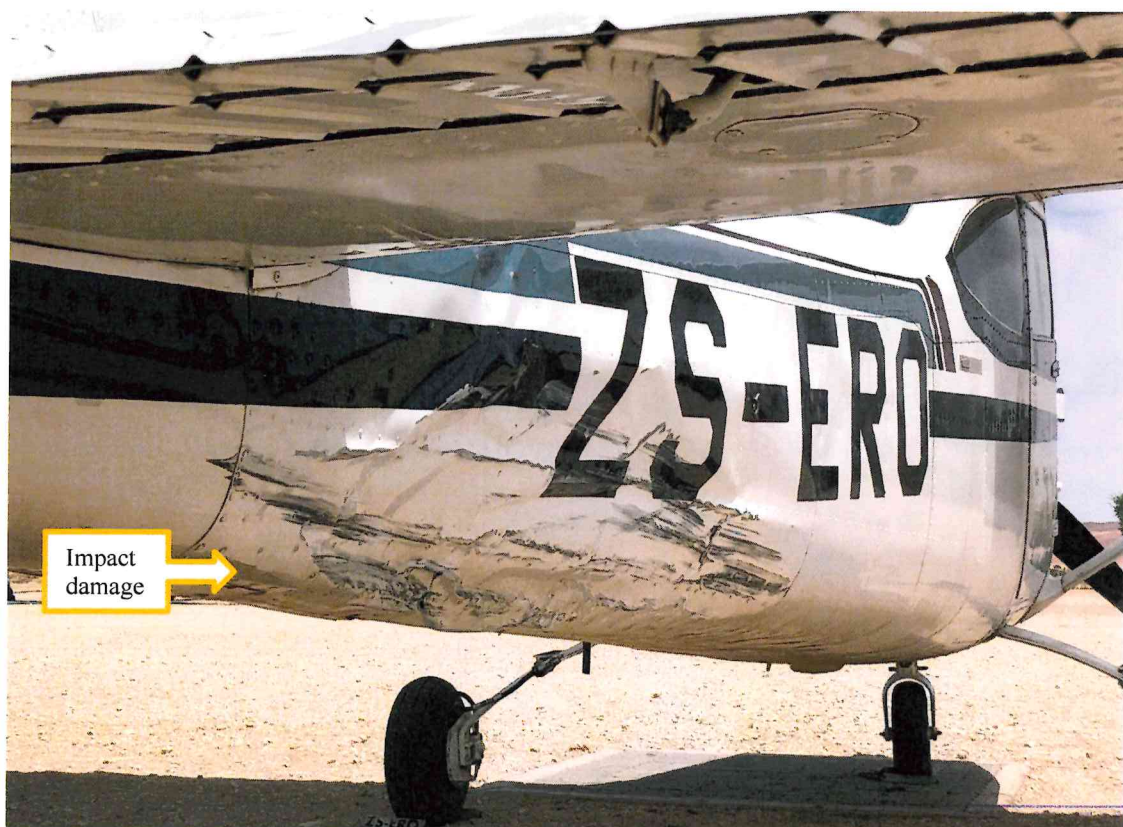
Figure 1: Damage to the lower aft fuselage appr. 1,5 m behind the right door.

- 1.12.1 Damage to the lower aft fuselage approximately 1,5 m behind the right door.

The edge markers tyres were lying horizontally at the edge of the runway. The aircraft was drifting to the right edge of the runway, at the last minute the wheel hit the edge marker tyre which flipped and hit the lower aft fuselage and caused the damage.

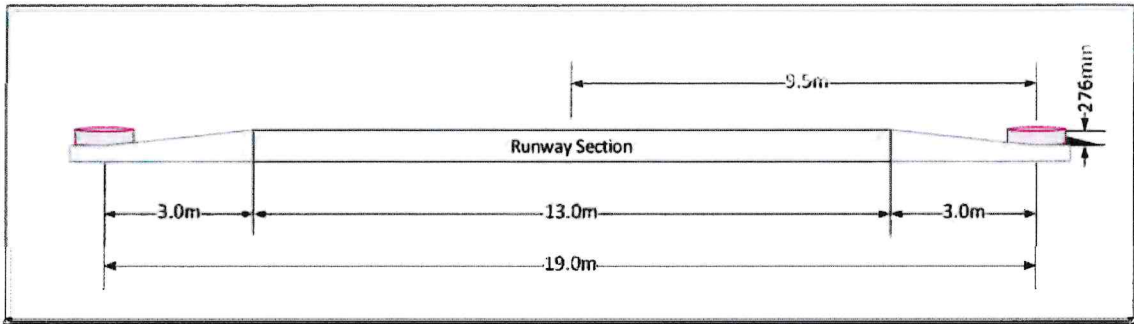
- 1.10.1 The aerodrome investigations (Twyfelfontein) revealed that the airstrip is approximately 2200m long, 13m wide and has an east-west bearing. The edge markers (tyres) are painted white and are approximately 3m from the edges on each side of the landing strip. The height of the tyres is approximately 280mm, and the tyres are spaced 50m apart along the length on either side of the airstrip.

Figure 2. The edge marker tyres. (Aerodrome owner)

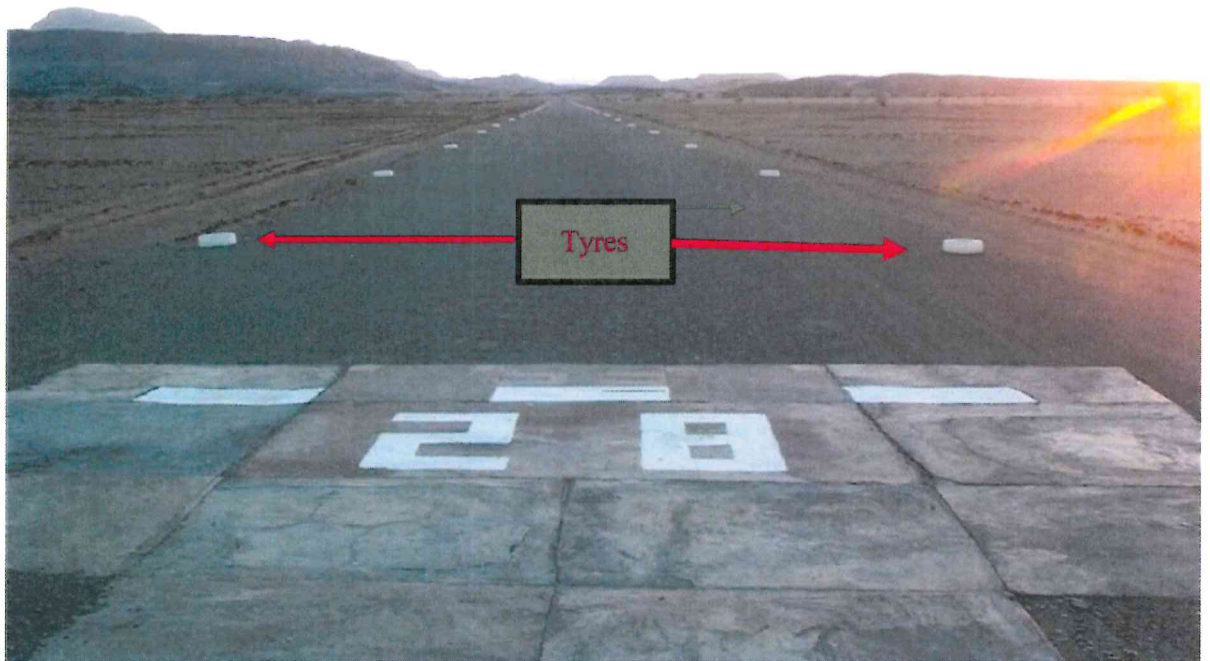
Figure 3. The edge marker tyres along the runway length.. (Aerodrome owner)
