CIVIL AIRCRAFT ACCIDENT REPORT

09082020
ACCID / ~~08092020~~ / 01-01

OPERATION	:	PRIVATE
AIRCRAFT	:	HELICOPTER
LOCATION	:	B2 GOLDMINE
DATE	:	08 SEPTEMBER 2020

Aircraft Registration	V5-HIK	Date of Accident	08 Sept 2020		Time of Accident	06:40 UTC
Type of Aircraft	SCHWEIZER 269		Type of Operation		Game capture	
Pilot-in-command license type		Commercial pilot	Age	30	License valid	Yes
Pilot-in-command flying experience		Total flying hours	1158.0		Hours on type	875.0
Last point of departure		Farm Felsenquelle 507 South of Otavi Namibia				
Next point of intended landing		Farm Felsenquelle 507 South of Otavi Namibia				
Location of the accident site with reference to easily defined geographical points (GPS readings if possible)						
Farm Felsenquelle No 507 B2 Gold Mine 30km South of Otavi Otjozondjupa Region S 20.01.32 E 017.06.35						
Meteorological Information		CAVOK				
Number of people on board		1	No. of people injured	1	No. of people killed	0
Synopsis

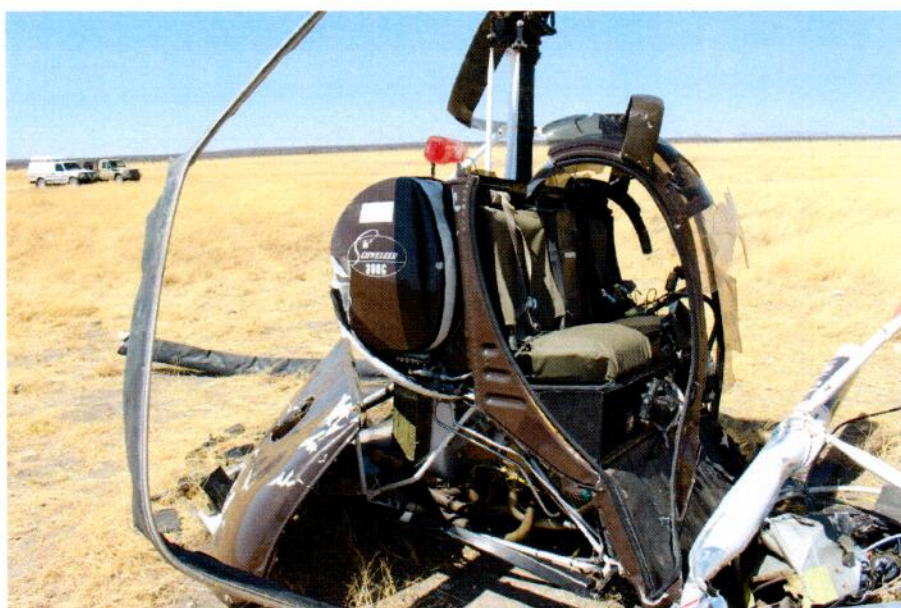
Image 1

- 1.3.1 The helicopter was destroyed on impact.

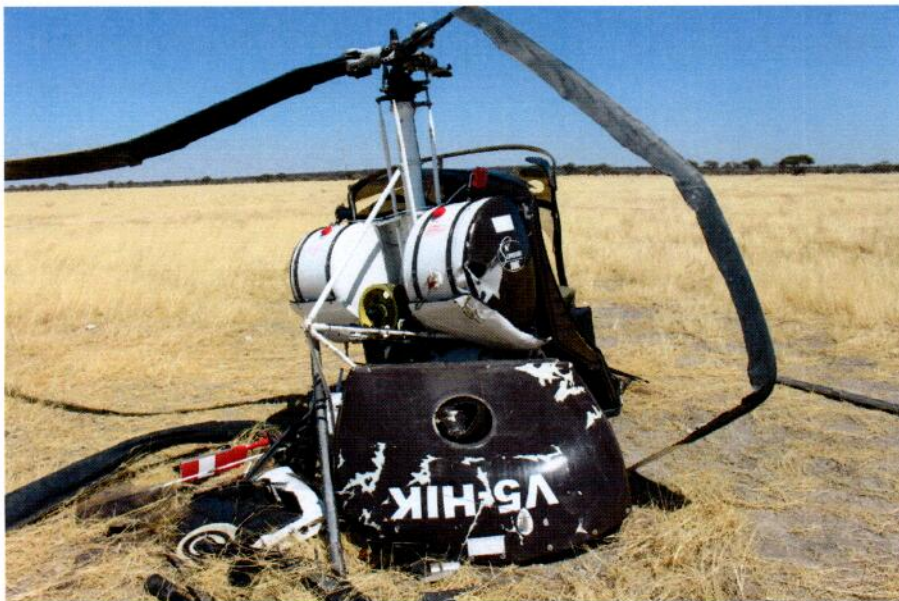
Image 3 The helicopter was destroyed on impact and ended up in the upright position.

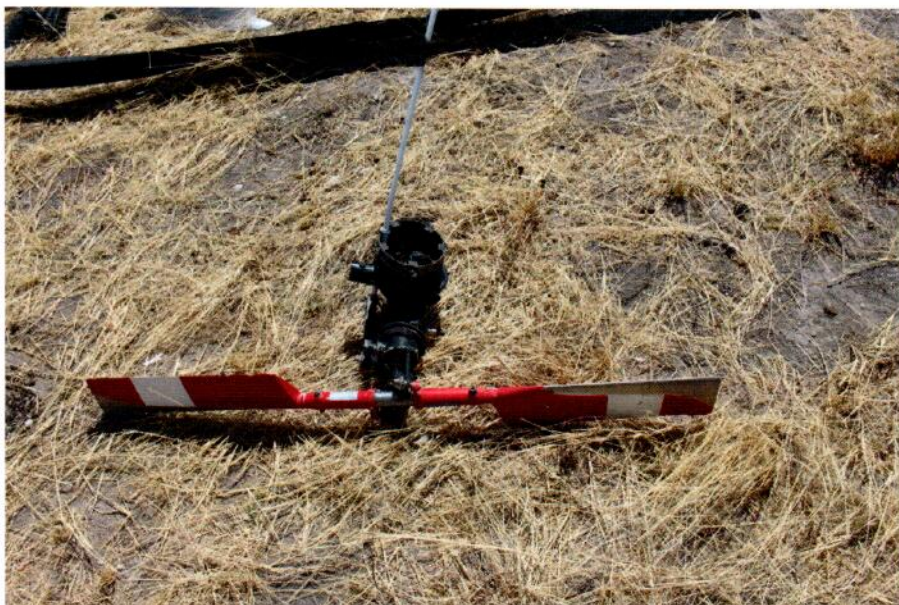
Image 4 Tail rotor blades shows low rotational speed impact damage.

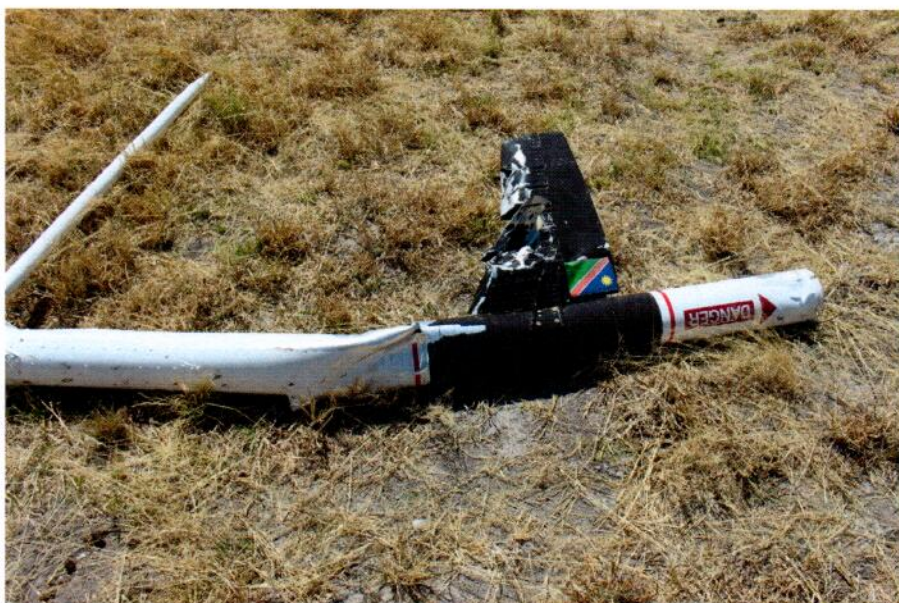
Image 5 Tail boom was struck and destroyed by the main rotor blades during excessive flare in landing phase.

- 2.4 The helicopter's tail rotor separated while the main rotor struck the boom. The helicopter was destroyed subsequently.
- 2.5 The ground crew which was nearby observed this manoeuvre and immediately rushed to the scene to render assistance to the pilot.
- 2.6 The helicopter was destroyed, however the pilot was still alive and was subsequently removed from the wreckage by the ground crew which alerted the owner of the helicopter to start the emergency response plan accordingly.
- 2.7 The pilot was taken by road to Otjiwarongo hospital 70 km away for observation.
- 2.8 The weather was fine in the area with unrestricted visibility and did not play a role in the accident.
- 2.9 The investigation revealed that the pilot had sufficient training on game capture operations and a recent flight test with a valid medical to his licence. The pilot does not have known accidents to his records.

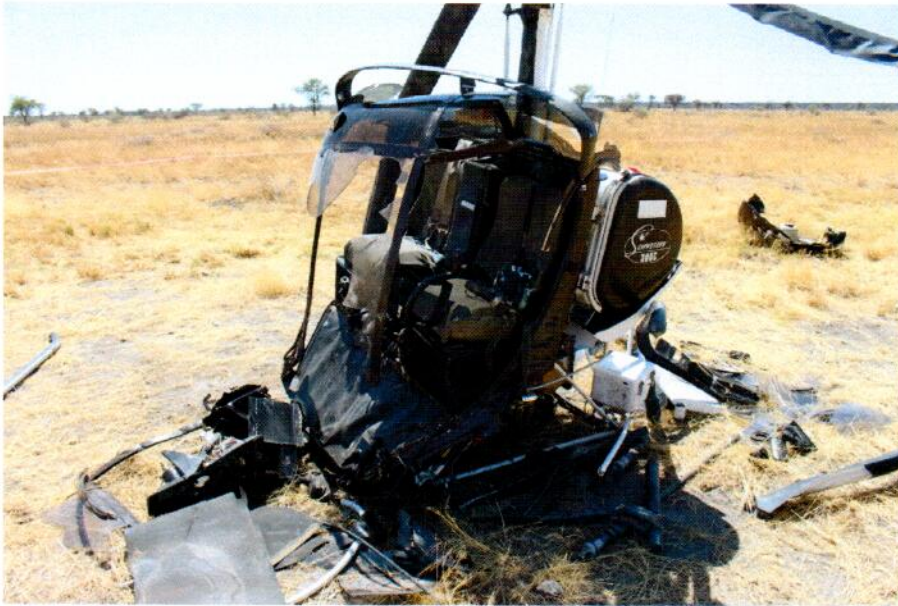
Image 6 The pilot was still strapped in the 5 point harness where the helicopter ended upright.

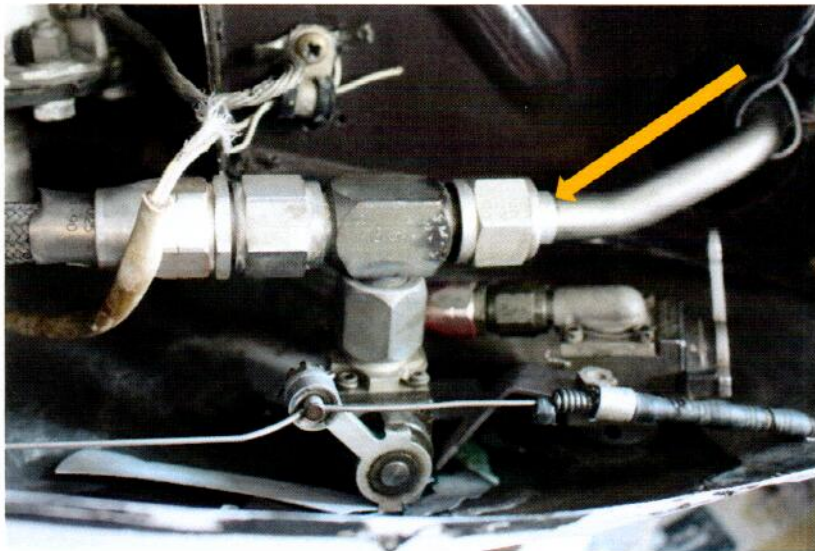
1.16.5 All tests above did not reflect any abnormality and the engine was found to operate satisfactory through the power range. ***The fuel supply line from the left (Aux) tank was found loose on the fitting connecting to the fuel shut-off valve. No EGT system installed and Temperature increase could not be observed.***

1.16.6 The loose fitting at the fuel shut –off valve may have caused air to enter the fuel line and cause cavitation on the fuel pump, which may have resulted in a lean fuel mixture leading to a lean cut condition.

Image 7 Coupling nut of reserve fuel supply line found loose.

- 3.1.10 The loose fitting at the fuel shut-off valve may have caused air to enter the fuel line and cause cavitation on the fuel pump that could have led to a lean fuel mixture cut condition.
