**DIRECTORATE OF AIRCRAFT ACCIDENT AND
INCIDENT INVESTIGATION**

CIVIL AIRCRAFT ACCIDENT REPORT

ACCID / 171119 / 01-01

OPERATION	:	TRAINING
AIRCRAFT	:	PARACHUTE
LOCATION	:	SWAKOPMUND AIRFIELD
DATE	:	17 NOVEMBER 2019

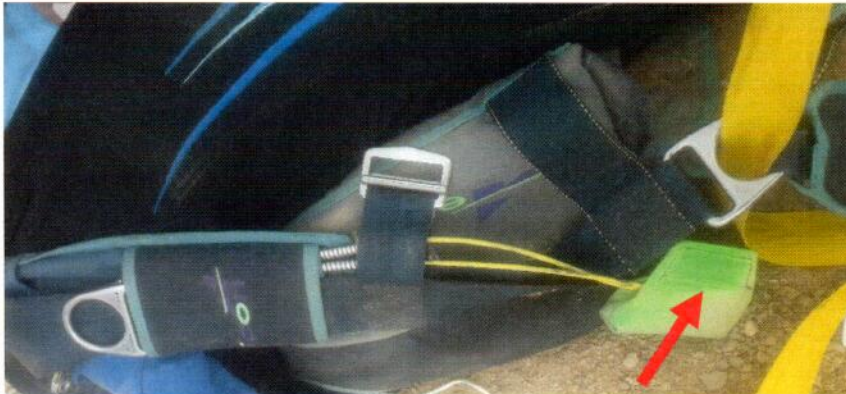
Image 1: Reserve shoot cable position

1.12.1 Reserve parachute deployment

Image 1: Unsuccessful reserve chute deployment handle (red arrow)

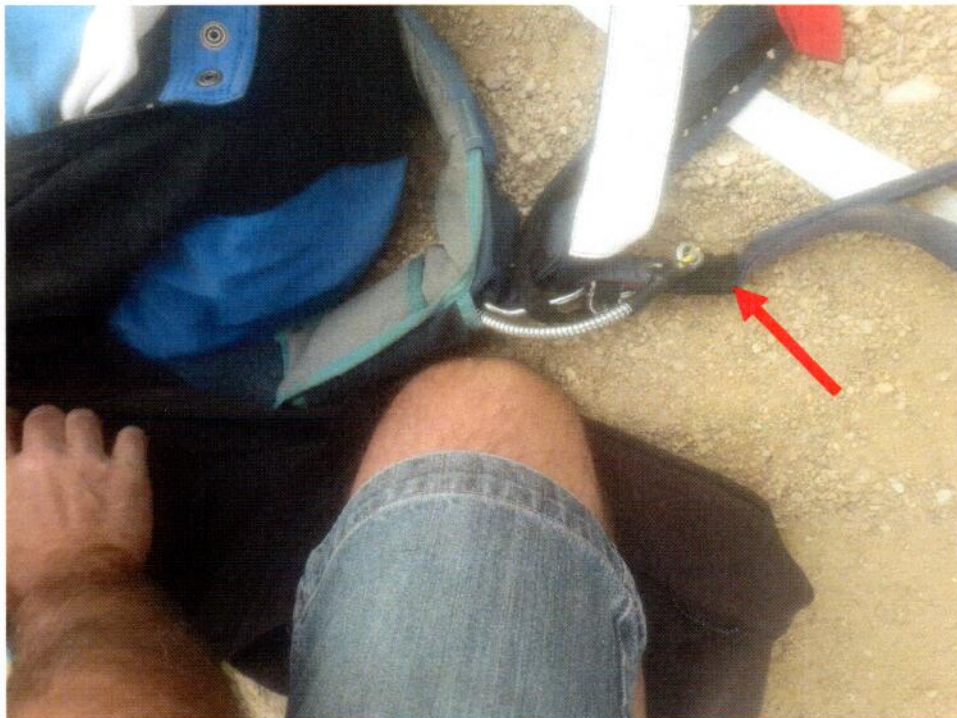
1.12.2 Left main parachute attachment

Image 2: Left emergency release cable still in place (red arrow)

- 2.7 The main parachute only released on the right shoulder harness buckle. The left main harness release cable was not pulled out all the way. This kept the left main harness strap attached to the student harness resulting in an entanglement with the reserve Parachute deployment.

- 3.1.6 No feasible answer could be found for the actions of the student in the operating of the equipment on this jump.
- 3.1.7 The main parachute was found with only one brake system deployed. The cutaway cables to the main chute was found to be released halfway, which resulted in the short cable releasing the right main shoulder strap.

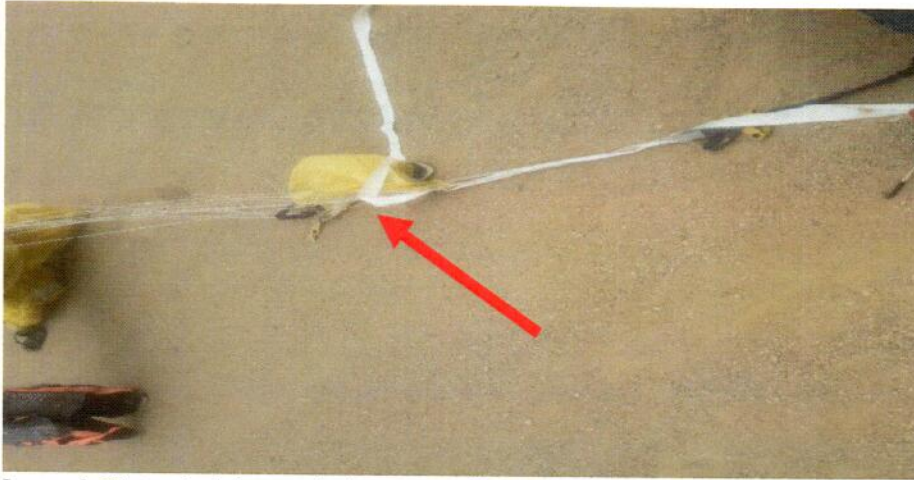
1.12.3 Reserve shoot drogue entangled with main parachute

Image 3: Entangled drogue deployment with left main drag lines (red arrow)

- 3.1.8 The height was insufficient for the deployment of the reserve parachute canopy. The spring operated drogue got entangled in the left main parachute shoulder harness strap.
- 3.1.9 The training records and video material was made available for the investigator on scene. An expert parachute instructor assisted in the investigation to the accident.
- 3.1.10 The Swakopmund Skydive Club was certified to conduct training by the NCAA and valid on the day of the accident.
- 3.1.11 The Instructor was qualified for the jump and had a valid licence to conduct training for the club in Namibia.

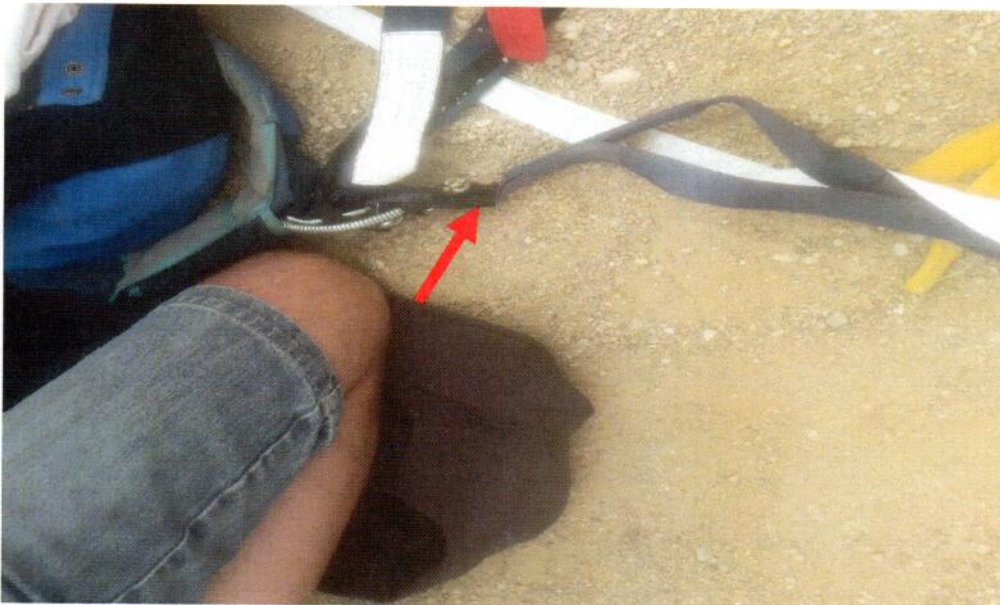
Image 4

1.12.4 Left main parachute strap still attached to harness

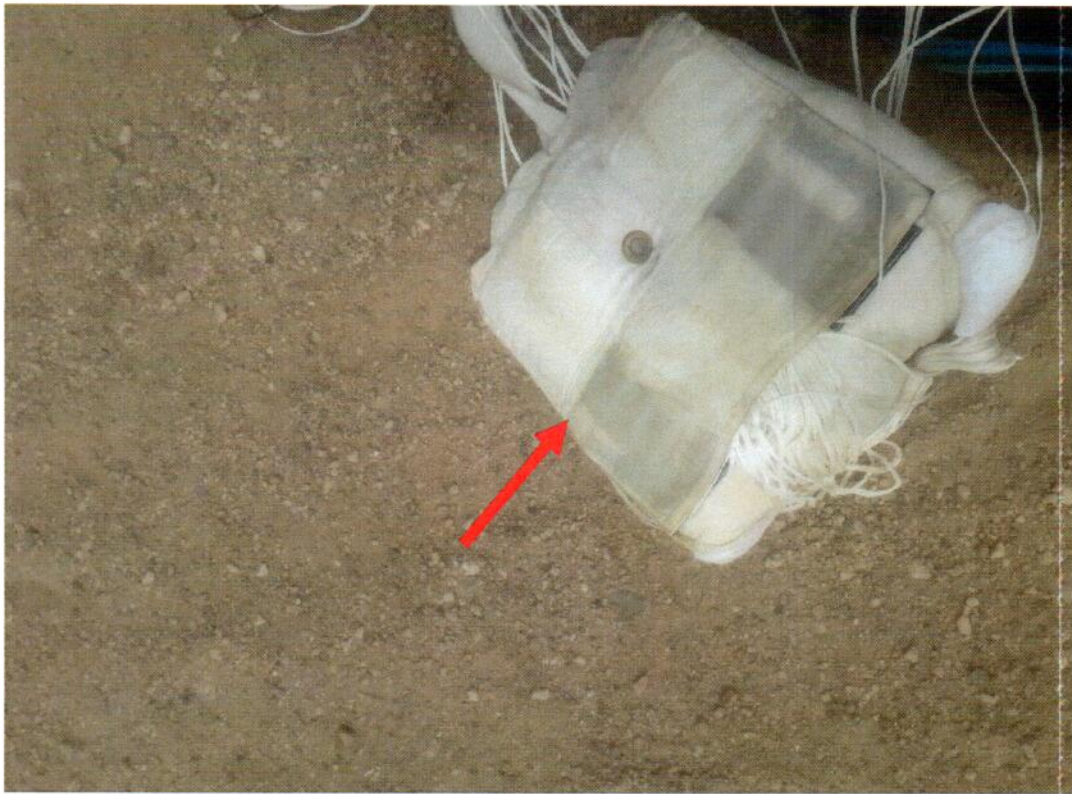
Image 5

1.12.5 Unsuccessfull deployment of reserve parachute system still intact.

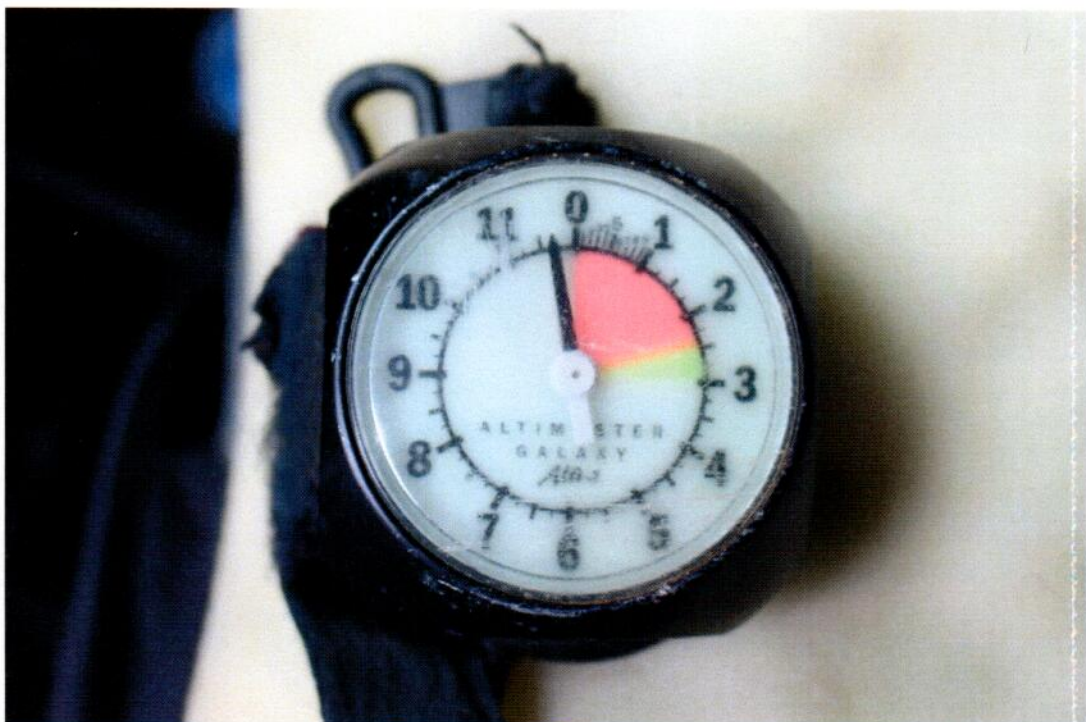
1.12.6 Altitude meter provided to student by the training organisation

1.8.2 The Altitude meter indicated clear specified heights to the student to easily recognise the caution and minimum height for deployment of the reserve parachute (refer to image 5).

Image 6: Altitude meter clearly indicating the caution (yellow) and danger zone (red) for deployment

of reserve parachute.
