**Directorate of Aircraft Accident and Incident
Investigations**

Aircraft Accident Investigation Final Report

CESSNA 206 V5-NSK

DESCRIPTION OF OCCURRENCE Runway Excursion

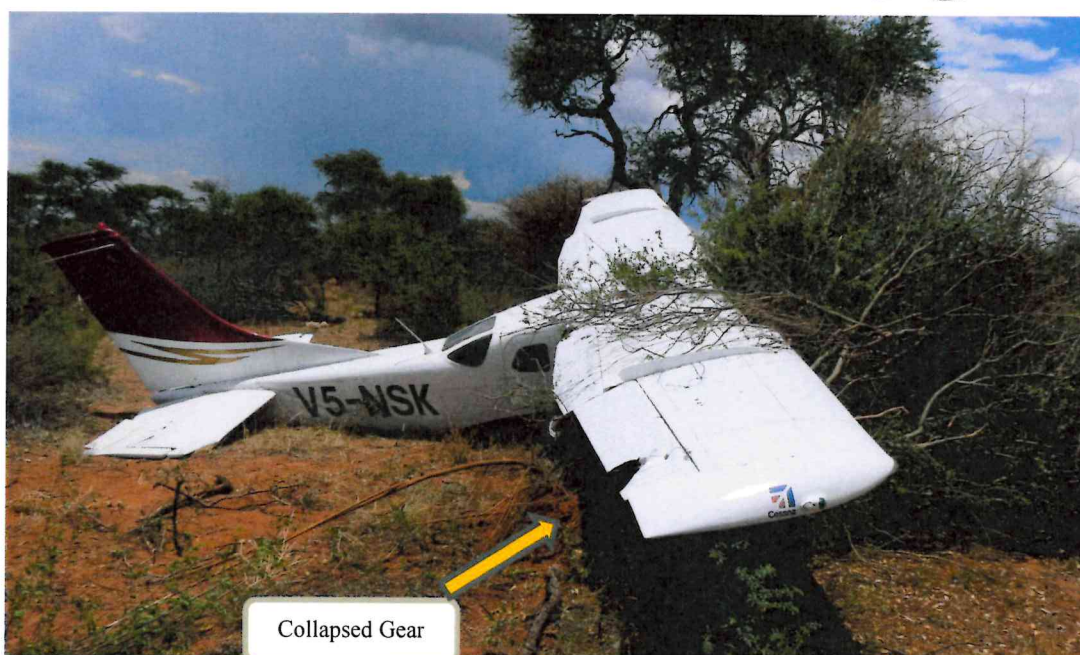
1.3.1 The aircraft sustained substantial damage.

Figure 1: Collapsed landing gear.

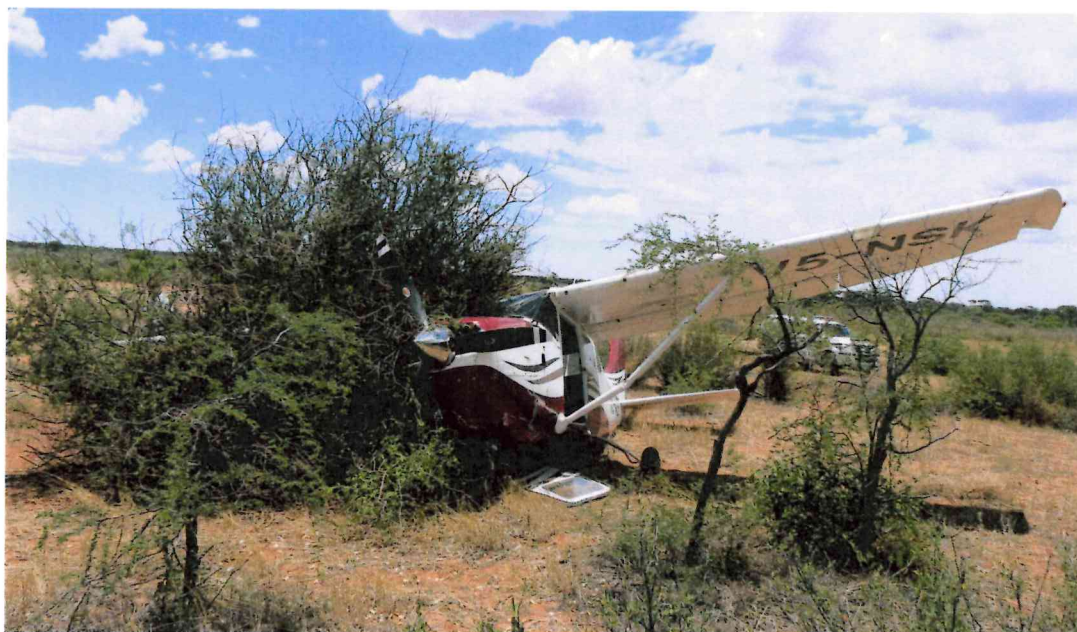
Figure 2: Depicting damage to the lower section and propeller.

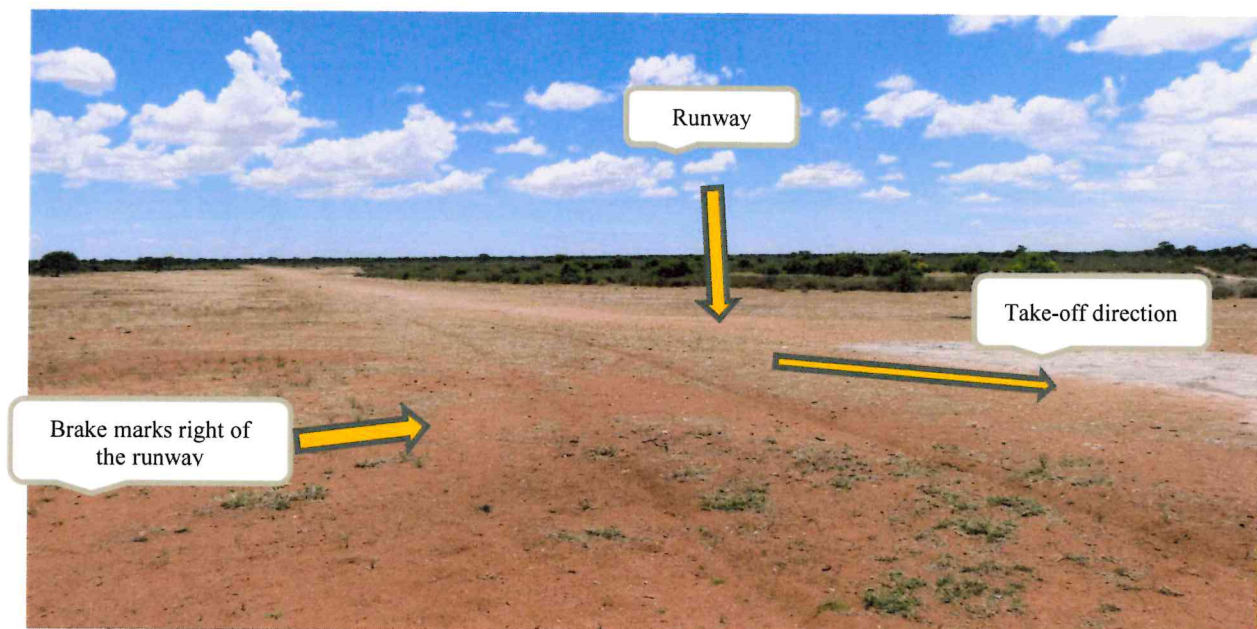
Photo 6 Photo depicting the ground scars by the aircraft's brakes as it left the runway veering to the right.

The aircraft tracks indicated that the aircraft left the runway and veered to the right and collided with a thick bush. The nose gear and right main gear were substantially damaged.

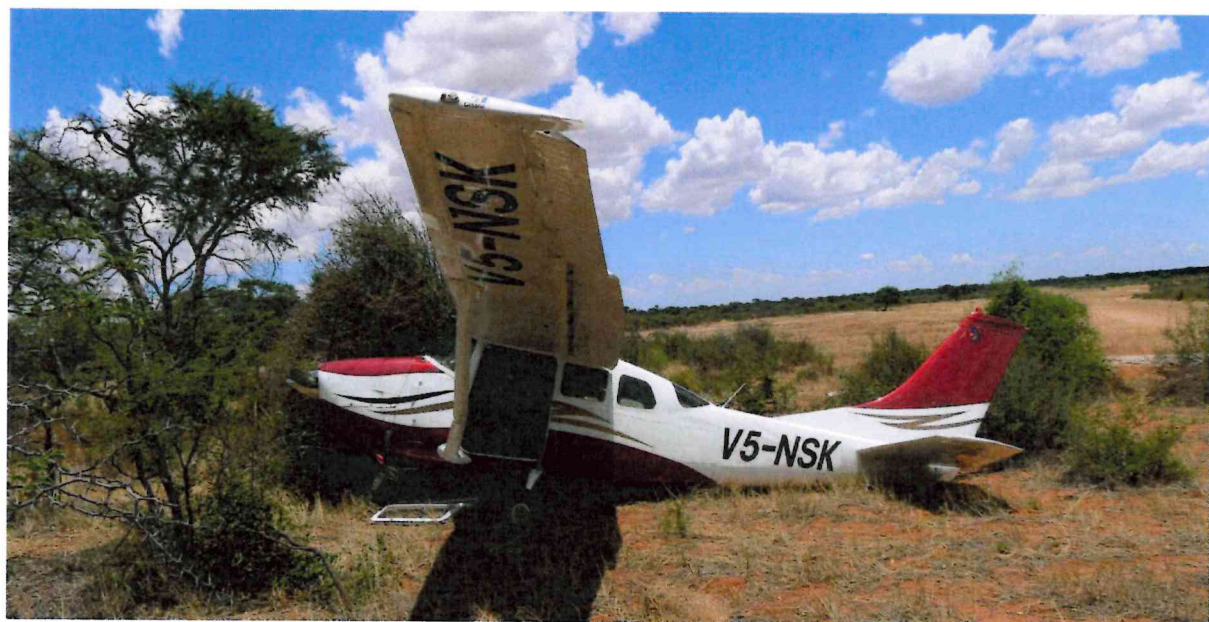
Photo 7 Photo depicting the aircraft's impact with the vegetation
