ENVIRONMENTAL FIELD SURVEY

UPGRADE OF THE RAILWAY LINE IN BETWEEN
KRANZBERG STATION TO TSUMEB AND OTAVI TO
GROOTFONTEIN

PHASE 1 – RAILWAY LINE BETWEEN KRANZBERG
STATION AND OTJIWARONGO TOWN

April 2022

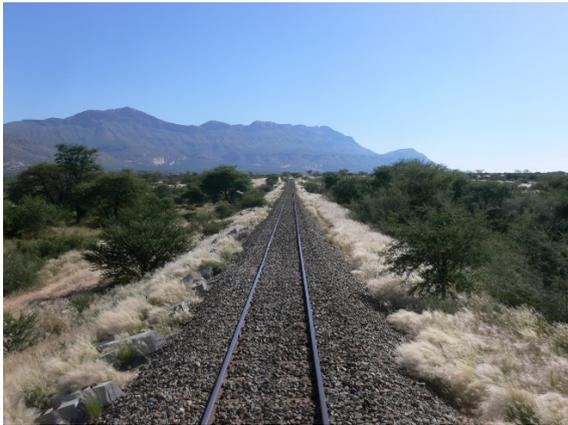
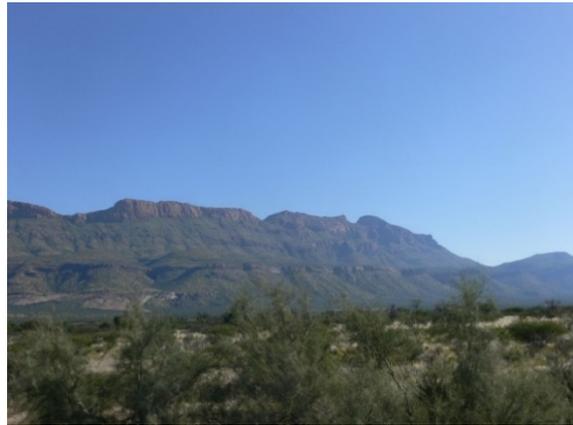
The mountain is known for its unique ecology and archaeological treasures, but the railway line construction and operation is not in close proximity of the mountain.

Photo 3.1.1 – Erongo Mountains to the west of the railway line

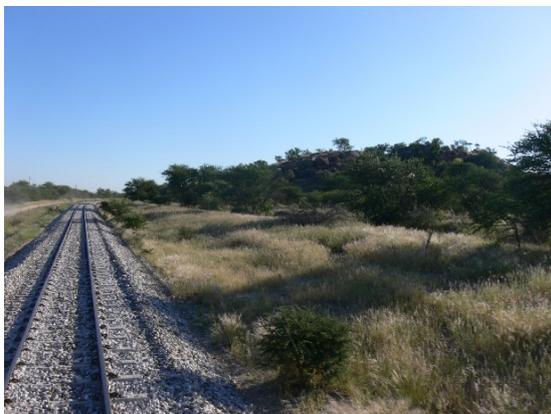
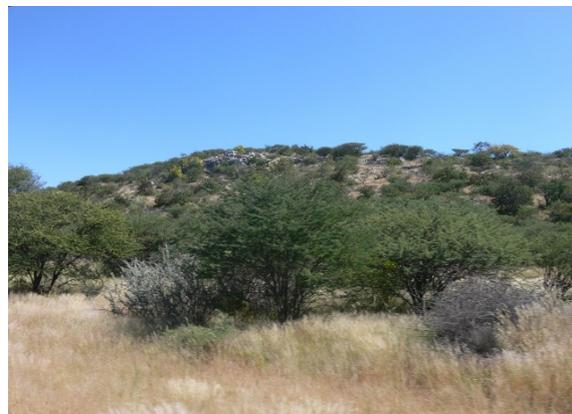
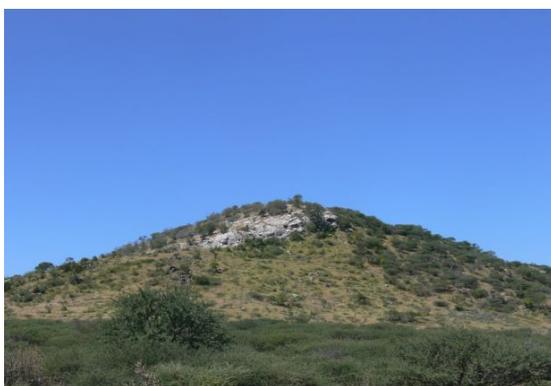
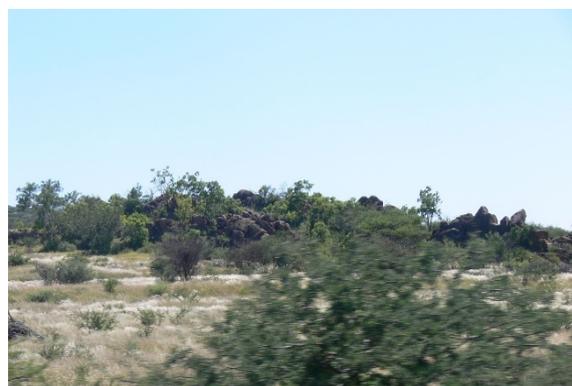
The railway line passes outcrops along its way in both Section 1 and 2. Deviations in the railway line in some places move towards some of these outcrops, but do not necessarily cross them. In other cases, outcrops may be partly in jeopardy.

These were marked for further investigation.

Photo 3.1.2 – Examples of outcrops along the railway line

Where possible rocky outcrops should be avoided during re-alignment of the railway line. This should happen automatically, due to the restricted gradient at which a railway line can operate. The outcrop areas have more sensitive ecology, with higher flora and fauna species biodiversity and endemism. Impacts on plains in the project area will cause less biodiversity loss and plains will recover more easily in a shorter period of time after a rainy season.

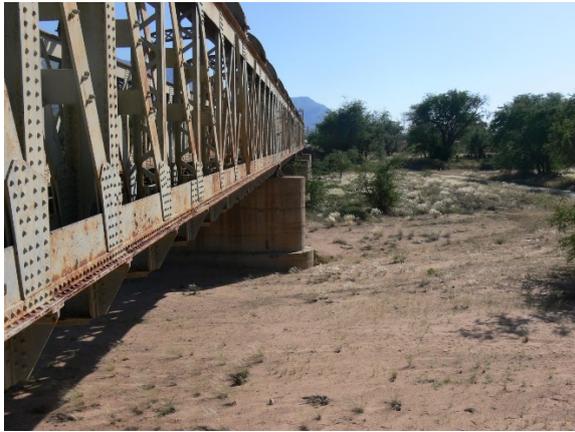
Photo 3.1.3 – Khan River

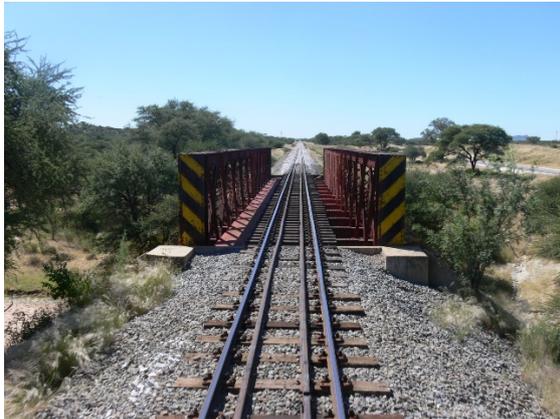
The railway line currently crosses all drainage lines and rivers with culverts and/or bridges that will be reconstructed during the upgrade construction phase. The ephemeral drainage lines and rivers carry surface water only occasionally during the rain season in November and/or February/March. For the rest of the year they are dry riverbeds. These dry riverbeds play an important role in the ecology of this arid area. The rivercrossings of the railway line was marked for further investigation, due to protected trees species present, possible fauna endemism here and possible surface and groundwater pollution during construction.

Photo 3.1.4 - Epako River Bridge

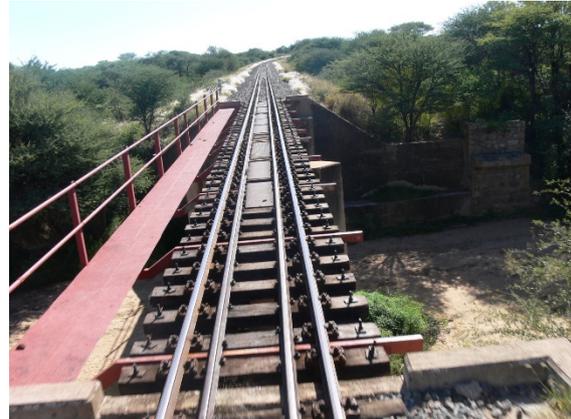
Erundu River Bridge

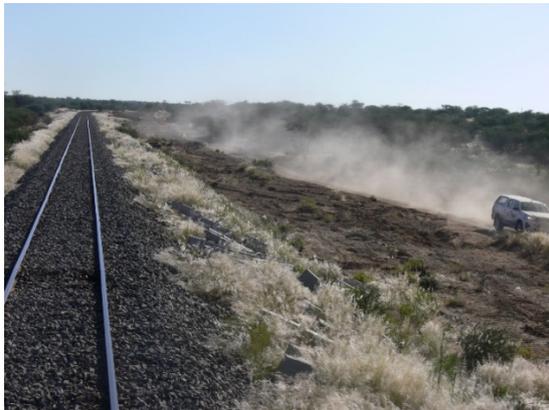
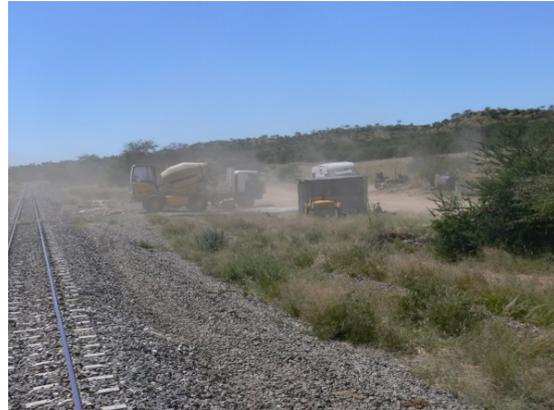
The air quality in Section 1 and 2 is good, since the railway line runs through rural environment for most of the way. The only nuisance in the servitude is occasional dust from maintenance vehicles on the service road next to the railway line as well as smoke from charcoal burning.

Photo 3.2.1 – Maintenance vehicles on the service road cause dust emissions

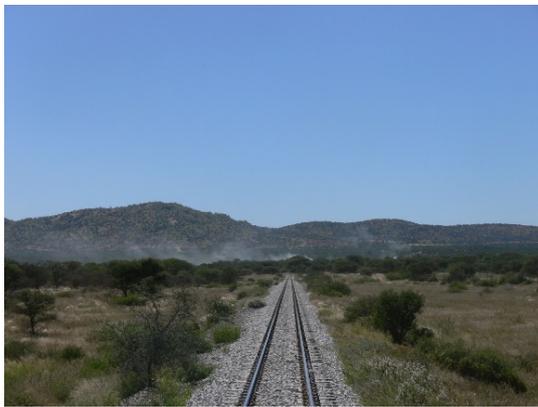
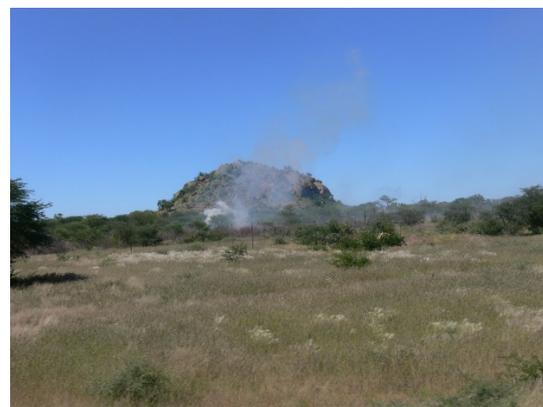
Photo 3.2.2 – Charcoal burning cause some form of air pollution on a small scale

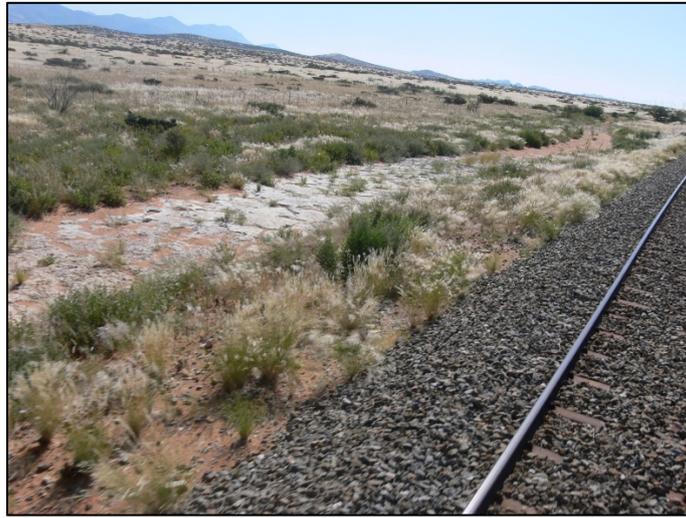
For most part of Section 1 and 2, the railroad runs over *Eutric Regosols*. This is relative fertile soil with high base saturation. Regosols are medium- or fine-textured soils of actively eroding landscapes. The thin layers lie directly above the rock surfaces from which they are formed. These soils do not reach depths of more than 50 cm and Photo 3.3.1 shows where the calcrete rock surfaces.

Photo 3.3.1 – Soil cover that expose underlying bedrock

Dust suppression will be required during construction for this soil type and where there is a degree of slope this soil type is susceptible to erosion.

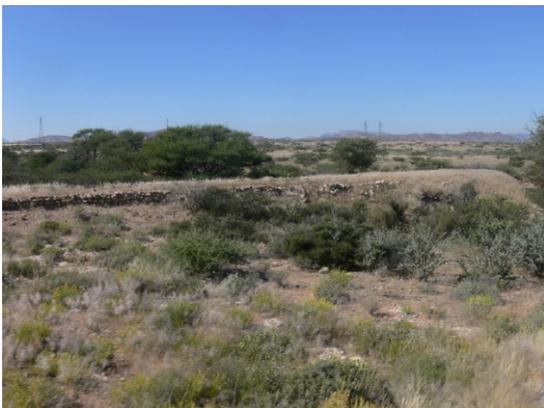
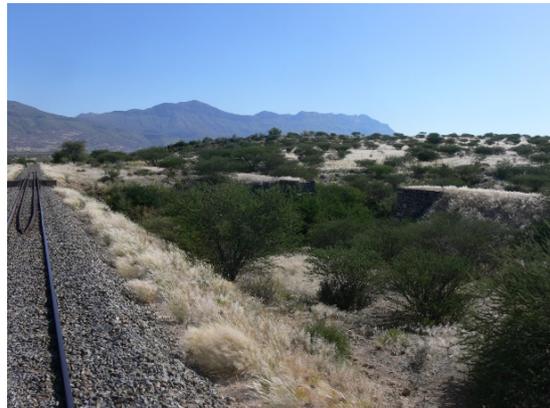
The servitude area can be described as an area that was previously disturbed and not in pristine condition any more. The railroad has been in existence for decades since early 1900 and was re-aligned and rebuilt already. The old embankment, with remains of culverts and bridge pillars are still visible in some places.

Photo 3.6.1 – Old embankment east of current railway line Section 1 Sample 1

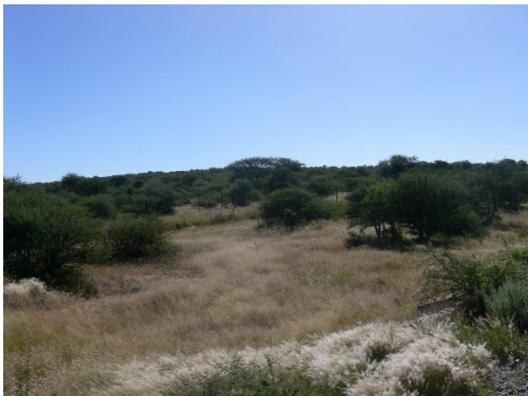
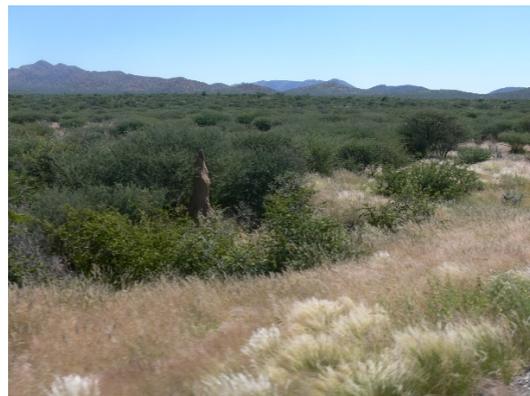
Bush encroachment is visible in areas with dense Acacia thickets in and around the servitude.

Photo 3.6.2 – Bush encroachment in Section 1 and Section 2

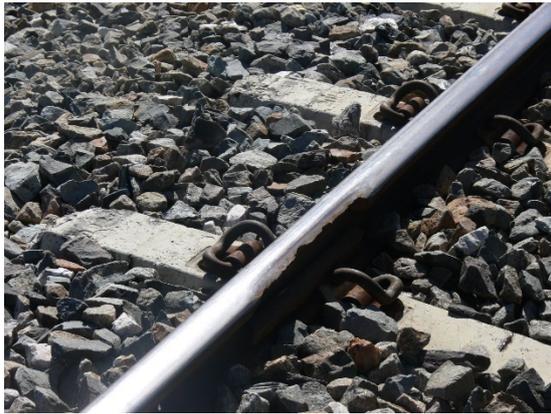
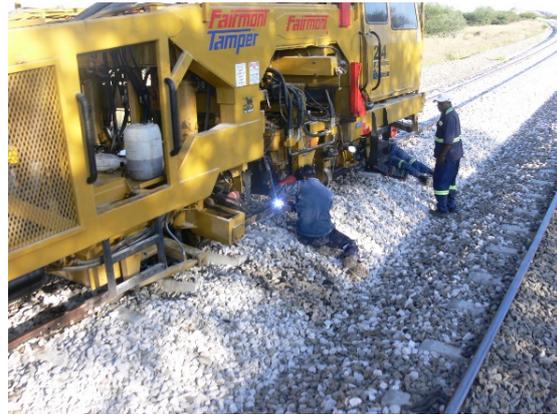
Maintenance and minor construction activities are on-going on the existing railway line. The railroad currently poses a threat to Health and Safety, because of its dilapidated condition in some areas.

Photo 7.8.1 – Broken rail between Erundu and

Replacement of rail near Norman Siding Avond Siding

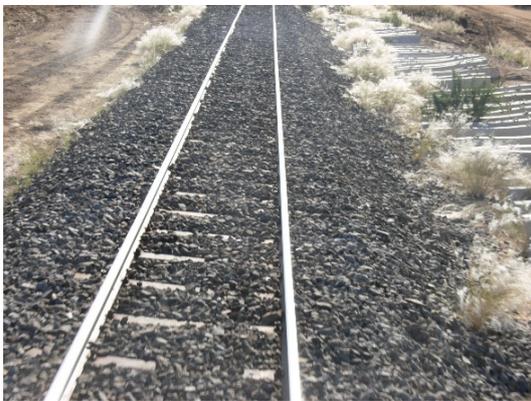
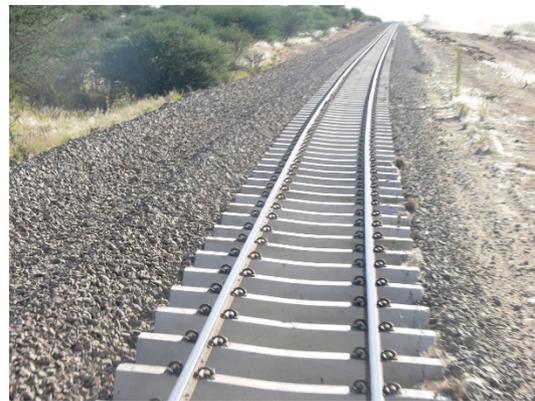
The old steel sleepers have been replaced with concrete sleepers for most of the way from Norman Siding northwards. Sleepers are currently being replaced between Erongo and Norman Siding. From Kranzberg to Erongo Siding the original steel sleepers are still in place and poses a Health and Safety hazard.

According to the engineers this maintenance programme is expensive and not sustainable in the long run.

Photo 3.8.2 – Original rail sleepers

Skeleton tracks without ballast may not be longer than 4 km during maintenance for Health and Safety reasons

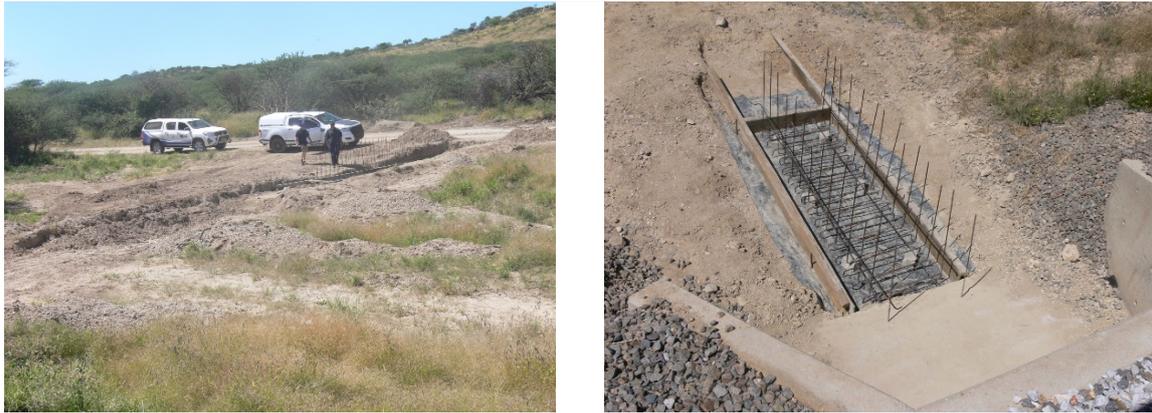
Photo 3.8.3 – Culverts are being reconstructed between Okozongoro and Etuo Siding
