**REPUBLIC OF NAMIBIA
MINISTRY OF WORKS AND TRANSPORT**

**Aircraft Accident Investigation Preliminary
Report**

Aero Commander- 695B (AC95): V5-DAM

DESCRIPTION OF OCCURRENCE: Runway Excursion

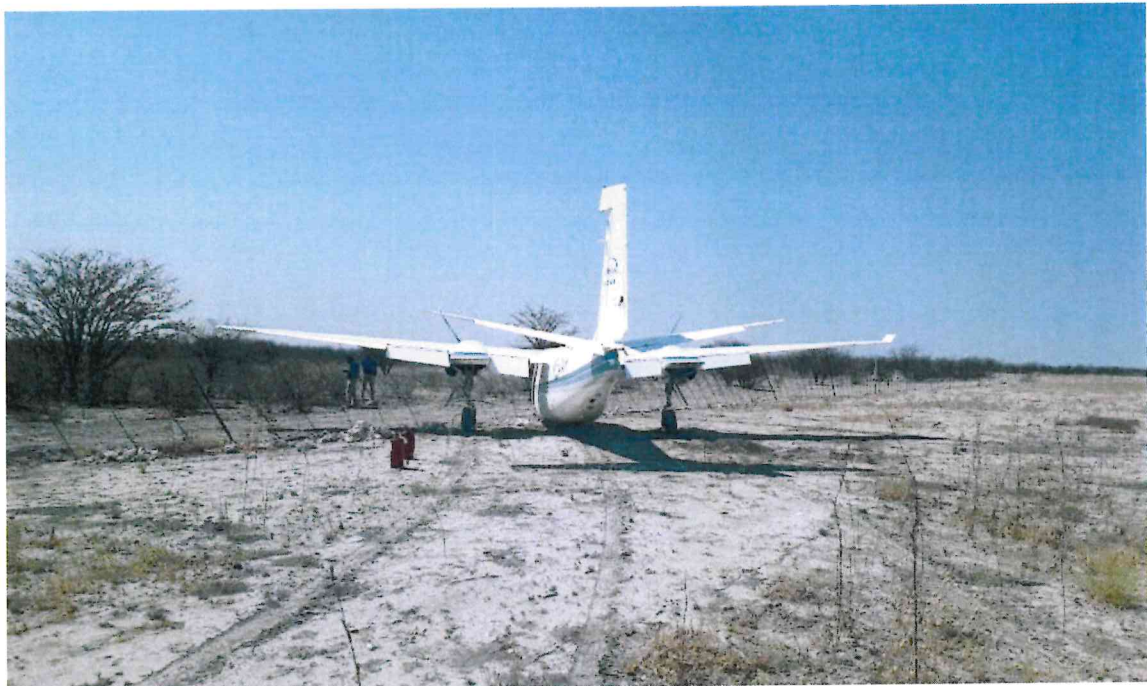
- 1.1.3. The aircraft left the runway and continued towards the perimeter fence until it collided with it. The distance from the point where the aircraft left the runway until the point where it collided with the perimeter fence was 171 meters.

Figure 2: Picture showing how the aircraft came to a full stop.

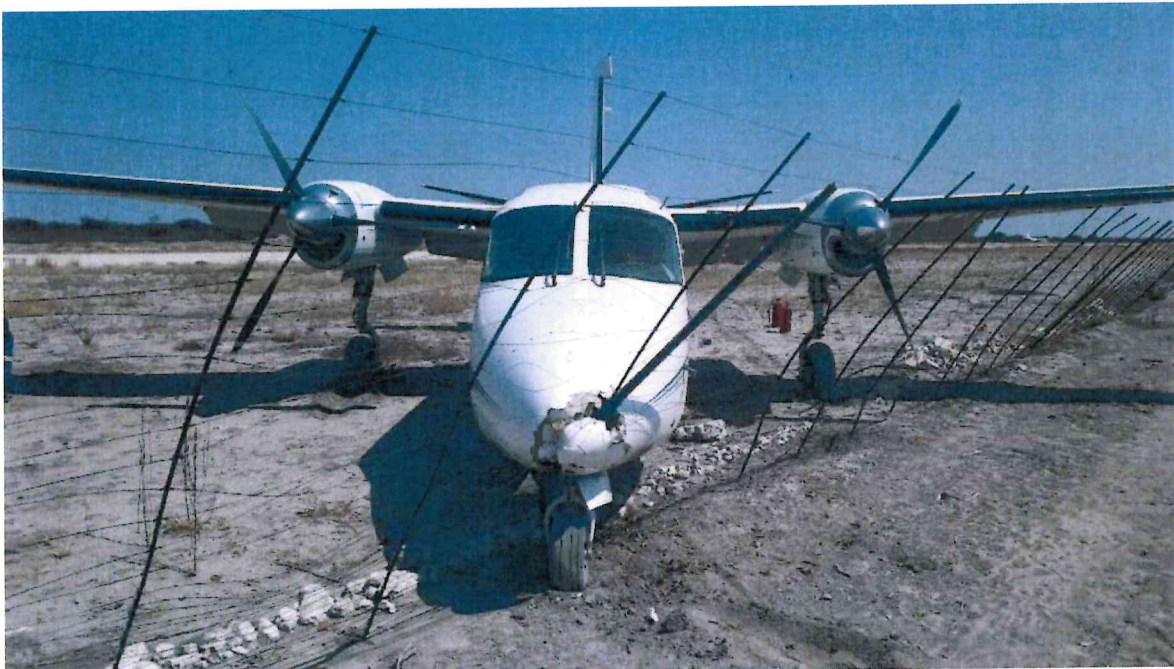
The Aircraft sustained substantial damage. When the aircraft collided with the perimeter fence, the radome (nosecone) hit an iron pole, causing the nose section of the aircraft to lift almost one meter off the ground before coming to a full stop. The iron pole caused substantial damage to the nosecone. The left propeller was also damaged when it struck the fence and smaller iron poles. The left wing of the aircraft made contact with the fence, but because the AC95 is a high-wing aircraft, only the underside of the wing, the de-icing boot, and the glass of the navigation light were damaged. The nose gear door also suffered some damage during the accident.

Figure 3: Picture showing the damage to the nosecone.

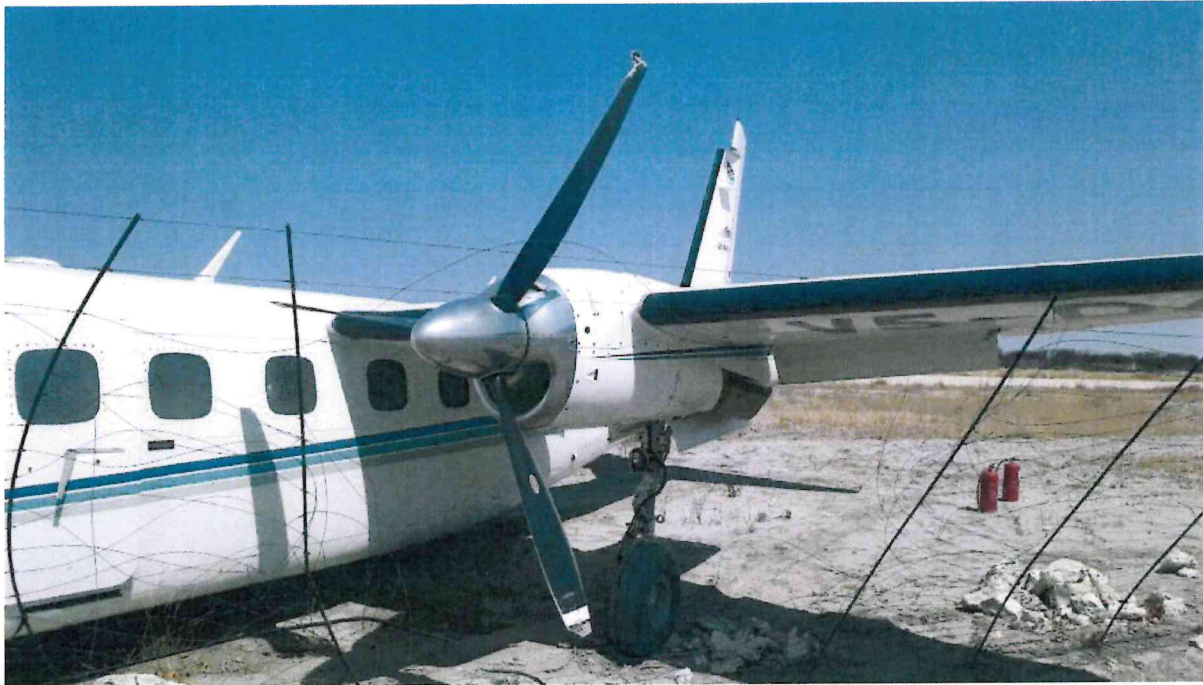
Figure 3: Picture showing the damage to the left propeller.
