**Directorate of Aircraft Accident and Incident
Investigations**

Accident Reference: ACCID/05032024-01-01

Reims Cessna 406 aircraft: V5-ASB

**Aircraft Accident Investigation Preliminary
Report**

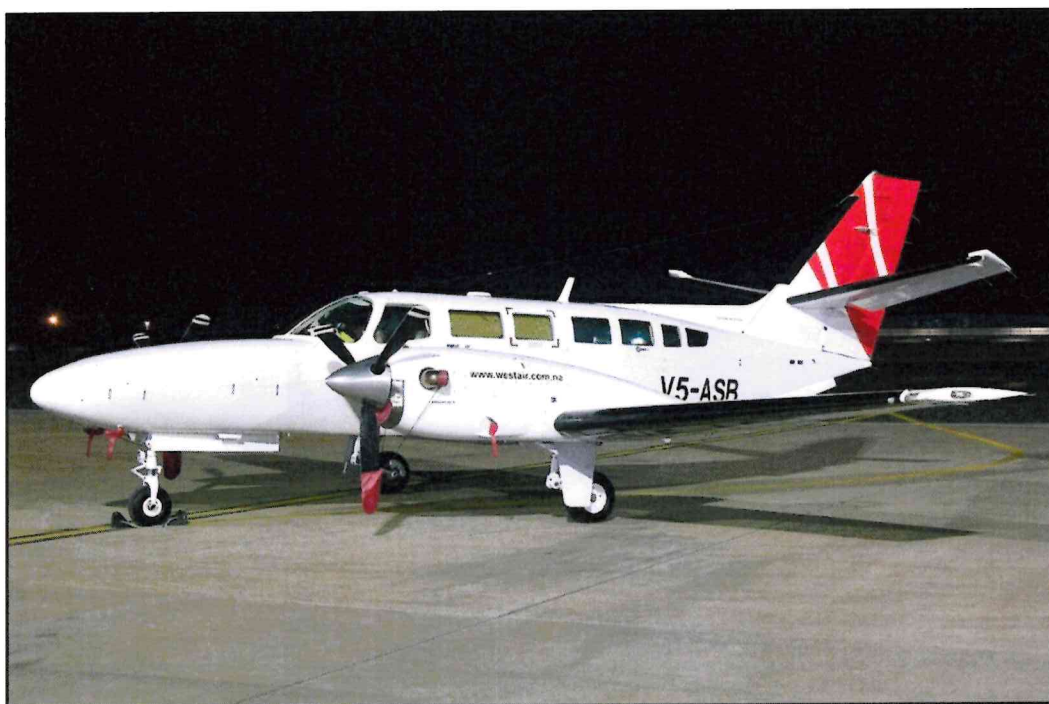
Figure 1: The Reims Cessna 406 aircraft V5-ASB accident aircraft (source: Operator)

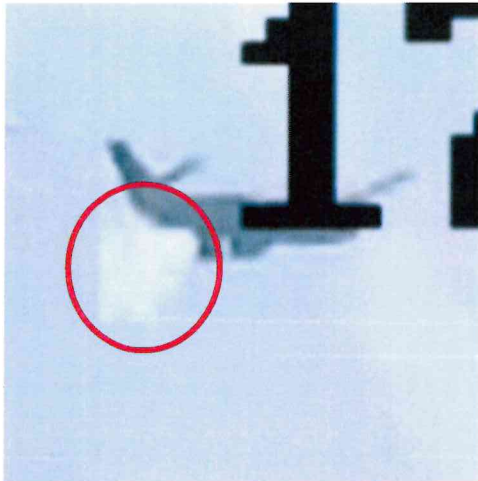
- 1.1.3. After take-off, according to CCTV camera footage, a cloud of smoke could be observed consistent with a malfunction in the left engine. As soon as the smoke around the left engine was observed, the aircraft banked sharply to the left and crashed.

Figure 2: Image shows a cloud of smoke observed around the left engine. (CCTV Footage courtesy of the Operator)

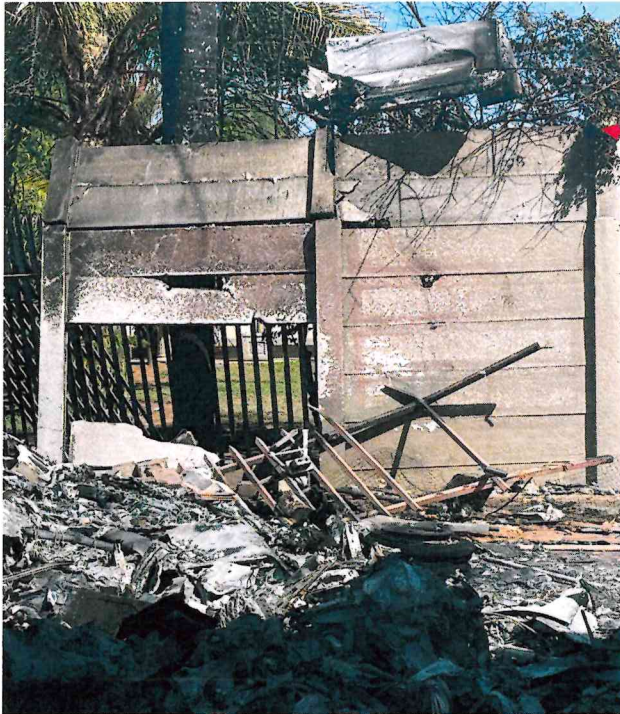
Horizontal stabilizer and elevator

Figure 3: Picture showing where the left horizontal stabilizer and elevator ended up.

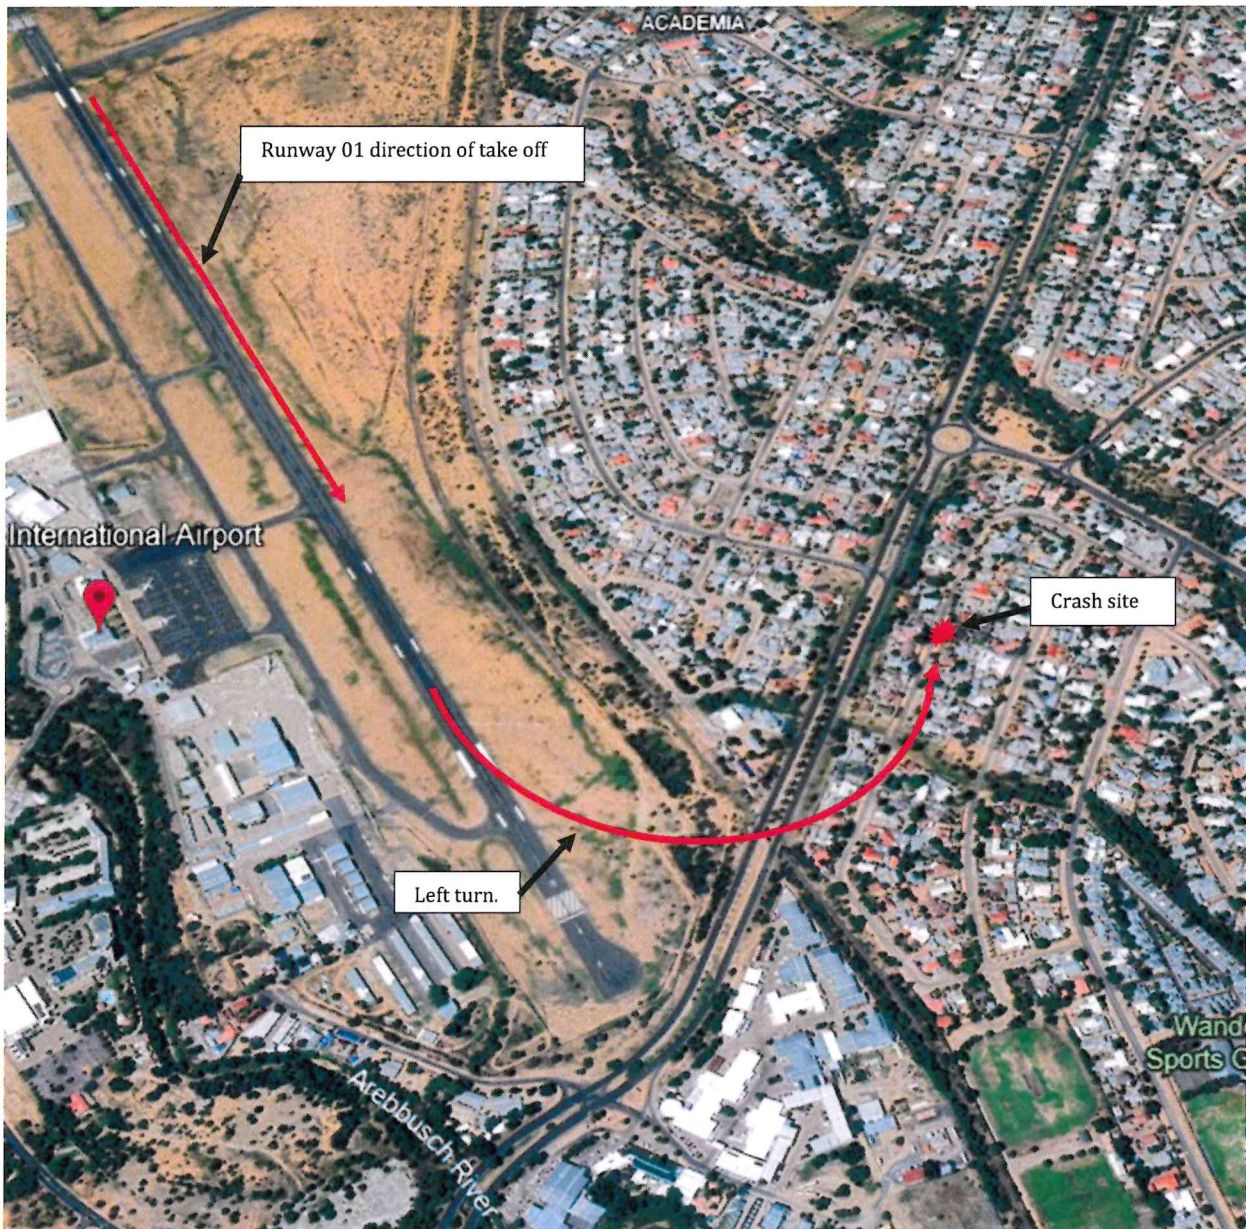
- 1.1.5. The left wing impacted the ground first followed the left engine and the nose section of the aircraft, hitting trees in the first yard. The impact caused the aircraft to flip over sideways breaking through 2 precast fences and small wall and came to rest in the corner of the second yard with the right horizontal stabilizer and elevator ended up on top of the precast fence. The impact also caused fuel to squirt from the left wing onto the street. One of the left propeller blades was thrown approximately 200 meters away and landed in another yard. As soon as the aircraft broke through the first precast fence it burst into flames.

Figure 4: Picture showing where the Aircraft crashed (Image: Google Earth).

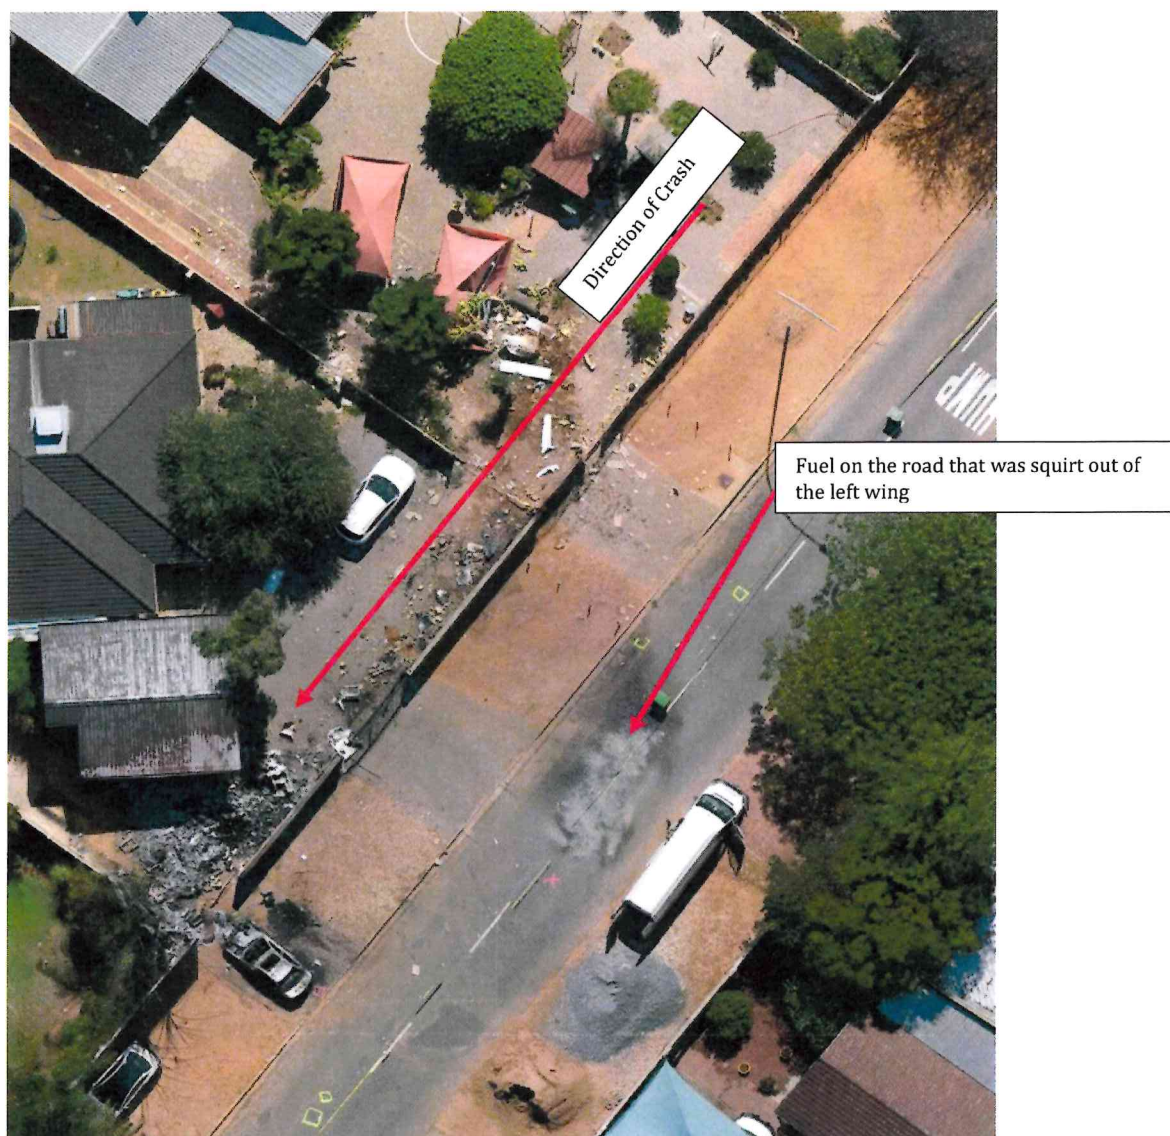
- 1.12.1 The left wing of the aircraft impacted the ground first followed the left engine and the nose section of the aircraft, hitting trees in the first yard. The impact caused the aircraft to flip over sideways breaking through 2 precast fences and a small wall and came to rest in the corner of the second yard with the right horizontal stabilizer and elevator ended up on top of the precast fence. The impact also caused fuel to squirt from the left wing onto the street. One of the left propeller blades was thrown approximately 200 meters away and landed in another yard. As soon as the aircraft broke through the first precast fence it burst into flames.

Figure 8: Picture showing the impact sequence.
