Aircraft Accident Investigation Preliminary Report

DESCRIPTION OF OCCURRENCE: Propeller separated in flight.

AIRCRAFT TYPE: Jabiru 4 (V5-UKT)

DATE AND TIME: 2024/10/05 (1615 UTC).

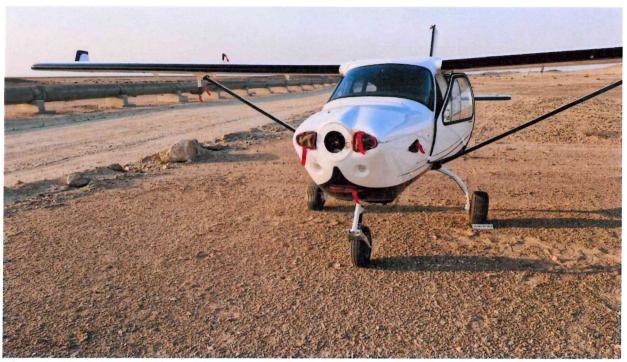
Due to a sharp curve in the road, the pilot opted to continue straight, running off the road onto uneven ground. Using full backstick, the pilot aimed to preserve the nose gear during the rough landing. After coming to a stop, both occupants disembarked without injury.

Photo 1. Aircraft next to the service road.

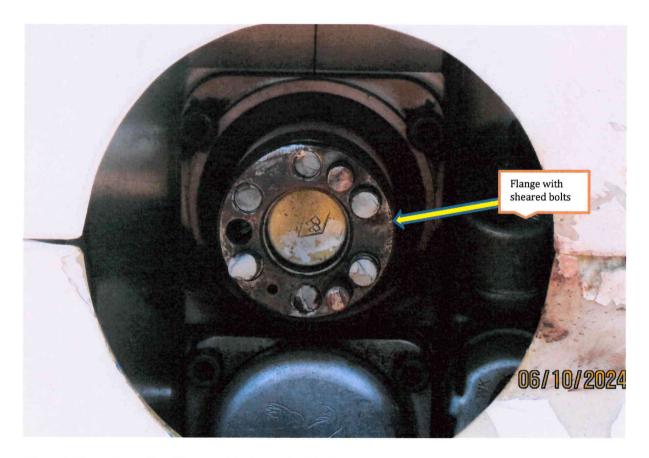
Photo 2 Photo Propeller Flange with sheared off bolt.

An inspection of the aircraft revealed the following damage: the propeller was missing, causing some impact damage to the engine cowling, and minor delamination was observed on the right-hand landing gear
