Aircraft Accident Investigation Preliminary Report

Cessna 206 (V5-NSK)

DESCRIPTION OF OCCURRENCE: Runway Excursion and subsequent collision with terrain.

LOCATION: Farm Masindi 371, Gobabis

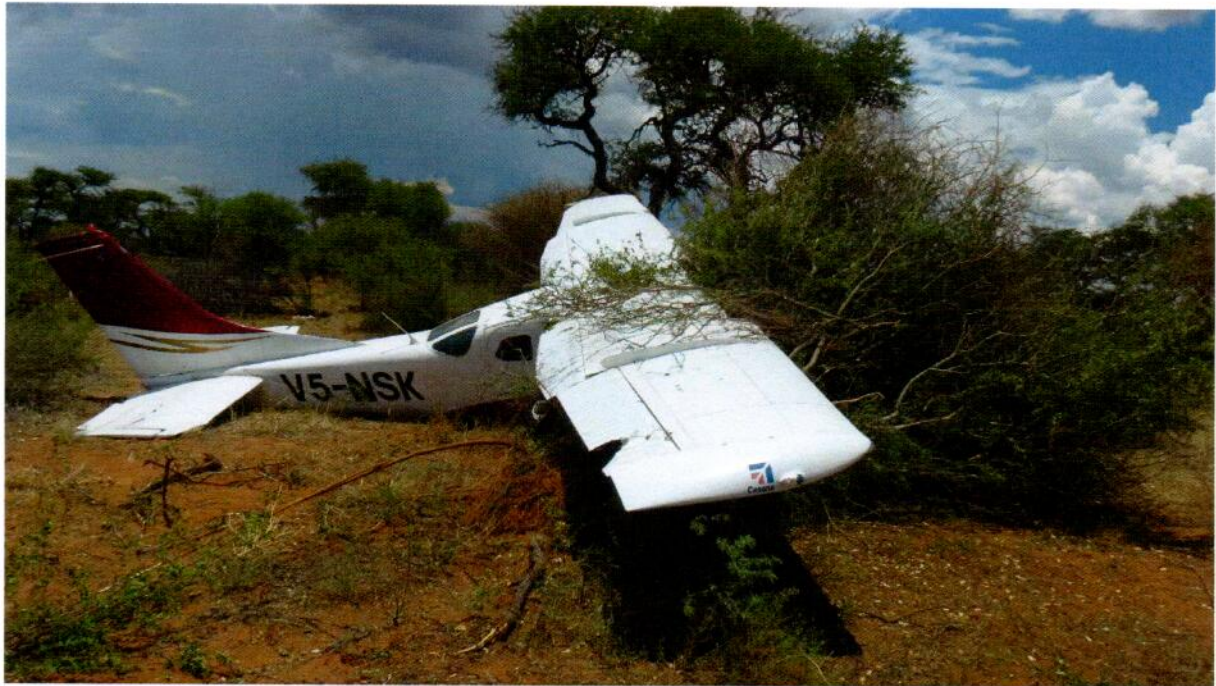
Photo 2 Photo depicting the aircraft's impact on vegetation

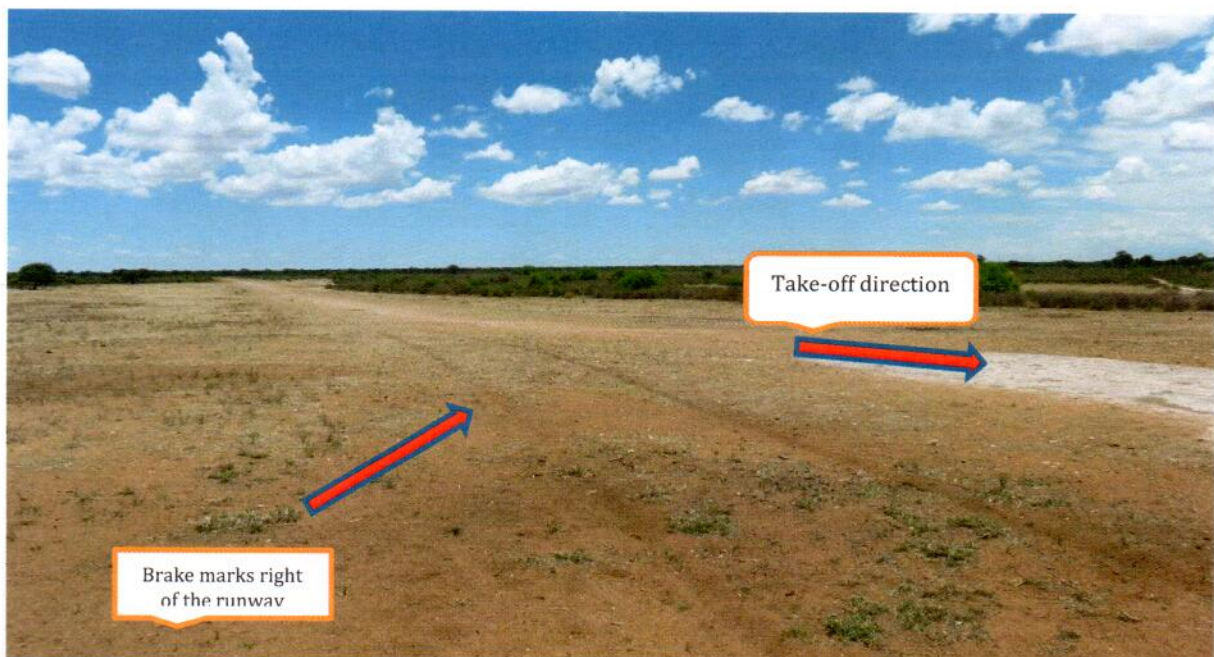
Photo 3 Photo depicting the aircraft's brakes as it left the runway veering to the right.
