Accident Reference: ACCID/07172023/01-06

Aircraft Accident Investigation Preliminary
Report

DESCRIPTION OF OCCURRENCE: Robinson 44 Helicopter
crashed East of Swakopmund Airfield

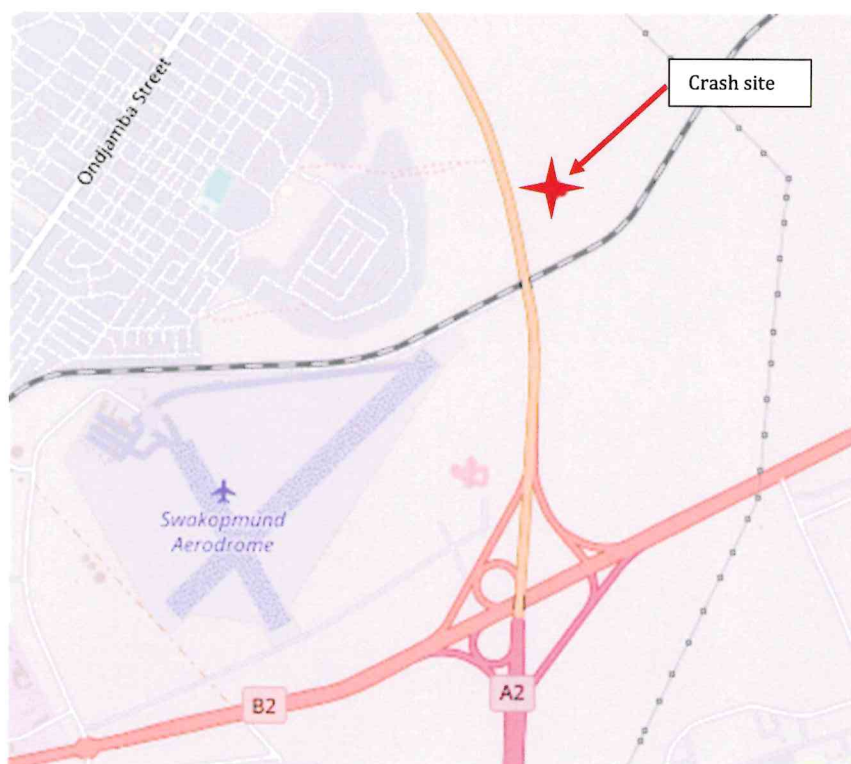
- 1.1.5. The helicopter impacted the ground on the left side at a very high velocity. The tailboom was found 158 meters away from the wreckage. The front part of the blade that struck the tail was found 55 meters away from the main wreckage. The resultant accident was not a survivable accident.

Figure 2: Picture showing where the helicopter crashed.

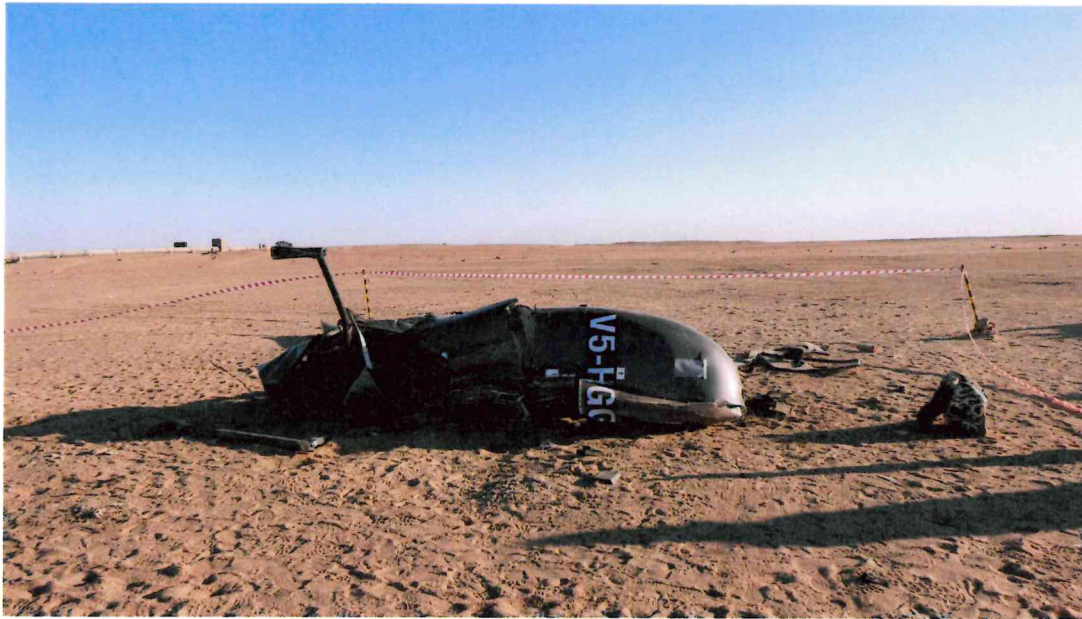
1.3.1. The helicopter was destroyed.

Figure 3: Picture showing the destroyed Helicopter as it came to rest.

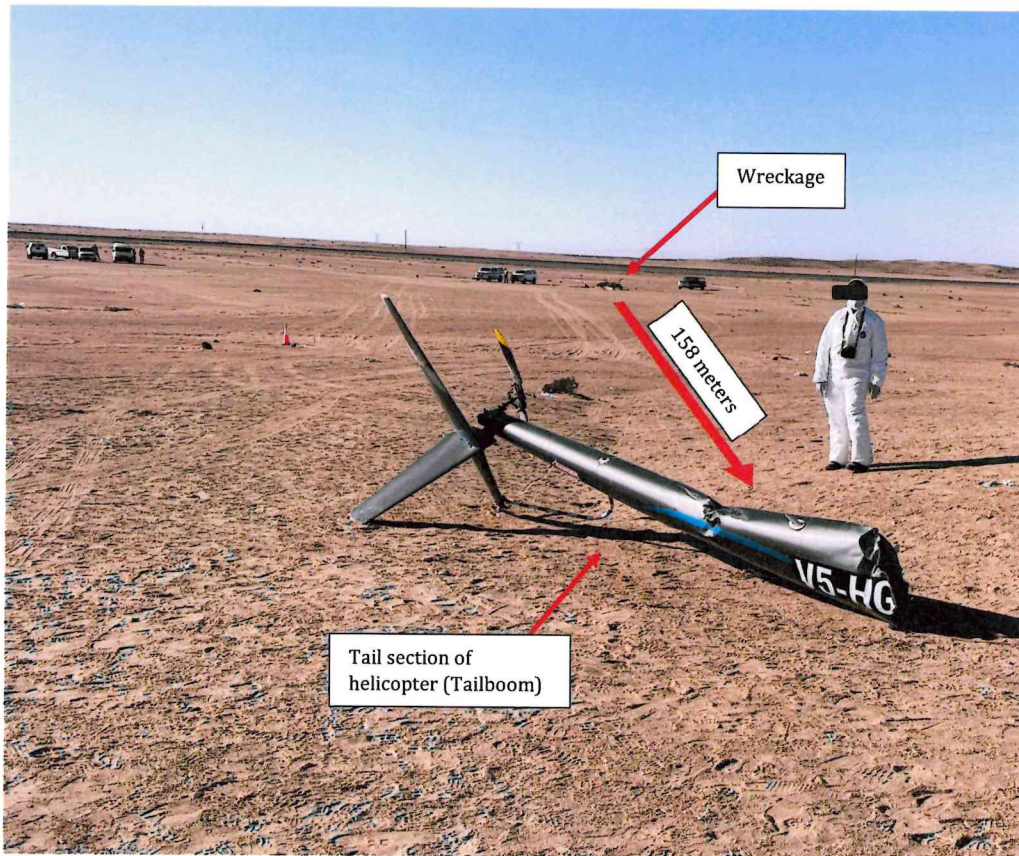
- 1.11.1. The tailboom was found approximately 158m from the main wreckage and the front piece of one of the main rotors was found 55 meters away from the main wreckage. The impact was so severe that the main cabin was compressed. The helicopter was destroyed.

Figure 4: Picture showing how far the tailboom landed away from the main wreckage.

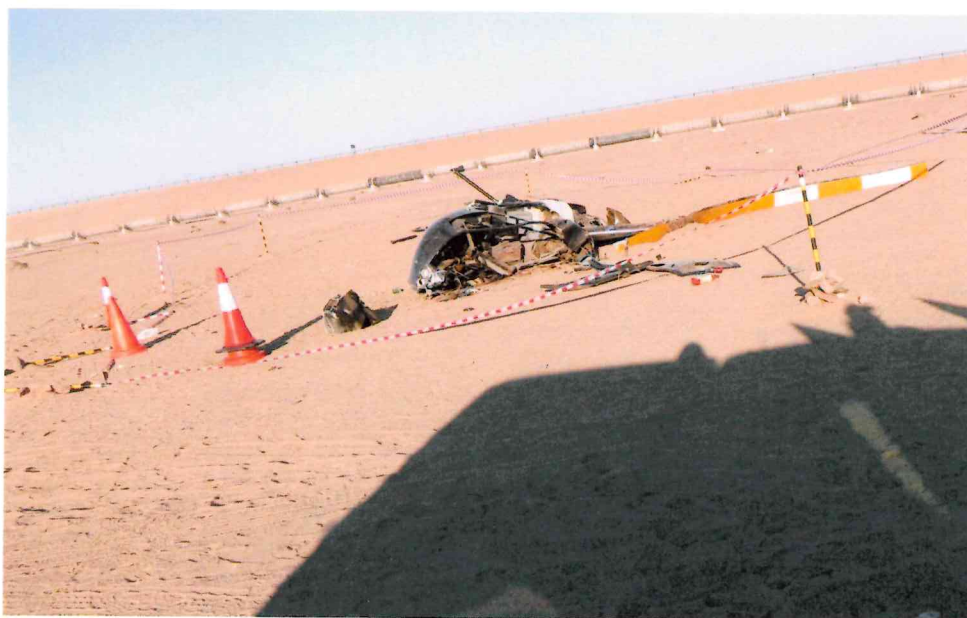
Figure 5: Closer view of helicopter.
