Occurrence Reference: ACCID/01292023/01-01/

**Aircraft Accident Investigation Preliminary
Report**

AIRCRAFT TYPE: ULF-1E, (D-NEQR)

DATE: 29/01/23

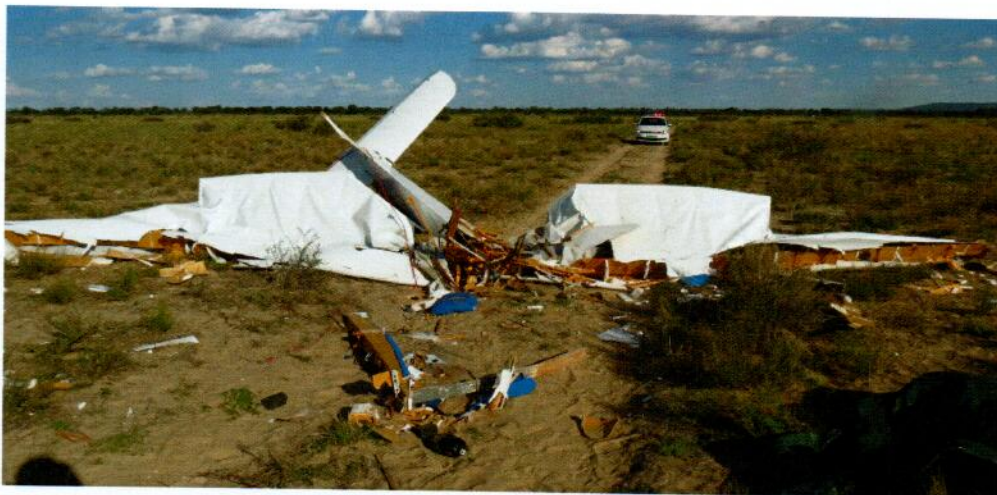
- 1.12.1 The aircraft dived into the ground at near vertical angle and then broke apart. A small crater on the ground with protruding wooden splitters was evident. The dope and wood airframe was scattered over a small radius.

Figure 1: Extent of damage on the fuselage and relatively small radius of wreckage distribution.
