Aircraft Accident Investigation Preliminary Report

Loss of Elevator control due to broken Control Cable

Cessna F406

V5-WAI

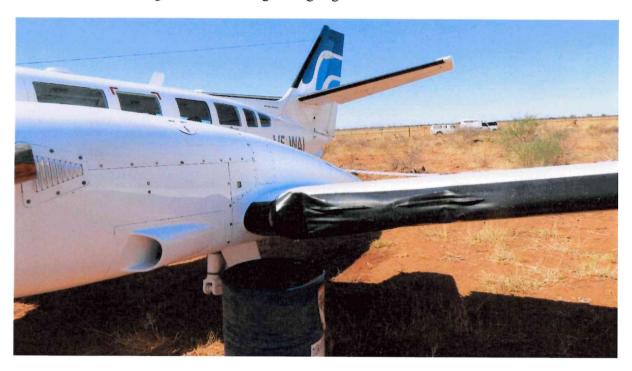
The aircraft sustained damage on the left wing leading edge, the left windshield, propellers and both pitot tubes. A detailed investigation on the damage is ongoing.

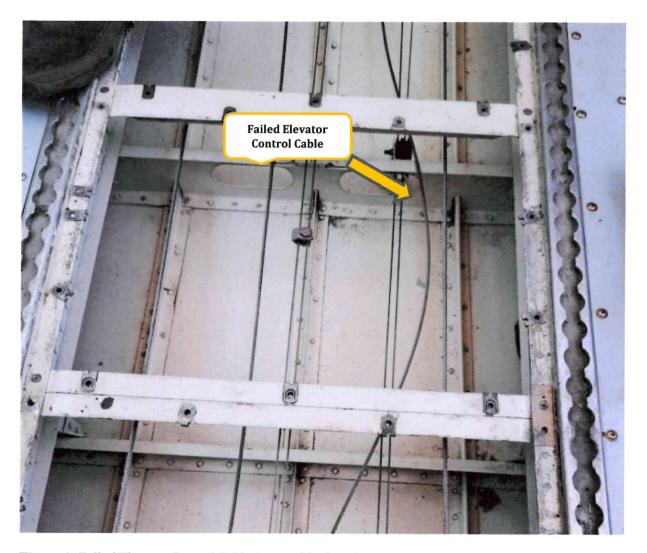
After gaining acces to the rear floor panels, the investigation revealed a failed Elevator Control Cable,

Figure 1: Failed Elevator Control Cable (rear cabin floor.)

DAAII reccomends operators of F406 to note the preliminary details of this occurrence, and that all Cessna F406 and applicable series, undergo a visual and borescope inspection to ensure the integrity of primary control cables and their routing.

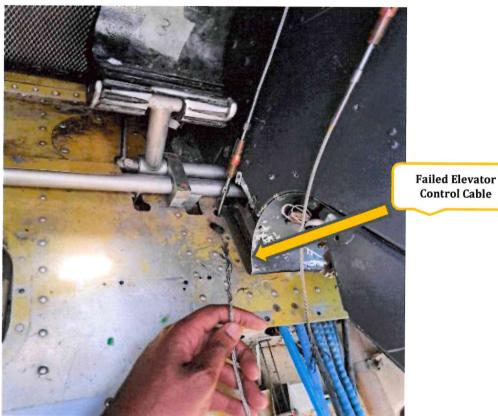
The forward floor panels were also removed. The actual point where the control cable failed was detected, which was underneath the left-side rudder pedals.

Figure 2. Broken cable underneath the rudder pedal.
