REPUBLIC OF NAMIBIA
MINISTRY OF WORKS AND TRANSPORT

Accident Reference: ACCID/050523/01-04

**Aircraft Accident Investigation Preliminary
Report**

DESCRIPTION OF OCCURRENCE: Cessna 182 crashed during the landing face

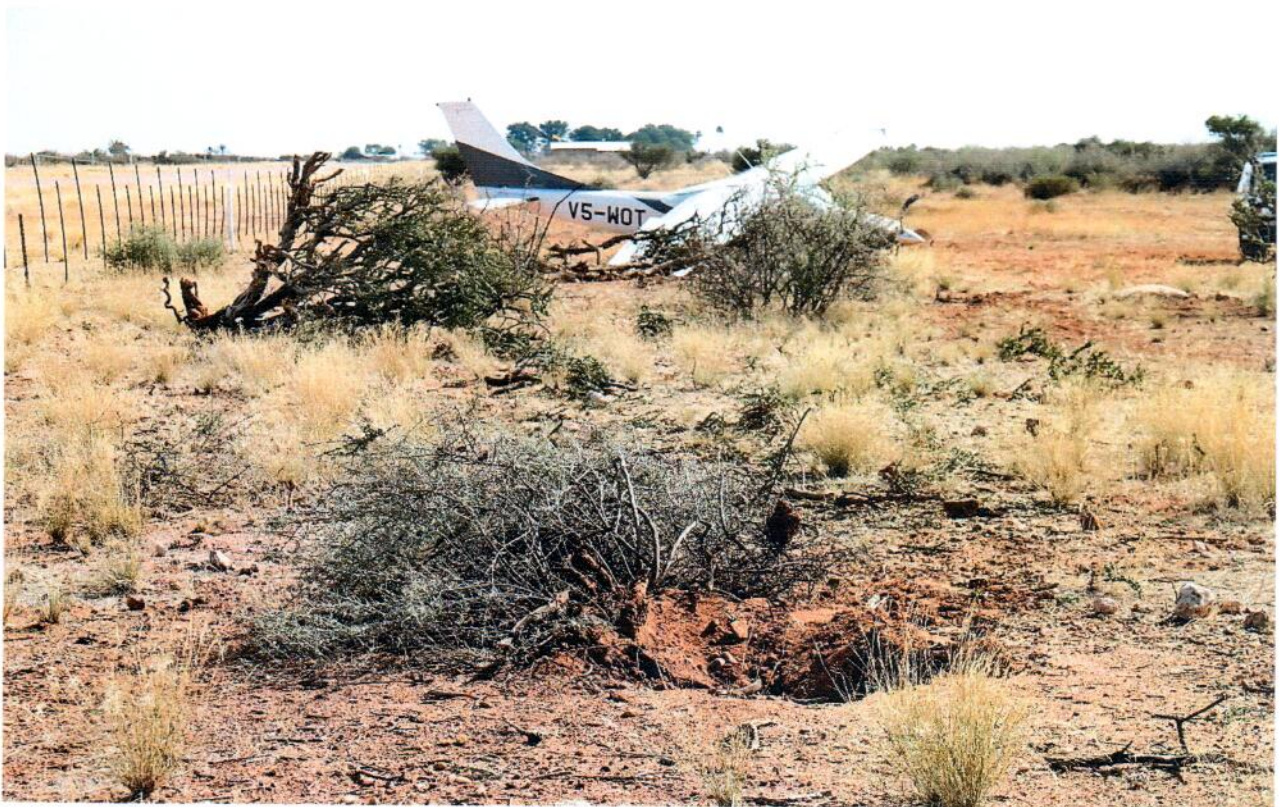
- 1.4 The aircraft stroked a sheppard tree first, uprooted the tree and take it along for a distance of 15 meters. It stroked another tree and came to a stop facing the easterly direction.

Figure 1. Photo depicting the area where the aircraft stroked trees and came to a halt.

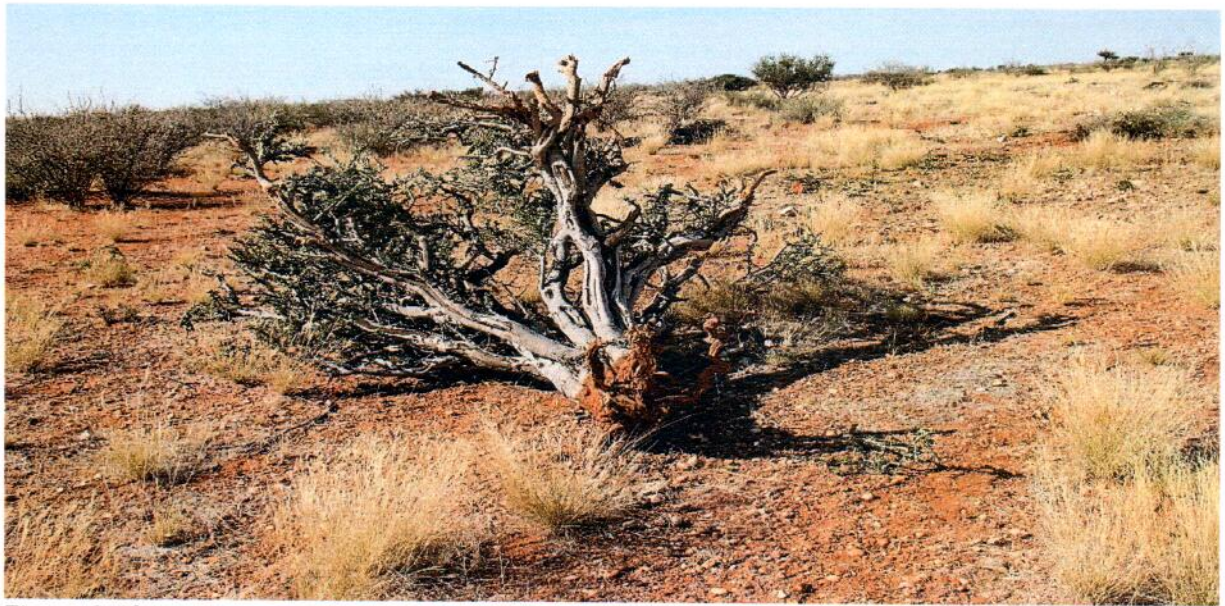
Figure 2. Photo Depicting the uprooted shepherd tree that the aircraft stroked first

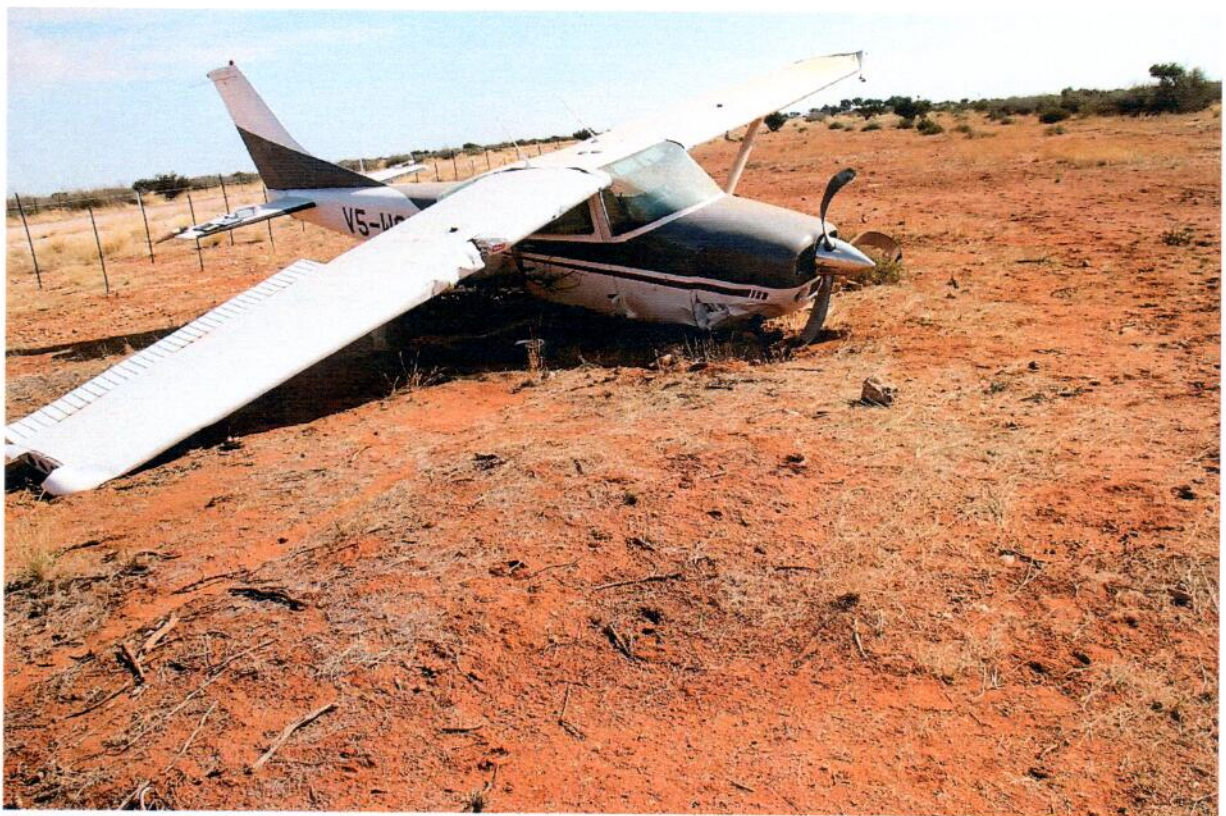
- 1.5 The aircraft sustained substantial damage especially to the undercarriage, berry, right wing, propeller and a lot of dent of the airframe.
- 1.6 The wreckage was transported to Windhoek on a trailer for further analysis to determine if there is more damage and if a need for more component examination will be required.

Figure 3. Photo Depicting aircraft and the damage sustained during the crash.

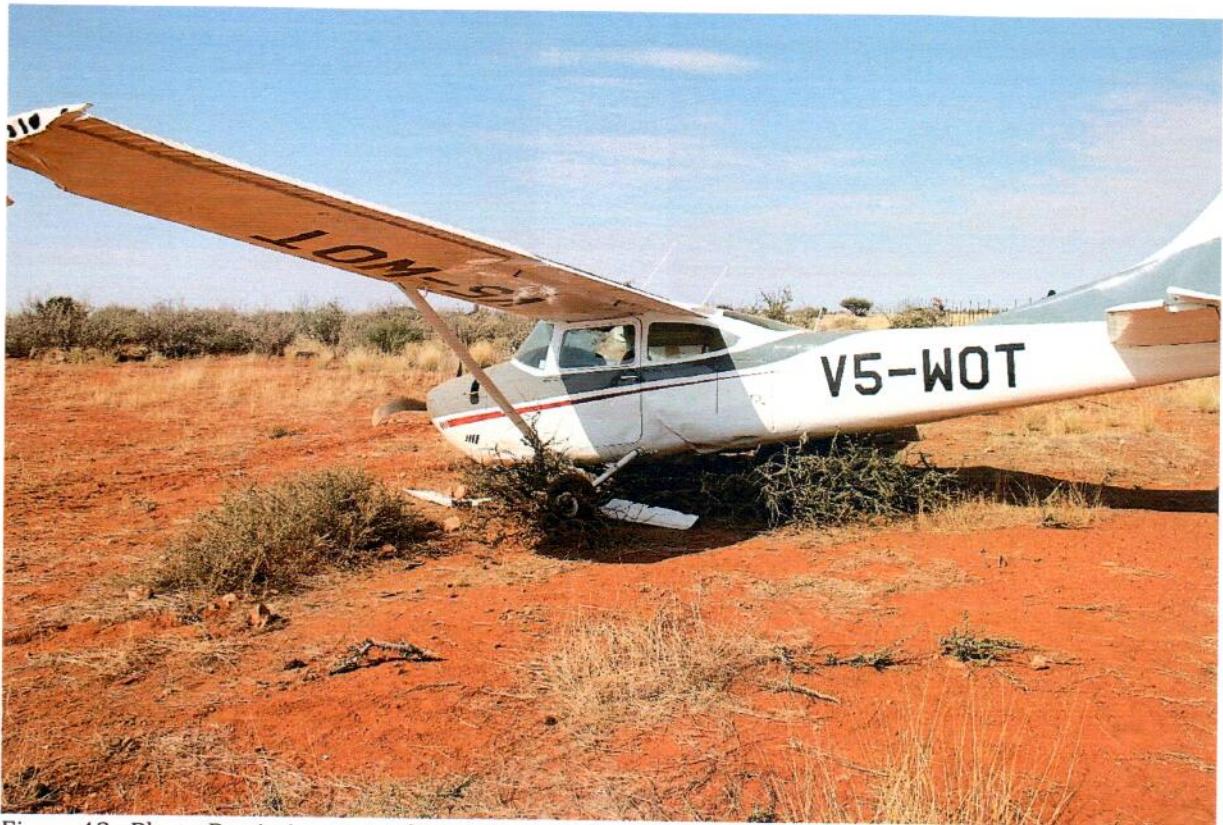
Figure43. Photo Depicting aircraft and the damage sustained during the crash
