Factual Report

| Type of Occurrence: | Accident |
| Date: | 16 November 2019 |
| Location: | Frankfurt/Main Airport |

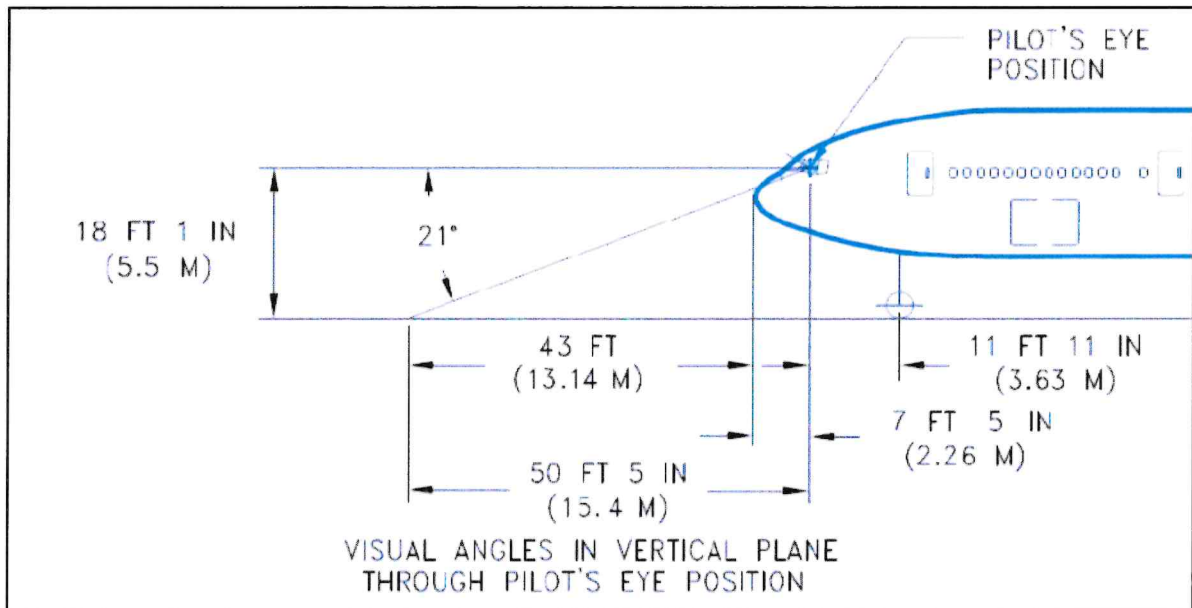
Fig. 2: Visual options from the cockpit down

The distance between nose wheel and the field of view ahead of the aircraft from the pilot's eye position is 19.03 m.

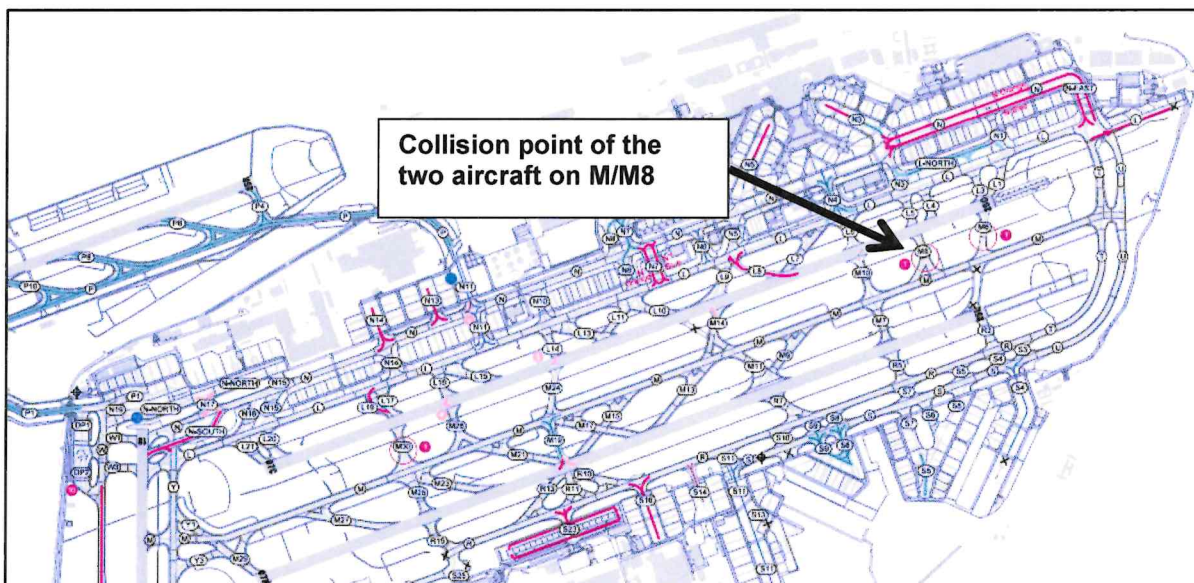
Fig. 3: Aerodrome chart Frankfurt/Main Airport

Taxiway M, where the accident took place at the intersection with taxiway M8, runs parallel between runways 25L and 25C. Taxiway M8 is located in the eastern area. For taxiway M8, the Aerodrome Ground Movement Chart included the note: *Explicit clearance required for crossing RWY 07C/25C. Stop at CAT II/III holding point, stop-bar is illuminated under all weather conditions.*

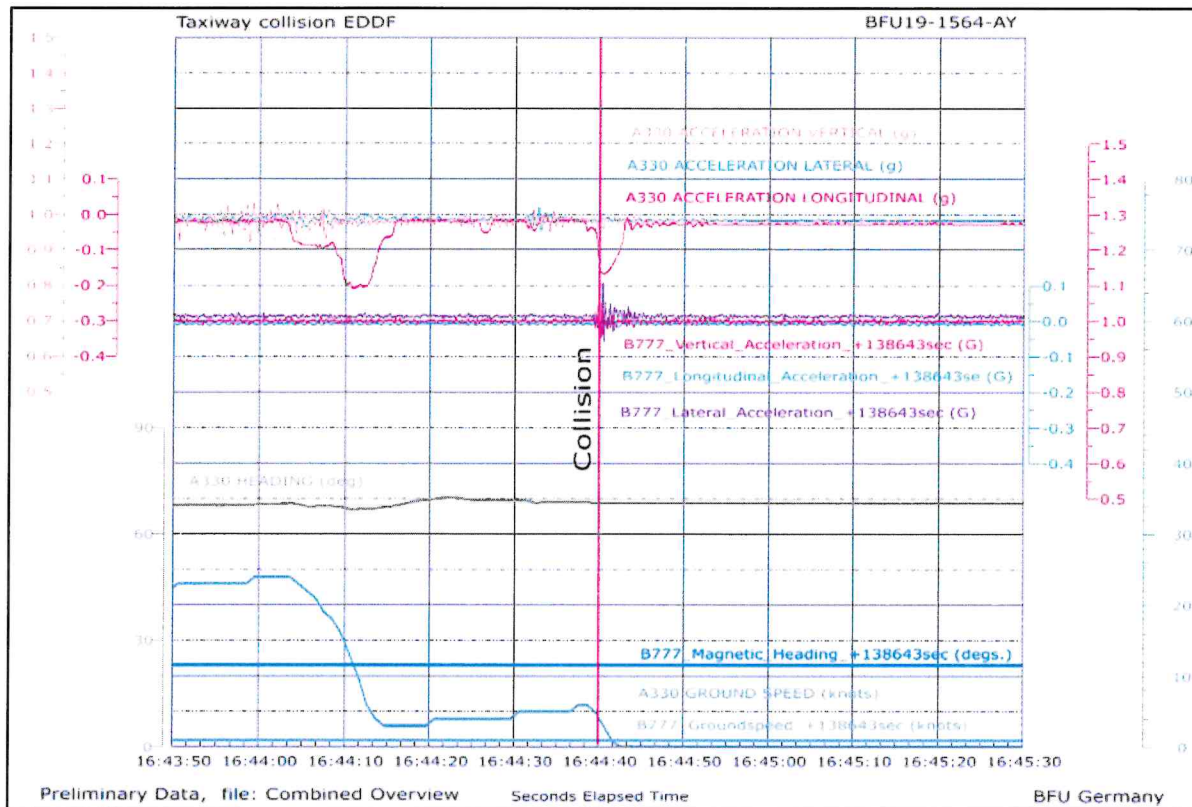
Fig. 4: Overview of the FDR data to determine the time of collision

The FDR data was used for the description in the chapter History of the Flight. The FDR data showed that the B777-300ER stood still and the A330-200 was decelerat-

ed prior to reaching the intersection and then taxied slowly farther until the collision (Fig. 4 and Fig. 5).

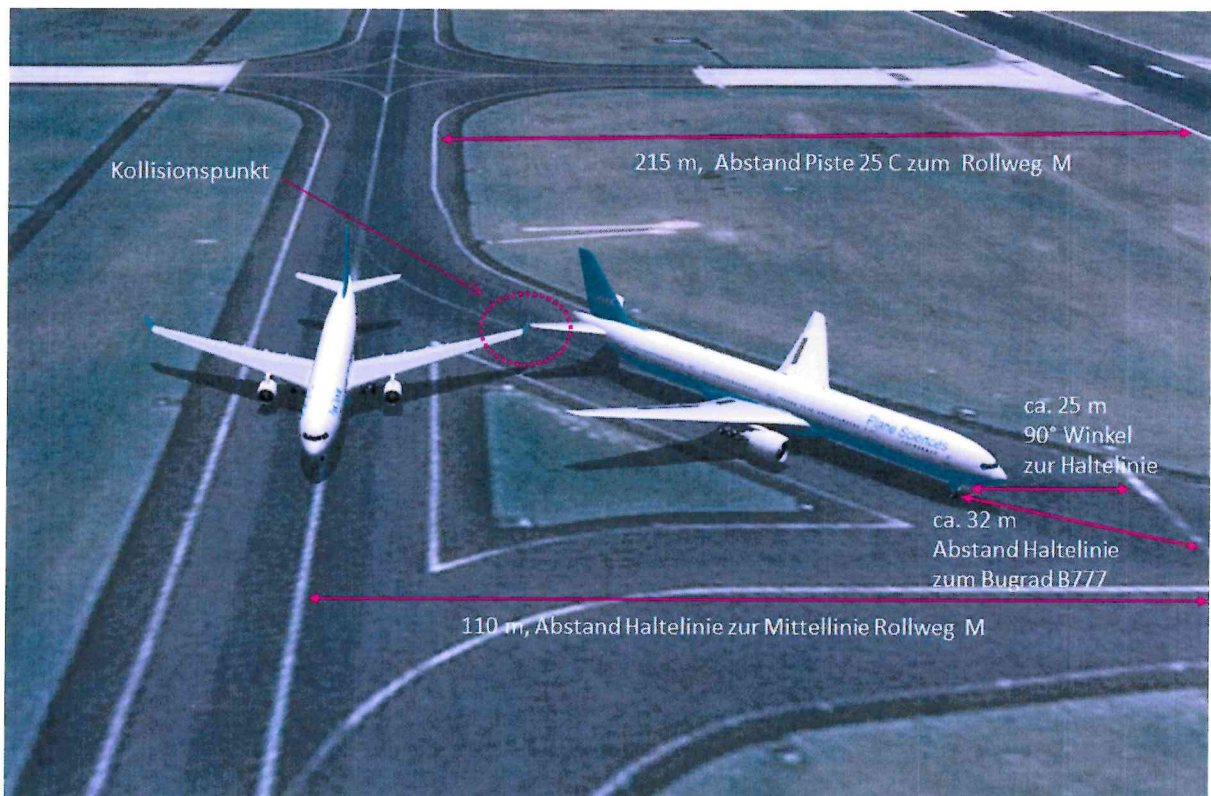
Fig. 5: Reconstruction of the aircraft positions during the collision

The collision occurred at the intersection with taxiway M to taxiway M8.

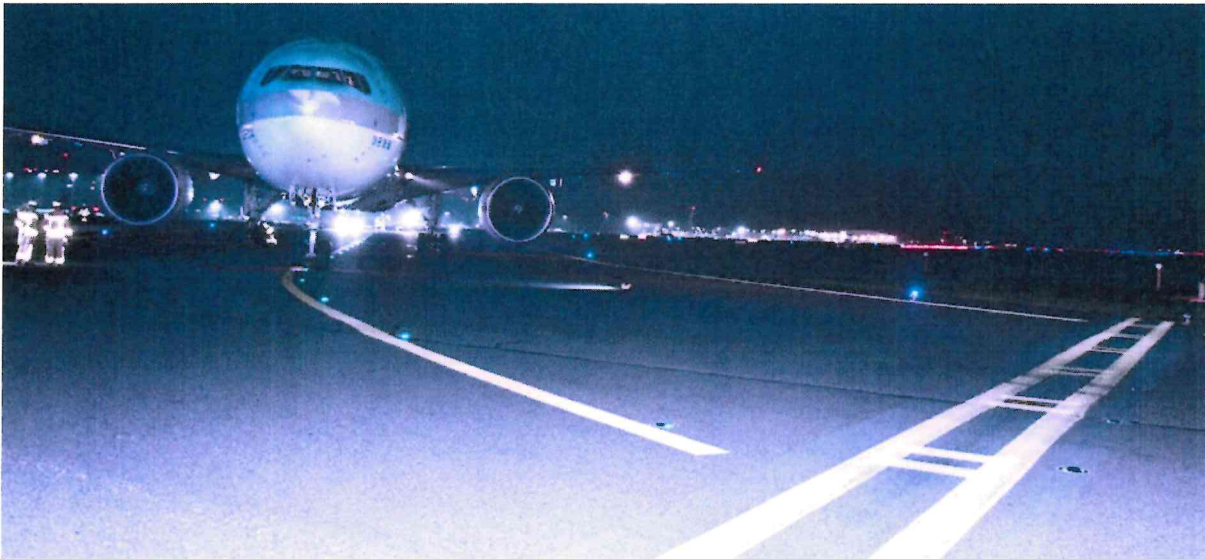
Fig. 6: Distance of the Boeing 777-300ER to the holding position

The Boeing 777-300ER stood pointing about north in the direction of holding position CAT II/III at the intersection of taxiway M with taxiway M8. The right nose wheel stood on the yellow centre line. If measured along the yellow centre line, the distance between the nose wheel and the holding position of taxiway M8 was about 32 m. If measured at a 90° angle it was about 25 m.

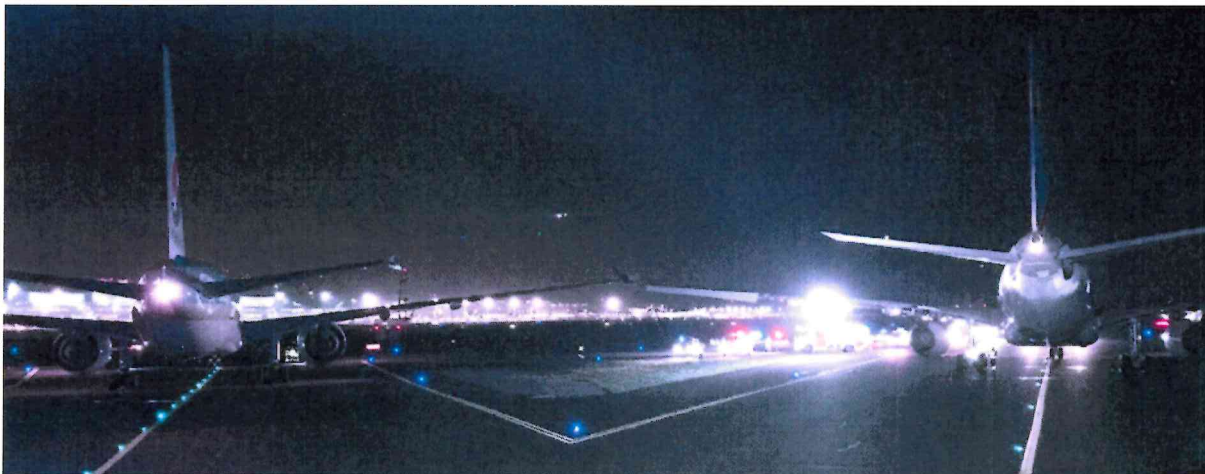
Fig. 7: Position of both aircraft after the collision

The Airbus A330-200 stood on taxiway M pointing east with the left nose wheel just about on the yellow centre line.

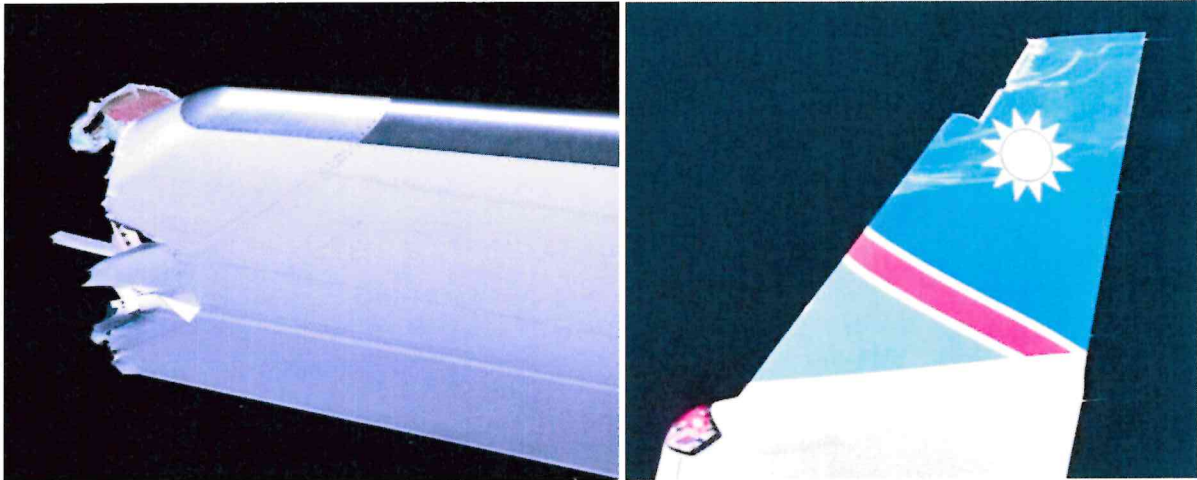
Fig. 8: Damage on the B777 elevator and the A330 winglet

The Airbus taxied along taxiway M. Shortly before reaching the intersection with taxiway M8 taxi speed was reduced. At about 1744 hrs when passing the intersection, the left winglet of the Airbus collided with the elevator of the Boeing. The elevator was substantially damaged. According to the CVR recordings, the Airbus flight crew had seen the Boeing and was aware that it could be a tight fit.

During the collision the outer area of the right elevator of the Boeing 777-300ER was damaged. Parts of the elevator were lying about 28 m behind the Boeing on taxiway M. The upward pointing winglet of the left wing of the Airbus A330-200 was damaged.

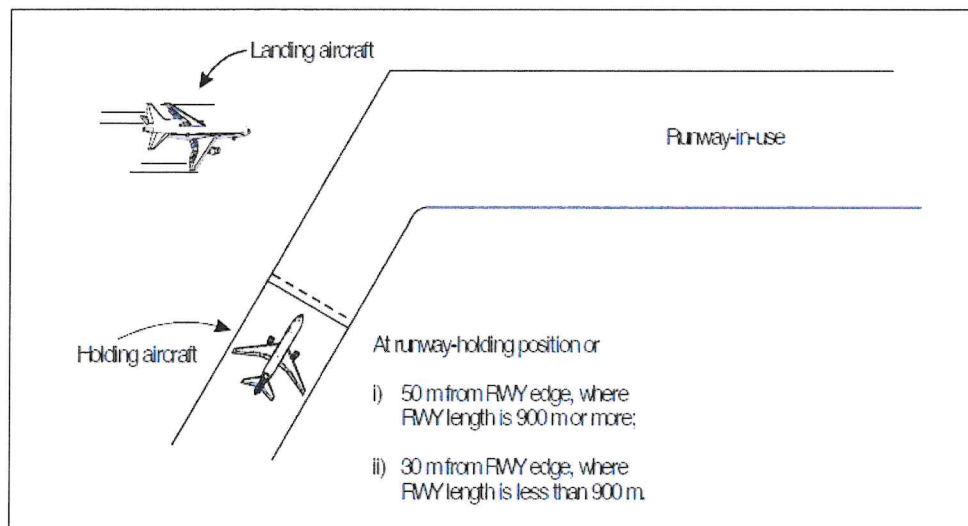
Figure 7-2. Method of holding aircraft (see 7.6.3.1.3.2)

7.6.3.1.3.1 Except as provided in 7.6.3.1.3.2 or as prescribed by the appropriate ATS authority, aircraft shall not be held closer to a runway-in-use than at a runway-holding position.
