**REPUBLIC OF NAMIBIA  
MINISTRY OF WORKS AND TRANSPORT**

**Accident Reference: ACCID/112913/1-12**

# **Aircraft Accident Investigation Interim Report**

11/29/2013  
Embrear 190  
C9-EMC  
Bwabwata National park.  
NAMIBIA

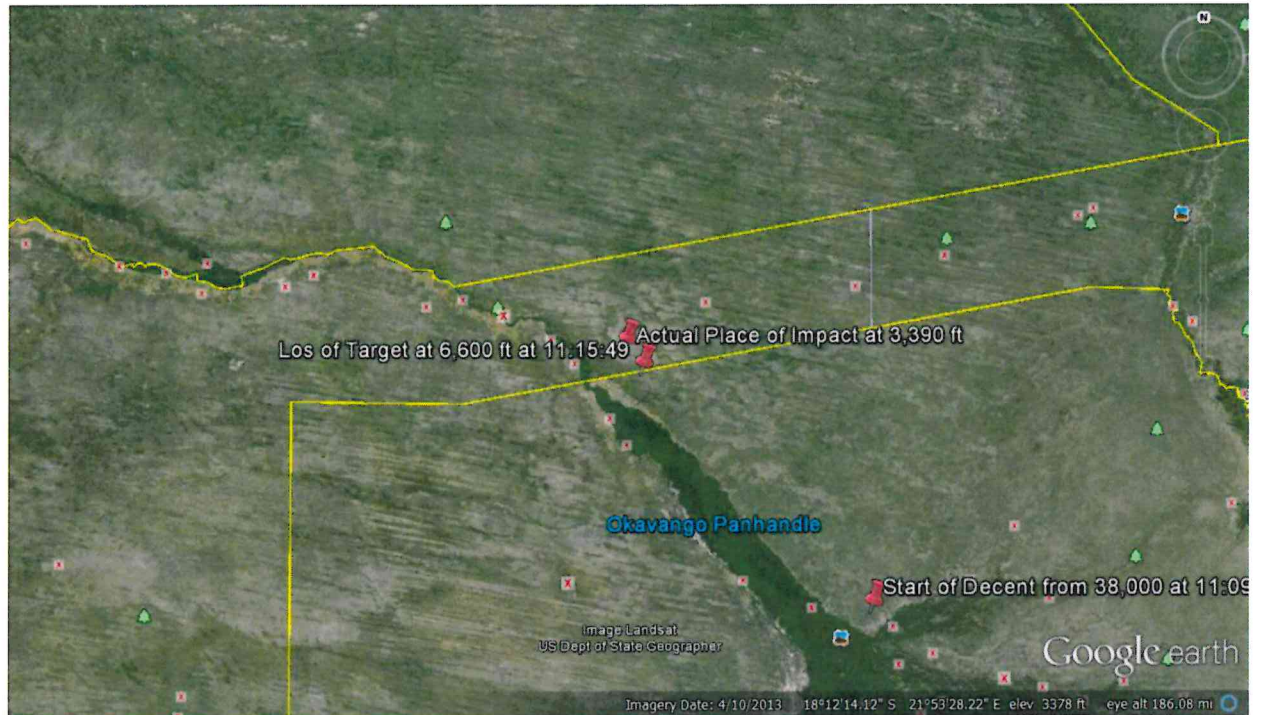
Map1 : Estimates from descent point to Radar loss Gaborone Airspace by the Namibian radar

Horizontal distance from top of descent to loss of radar 87.4 Km

Vertical distance from top of descent to radar loss 9 571m

Time taken from the descent till loss of Radar 6 min 43 sec

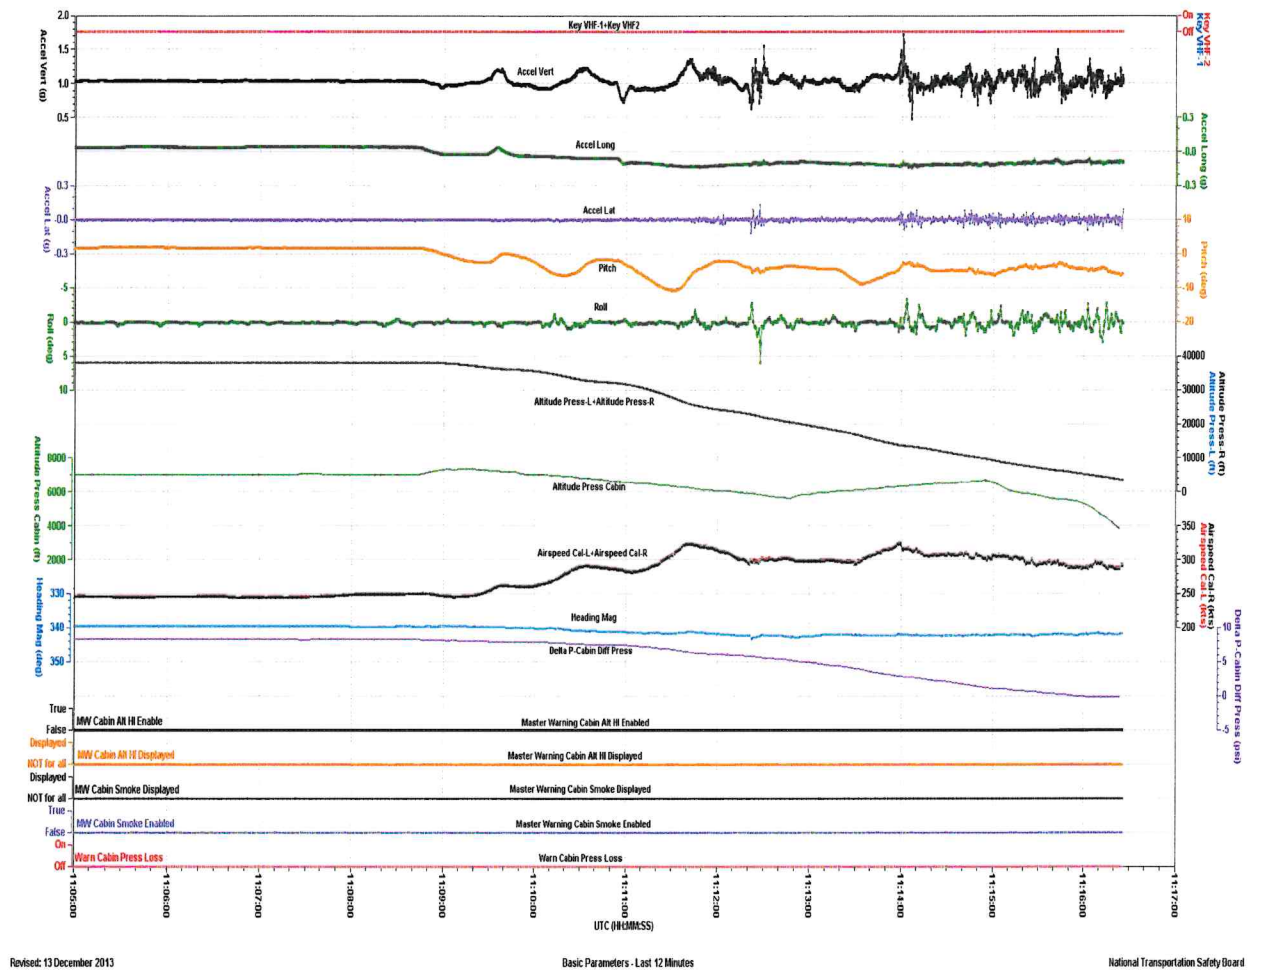
GRAPH 1 Basic parameter of the last 12 minutes of descent.

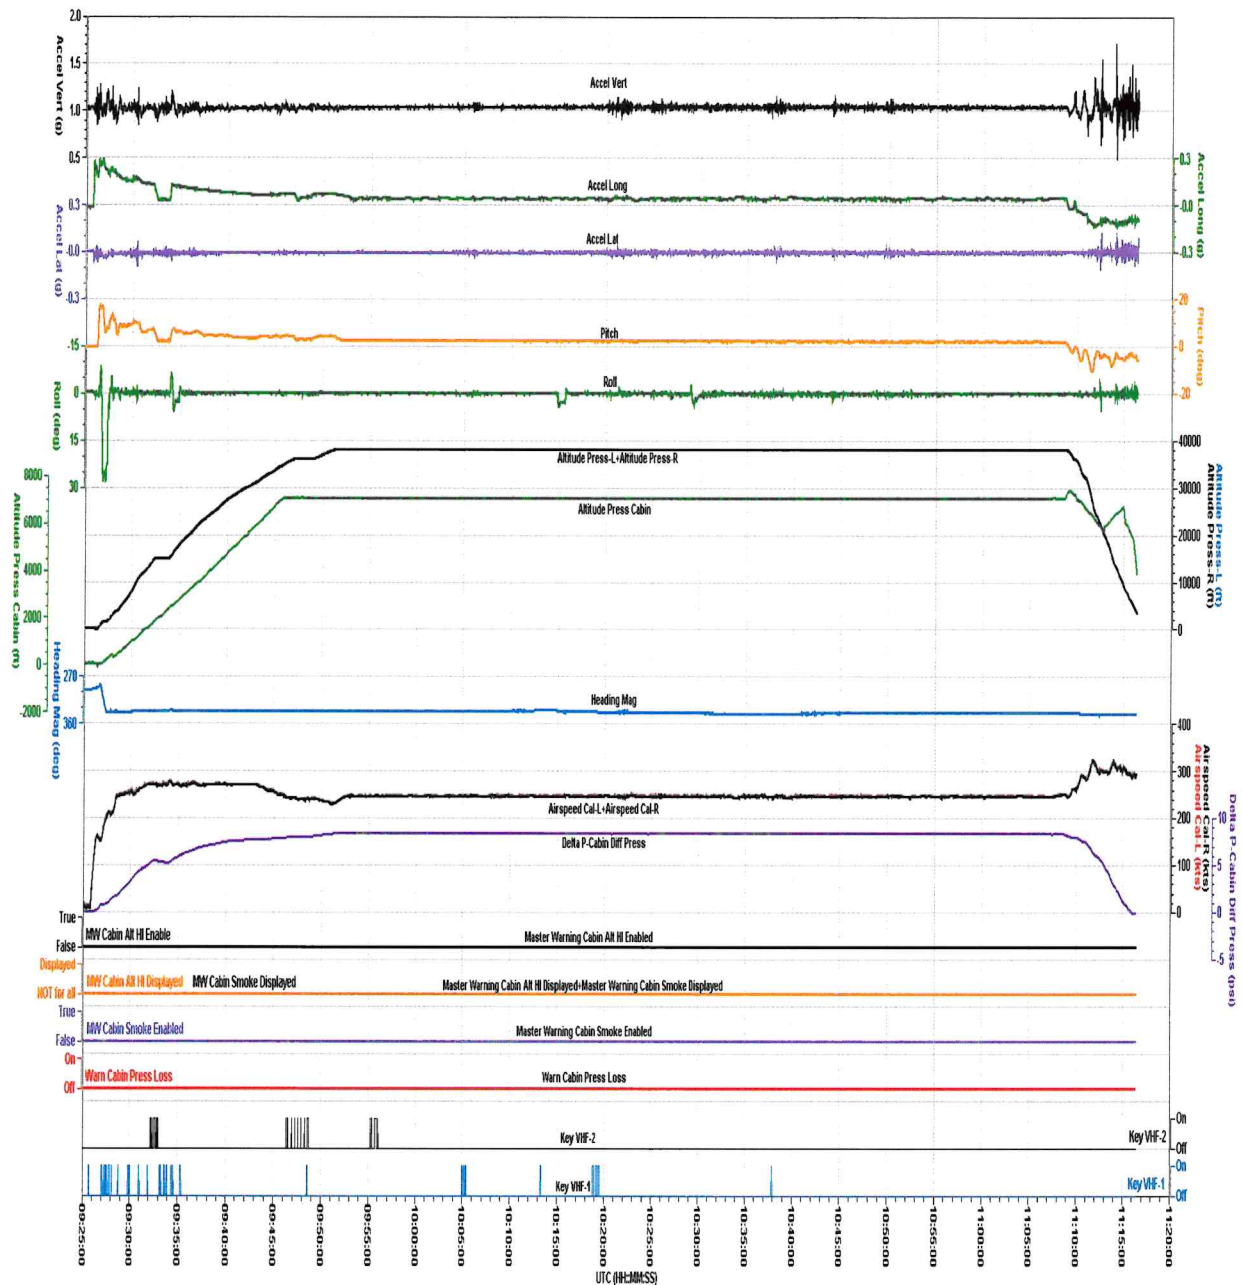
Graph 2 Basic parameters of the entire flight
