# Directorate of Aircraft Accident and Incident Investigations

Accident Reference: ACCID/07172023/01-06

# Aircraft Accident Investigation Interim Report

Release Date: 17 July 2024

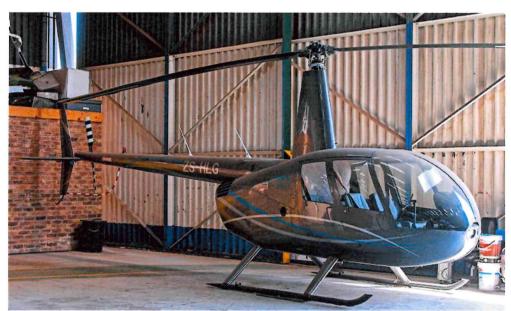
Figure 1: The Robinson 44 Raven II Helicopter ZS-HLG, accident aircraft (source: Flight Zone)

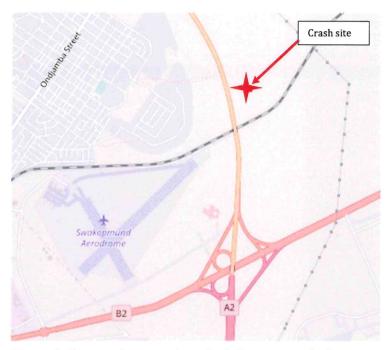
Figure 2: Picture showing where the helicopter crashed.

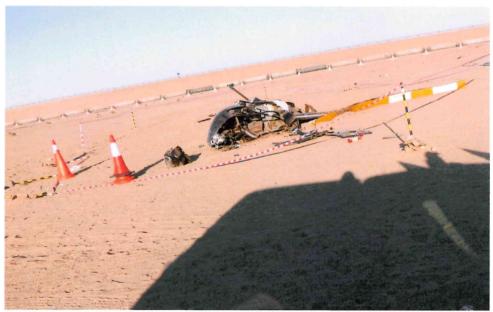
The helicopter was destroyed.

Figure 3: Picture showing the destroyed Helicopter as it came to rest.
