**Directorate of Aircraft Accident and Incidents
Investigations**

**Aircraft Accident Investigation Interim
Report**

16th November 2022 (12:45 UTC).
CESSNA 206 V5-NSK
Windhoek NAMIBIA

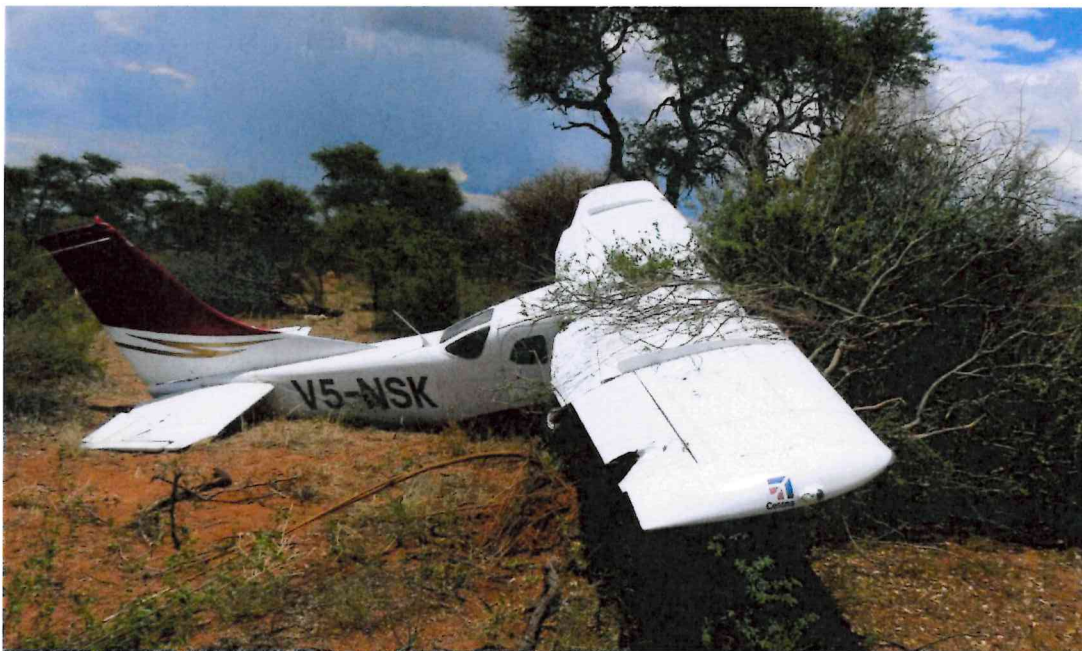
No one was injured however the aircraft was substantially damaged and later declared a hull loss.

Figure 1. Photo of damaged aircraft as it hit the bush

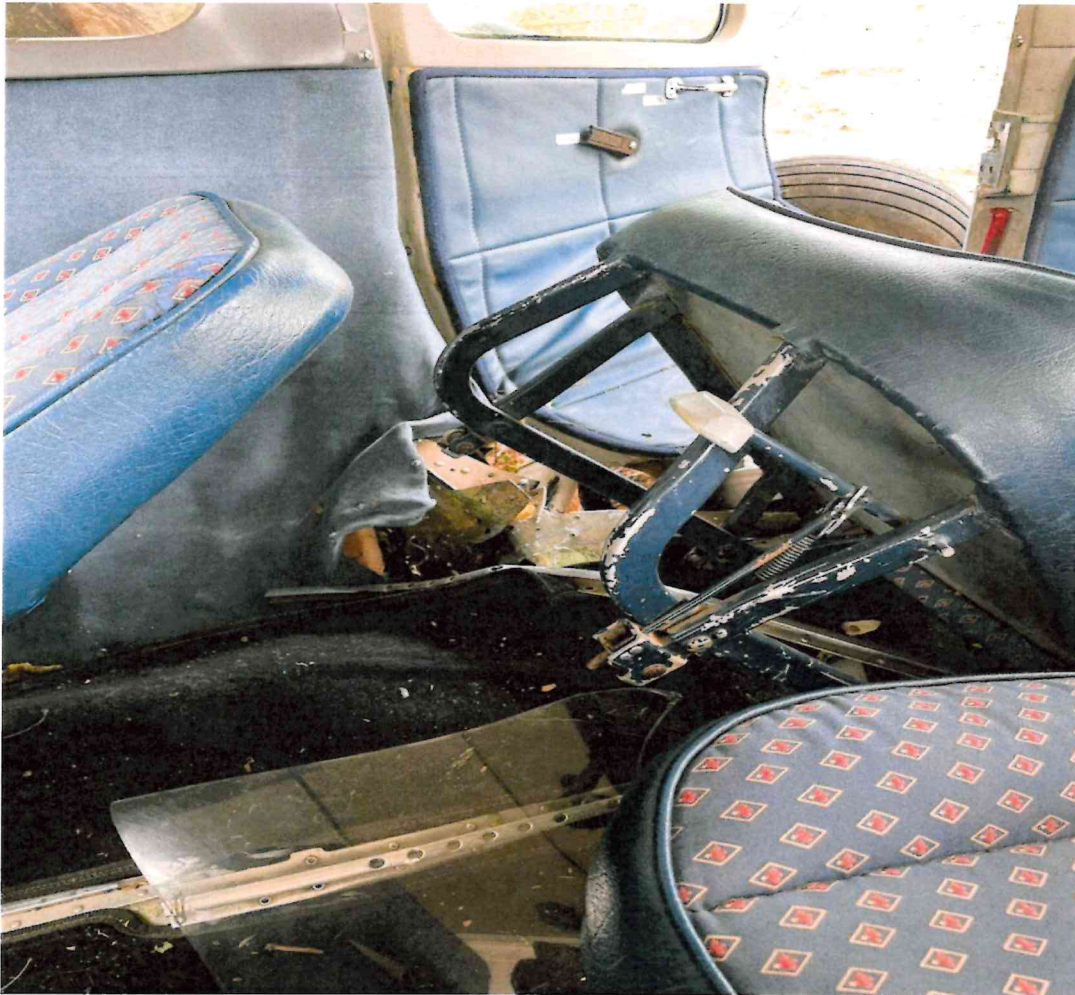
Figure 1. Aircraft wreckage was declared a hull loss.
