# Aircraft Incident Investigation Final Report

Occurrence number: INCID/02192023/02-02

Hard Landing

Registration: D-AXGB

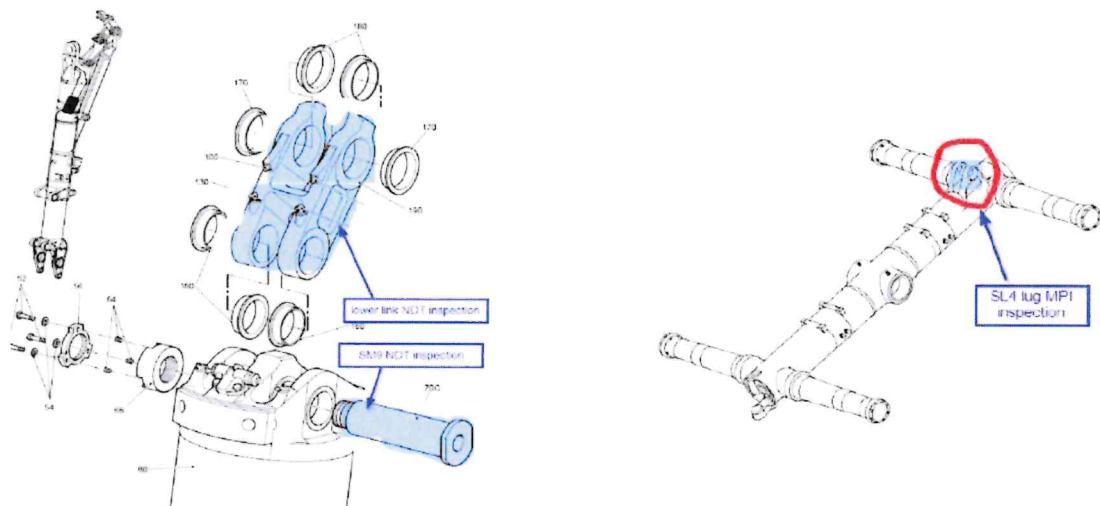
The left-hand main landing gear (L/H MLG) components, including Static Piston, Pitch Trimmer, upper Articulation link, Lower Articulation Link, SL1-5 pins had been detrimentally overloaded and were removed and scrapped by component mutilation.

The right-hand main landing gear (R/H MLG) Components, including the Static piston. Pitch Trimmer, SL pins 1,2,3,4 and 5, Upper and Lower Articulation links and the forward Pintle Pin were also found to have been detrimentally overloaded and were removed and scrapped.

Figure 1: NDT inspection

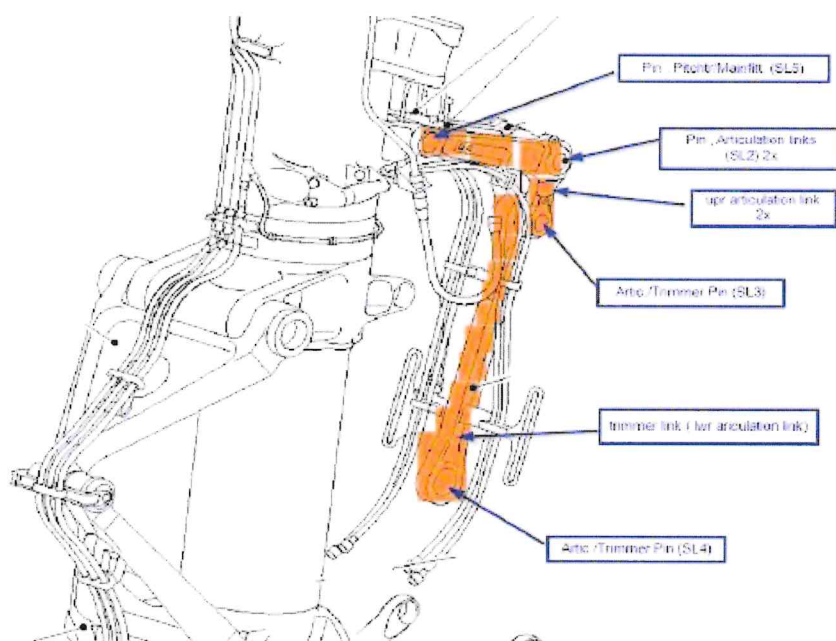
Figure 2: MLG components scrapped

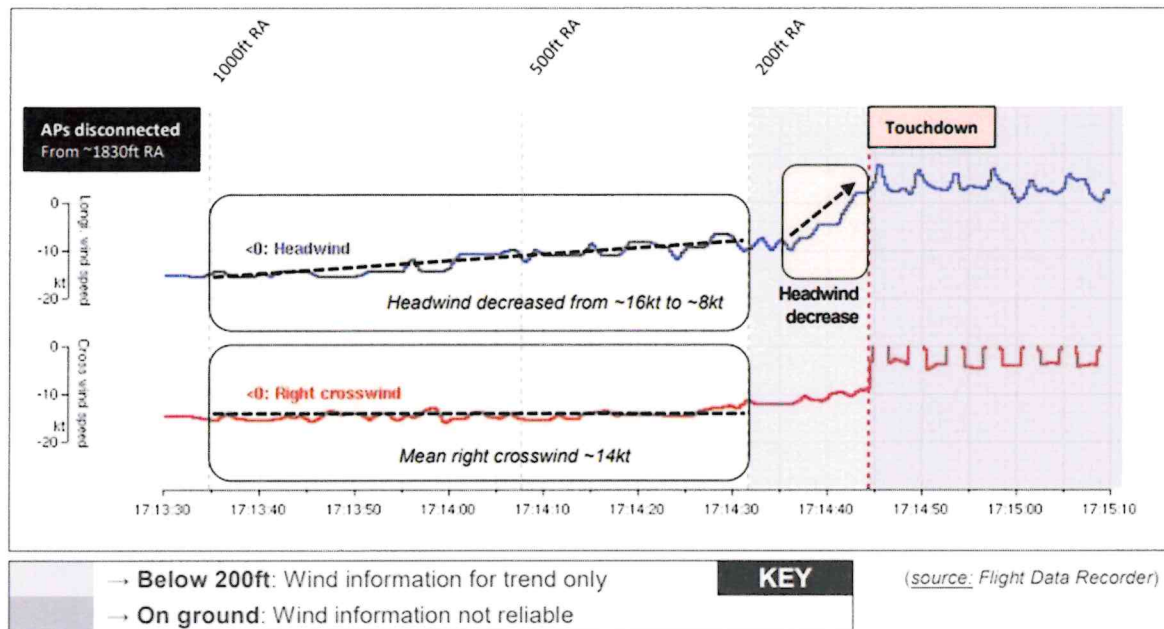
Figure 3 – Wind progression computed by the ADIRU<sup>2</sup>

The headwind component was decreasing from ~16kt to ~8kt.

The mean right crosswind component was around 14kt.

In the last 120ft, a progressive headwind decrease of ~13kt was encountered by the aircraft

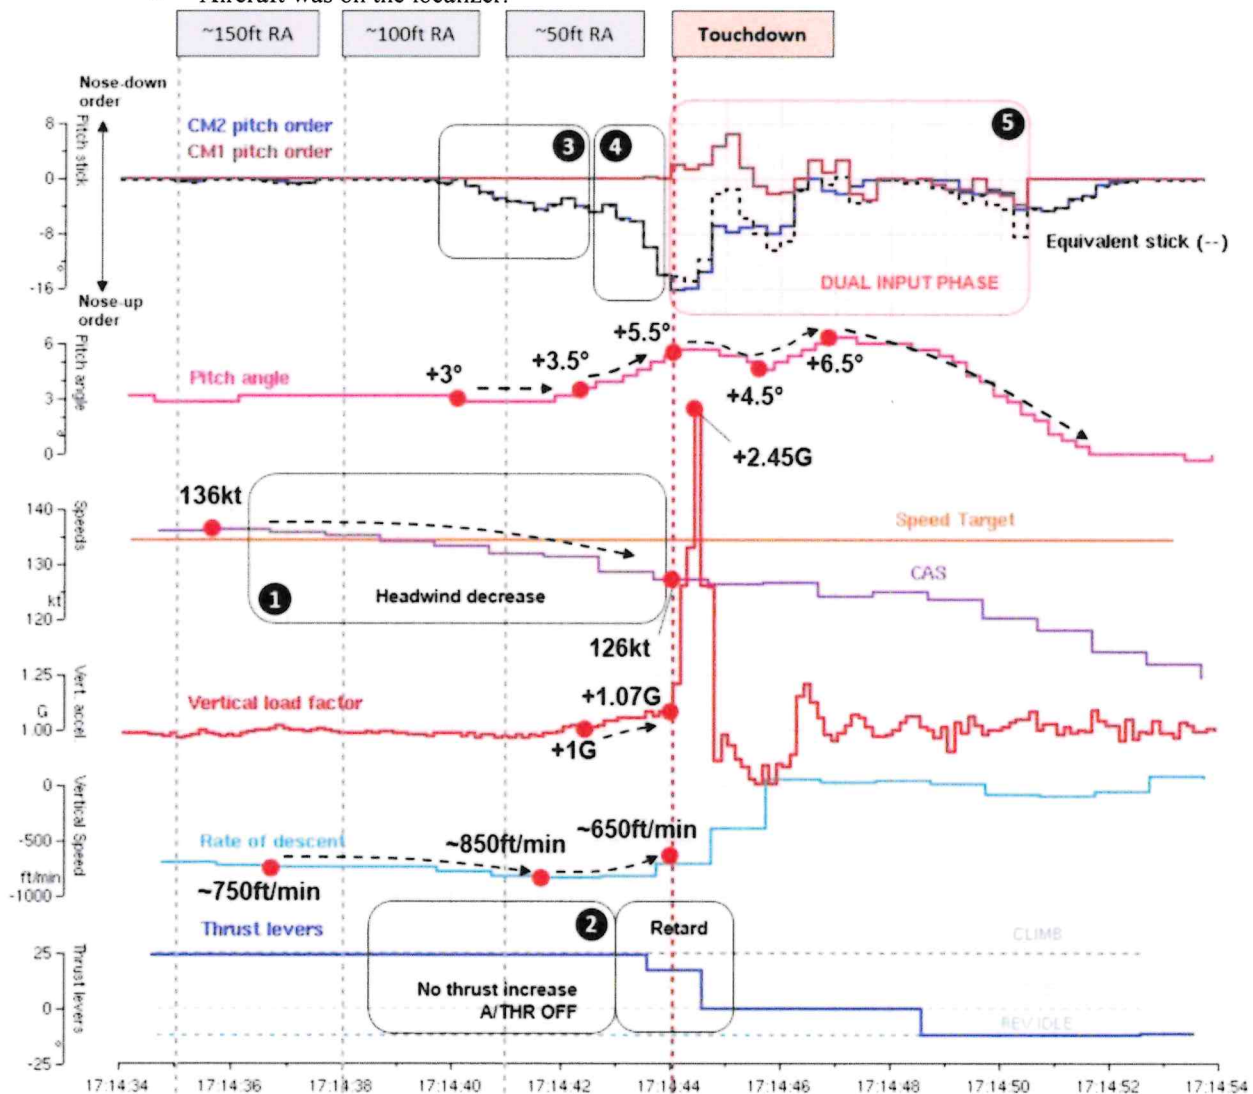
- At ~60ft RA, CM2 applied a progressive third of full nose-up deflection, which was then
- increased up to full deflection ~3s later:
- -Pitch angle increased up to +5.5° (nose-up).
- Rate of descent reached a maximum of ~850ft/min, then decreased to ~650ft/min.
- At ~5ft RA, thrust levers were retarded to the IDLE detent.
- CAS decreased from 136kt (speed target+2kt) to 126kt (VLS-3kt).

Figure 4 the last 120ft/longitudinal axis

*The insufficient back stick order applied by CM2 at ~60ft RA and this late back stick order applied at ~20ft RA did not sufficiently change the aircraft trajectory before touchdown to avoid a hard landing. See figure 4, number 2*
