# Directorate of Aircraft Accident and Incident Investigations

Occurrence Reference: ACCID/05092024/ 01-02

## Aircraft Accident Investigation Final Report

GYROPLANE ELA-07 V5-UIR

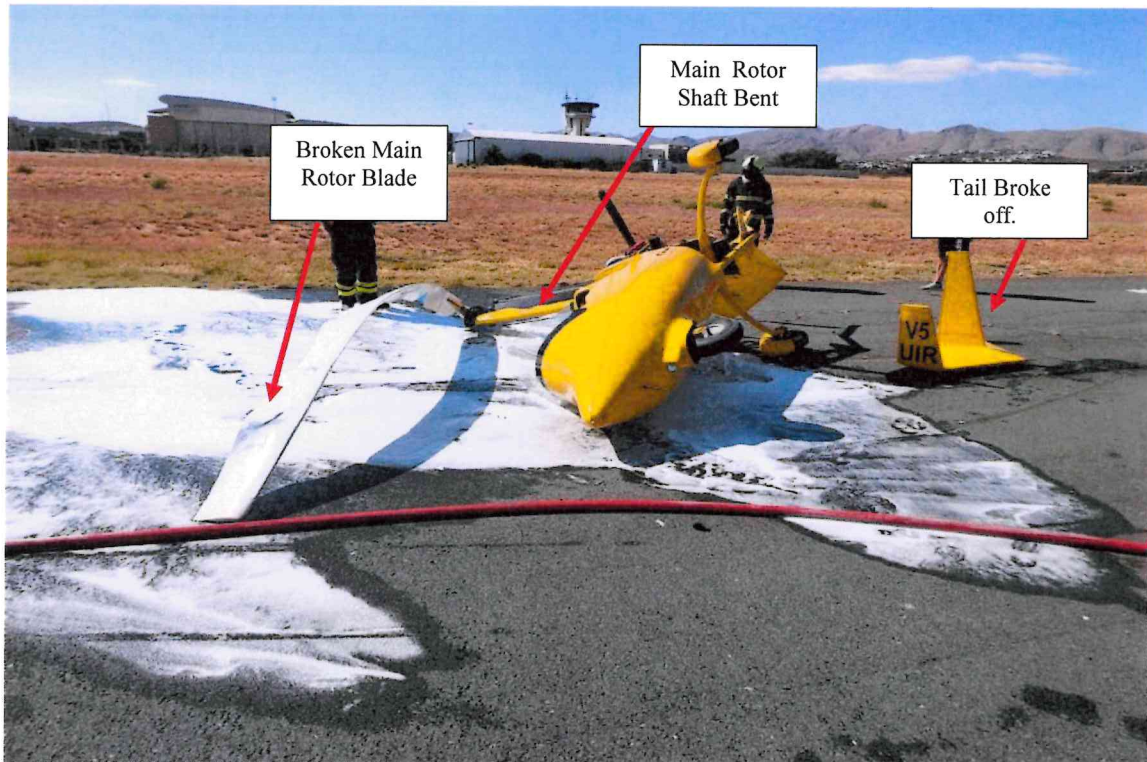
- 1.1.3 On touchdown on the second circuit, the pilot slowed the Gyroplane down to almost a complete standstill. Just before coming to a full stop, a gust of wind from the west (left side) hit the Gyroplane and lifted the left main wheel off the ground. Before the pilot could do anything about the gust (counter act), the Gyroplane fell over due to the gust onto its right-hand side.

1.3.1 The aircraft sustained substantial damage.

Figure 2: The aircraft as it came to rest.

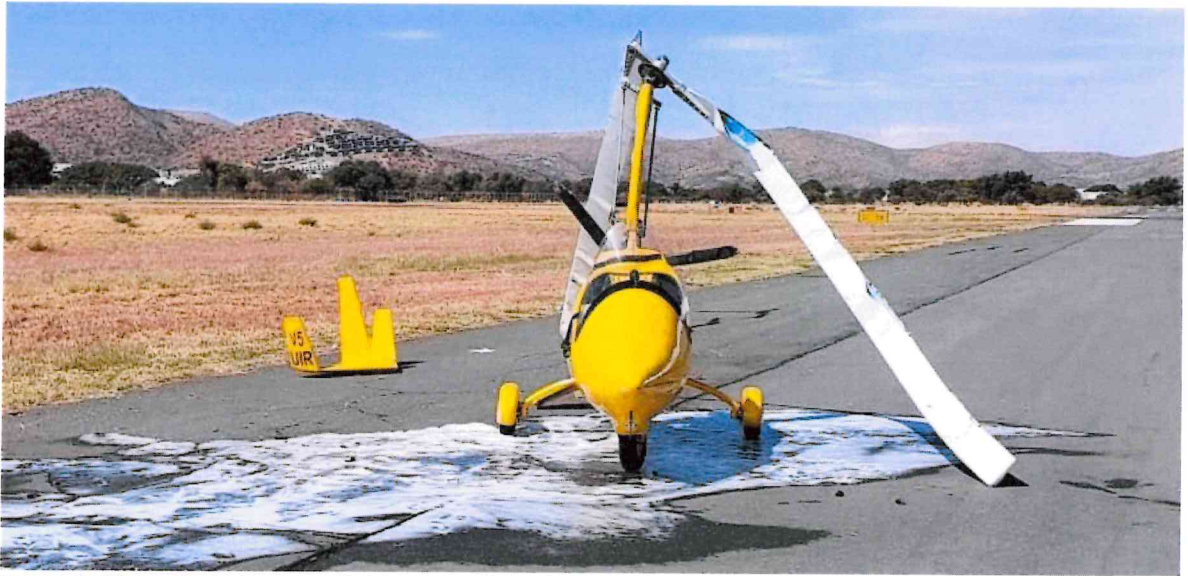
When the Gyroplane fell on its side, the spinning main rotor blades stroke the ground causing the blades to be substantially damaged. The propeller on the engine also impacted the ground and the propeller blades were broken. The impact also caused damage to the main rotor shaft and casing, the main rotor shaft was bent. The tail broke off and was separated from the aircraft.

Figure 4: Photo depicting overall damage to Gyroplane.

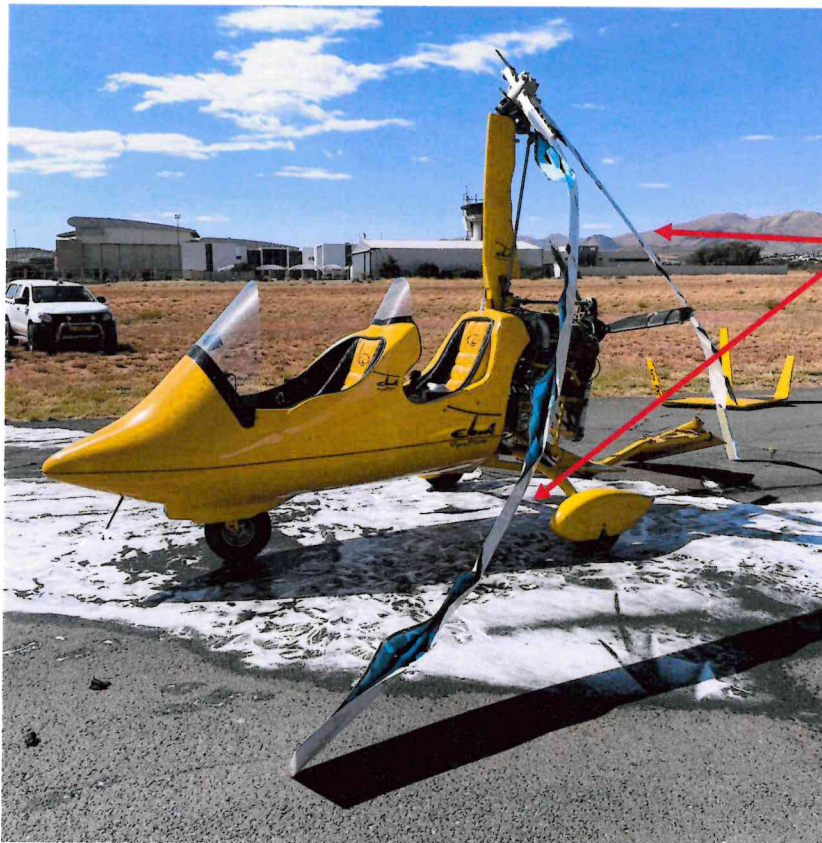
Damage to the main rotor

Figure 5: Photo depicting damage to main rotor.

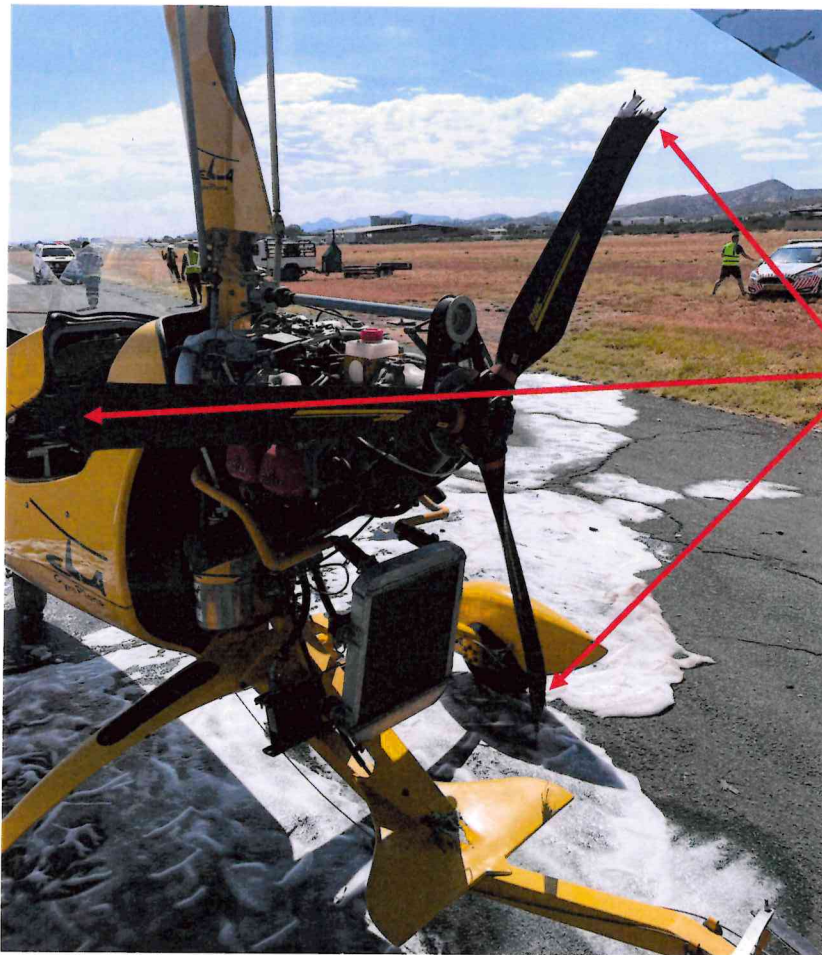
Damage to engine propeller

Figure 6: Photo depicting damage to the engine propeller.

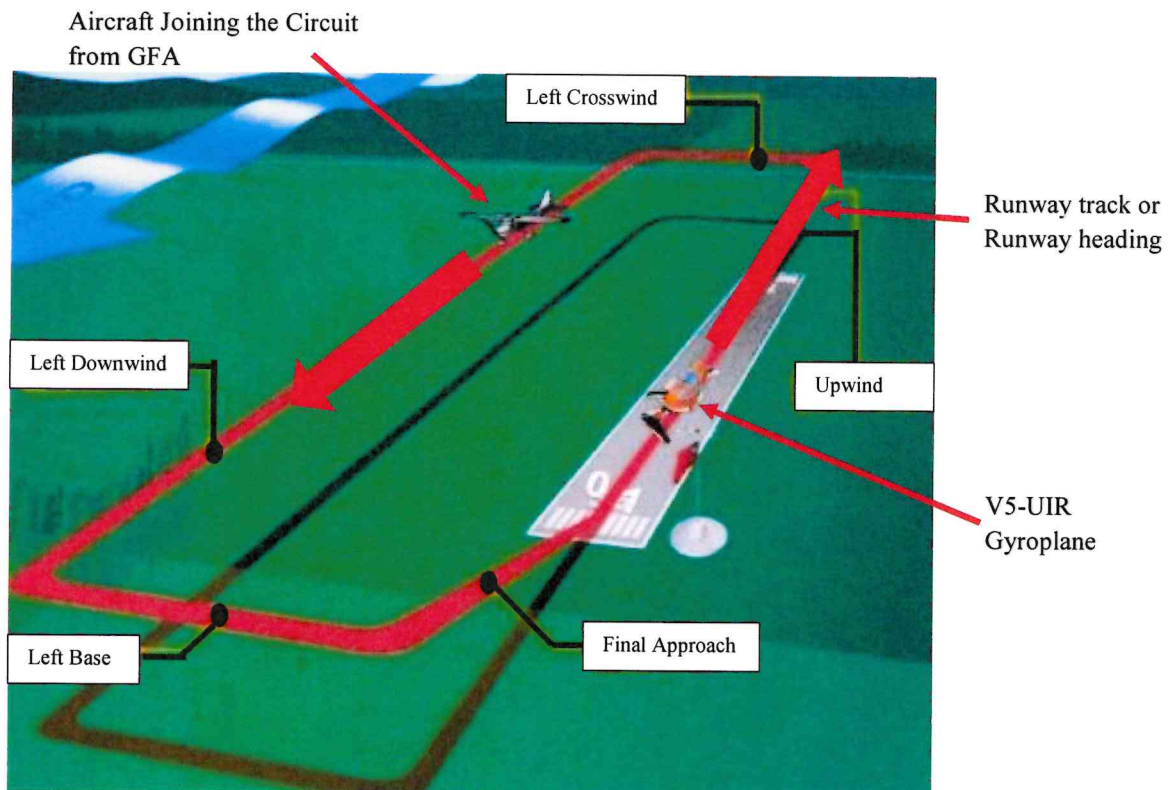
Recordings from the Eros Air Traffic Control tower frequency 118, 7 MHz were impounded for analysis. From the air traffic control recordings, the investigator found that the instruction to the gyroplane was, cleared for the touch-and-go and maintain runway track until the pilot have another aircraft that was returning from the General Flying Area and was joining the circuit via the left-hand downwind position insight. Runway track is, once an aircraft is airborne and on the same heading as the runway, the wind direction and speed must be considered and compensated for as not to blow the aircraft to the left or right of the runway heading.

Figure 7: Illustration of the traffic situation in the Eros circuit at the time of the accident.
