**Accident Investigation Preliminary Report**

DESCRIPTION OF OCCURRENCE: Loss of Control (LOC-I).  
TYPE OF OPERATION: Aerial Survey/Observation (Game Count).  
AIRCRAFT TYPE: Robinson R44 Helicopter  
LOCATION: Farm Uris, Mountainous Terrain (S19° 16' 13.81" E17° 32' 31.17")  
DATE AND TIME: 17 October 2025, 08:15 Local Time

Aircraft Registration: V5-HIG  
Aircraft Type: Robinson R44 Helicopter  
Operator: Namibia Helicopter Services  
Type of Operation: Aerial Survey/Observation (Game Count)  
Date & Time of Occurrence: 17 October 2025, 08:15 Local Time  
Location: Farm Uris, Mountainous Terrain (S19° 16' 13.81" E17° 32' 31.17")

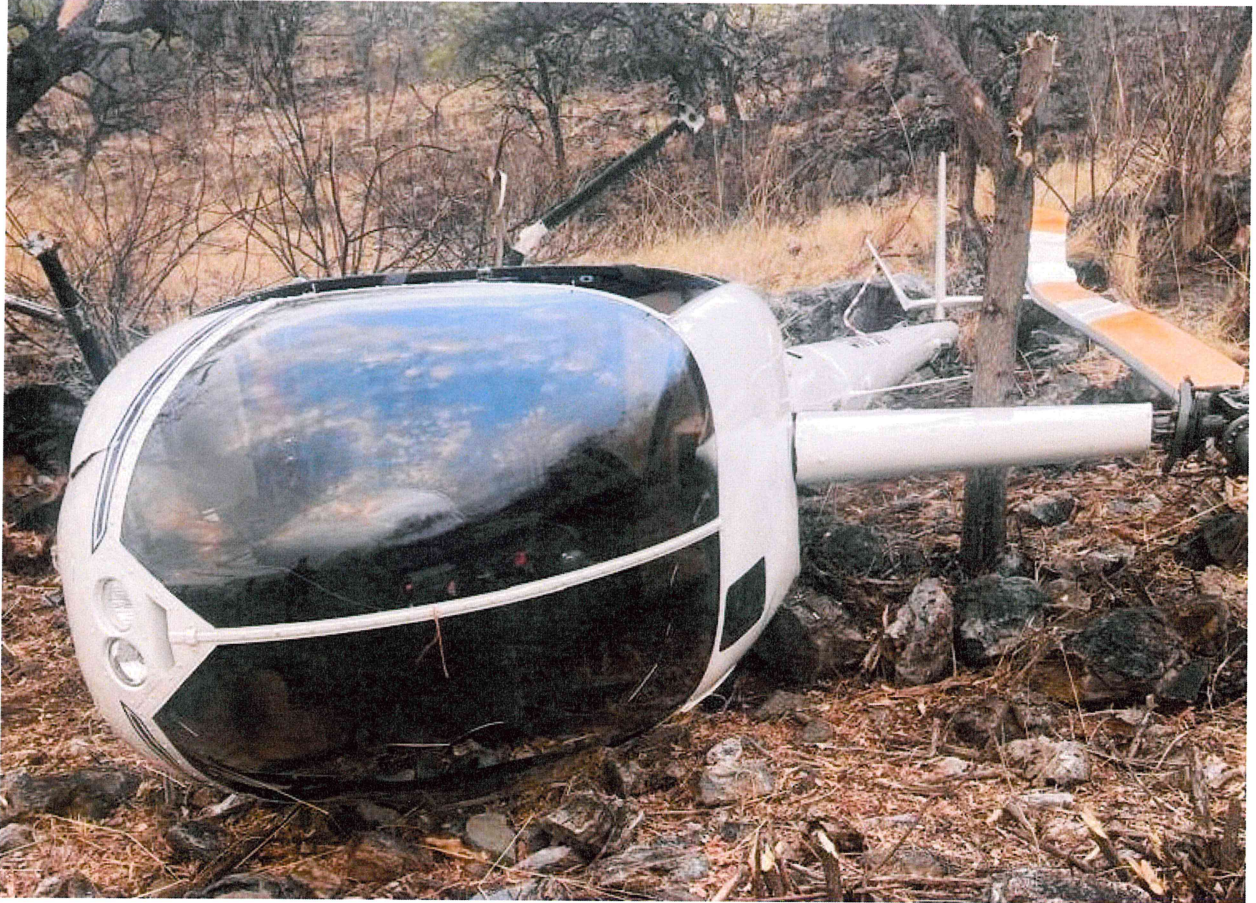
The pilot identified an open clearing on the sloped terrain for an emergency landing. During the final approach, the main rotor blades struck a high-density tree to the right of the aircraft. The impact caused the helicopter to pitch and roll left, sliding down the slope, and rolling onto its side, resulting in the catastrophic destruction of the drivetrain and airframe.

Photo 1. The helicopter rolled onto its left side after impacting the trees.

The attempted emergency landing resulted in the main rotor blades striking a tree, leading to catastrophic damage to the rotor system and the subsequent roll-over. The aircraft sustained substantial damage.

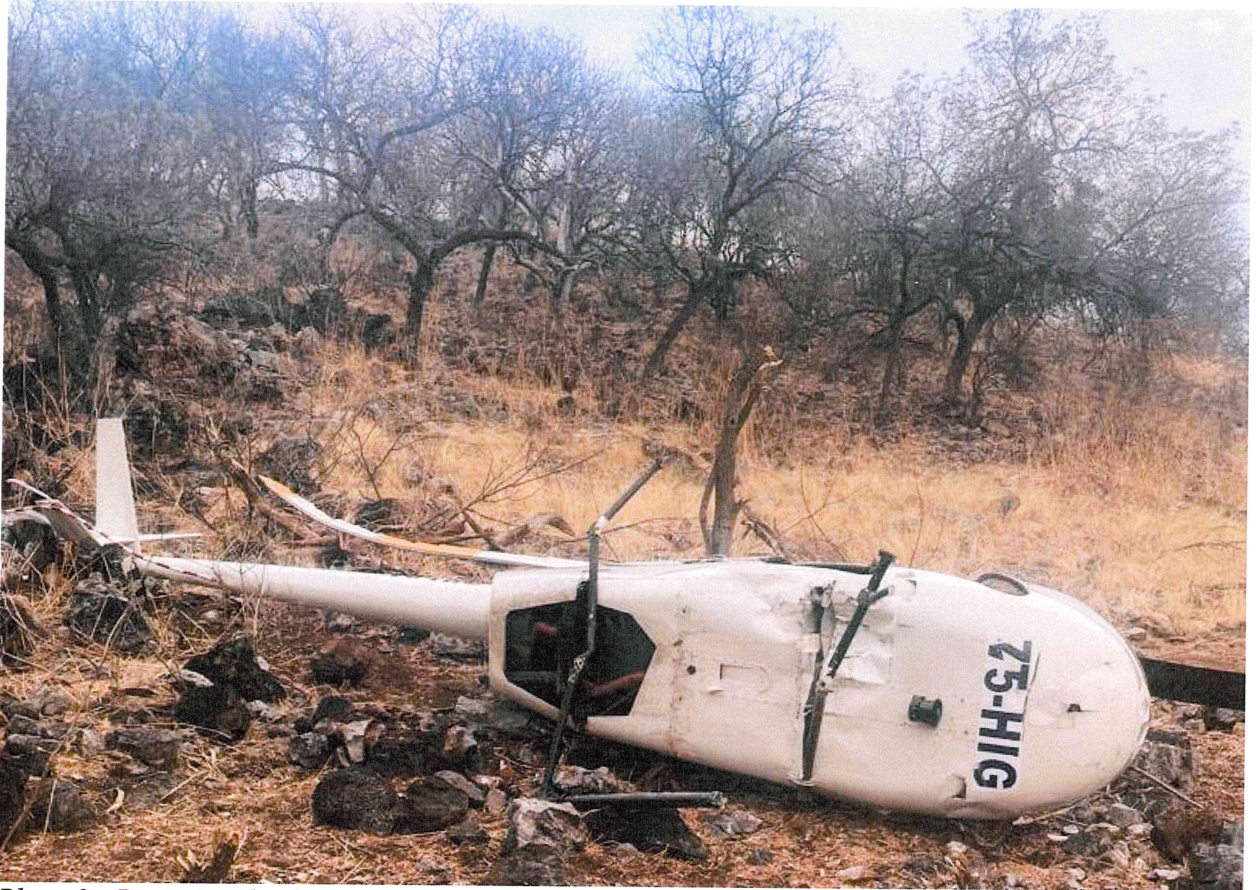
*Photo 2 : Depicting the damage to the under carriage*
